WYLE TEST REPORT NO. T59087.01

APPENDIX A.1

NOTICES OF ANOMALY

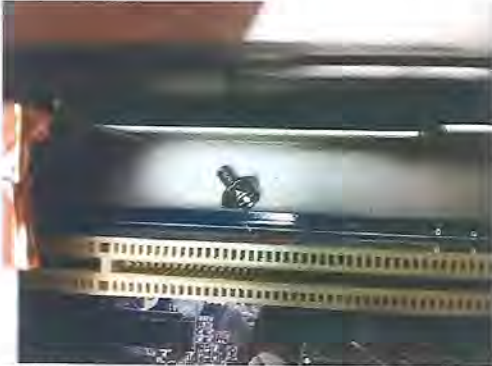
| <p>Following the vibration test performed on May 4, 2012, the Unit Under Test was examined for anomalies that may have occurred during testing. It was discovered, upon opening the exterior cover, that covers a screw with a captive washer had become loose and fallen into the bottom area adjacent to a large connector assembly on a metal tray. Photographs were taken of the anomaly and the remainder of the examination revealed no further issues.</p> | | |

| <p>The final disposition is pending a root cause analysis to be presented by the client.</p> | | |

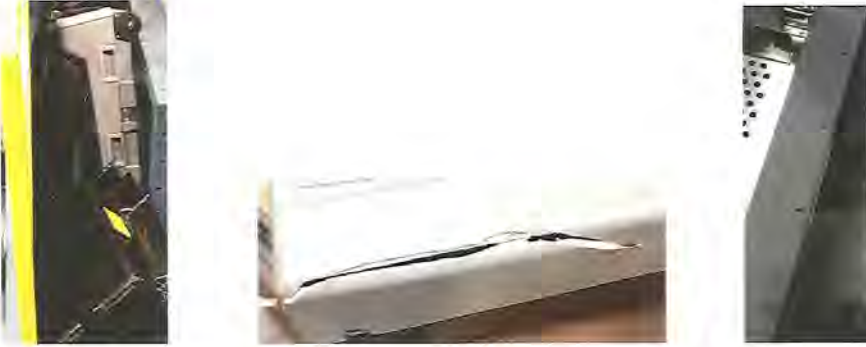
| NOTICE OF ANOMALY | | DATE: 05/17/2012 |
|--|--|---|
| <p>During the setup of the vibration test, the UUT was dropped on its side causing the whole carrying case with the DS200 in it to come apart from the lower part of ballot box. The DS200 and carrying case dropped from the vibration table to the concrete floor. The carrying case and the DS200 were damaged. The UUT was examined and a determination was made that the UUT needed to be replaced. The serial number of the new UUT is ES0108340579.</p> | | |

| NOTICE OF ANOMALY | | DATE: 05/17/2012 |
|--|--|---|
| <p>The client requested that the UUT be replaced with another unit so the testing can continue. The damaged UUT will be sent back to the client.</p> | | |

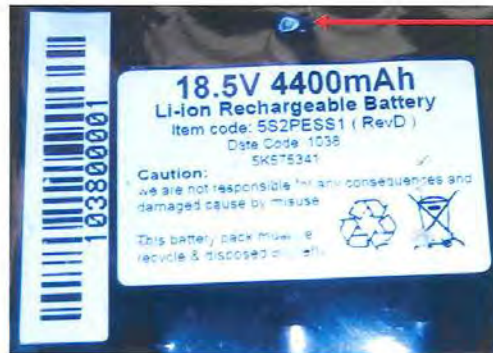
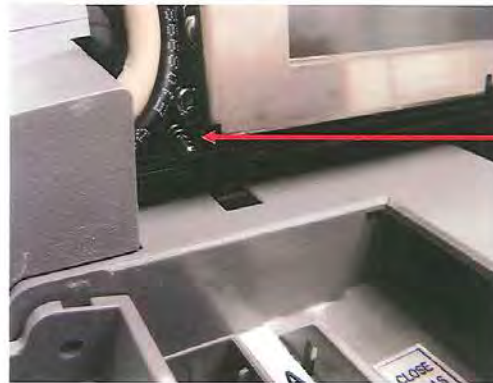
| NOTICE OF ANOMALY | | DATE: 05/17/2012 |
|--|---|---|
| <p>Following the vibration test performed on May 16, 2012, the Unit Under Test was examined for anomalies that may have occurred during testing. Initially a component was heard to be loose inside the LCD case. It was discovered, upon opening the exterior cover of the LCD, that a screw had become loose inside of the LCD case of the DS200. The like screw on the opposing side of the LCD bezel mount was found to be loose as well, but still attached. Photographs were taken of the anomaly and the remainder of the examination revealed some wear through 3 layers of material, exposing metal of the Li-ion Rechargeable Battery.</p> | | |

| NOTICE OF ANOMALY | | DATE: 05/17/2012 |
|--|---|---|
| <p>The final disposition is pending a root cause analysis to be presented by the client.</p> | | |

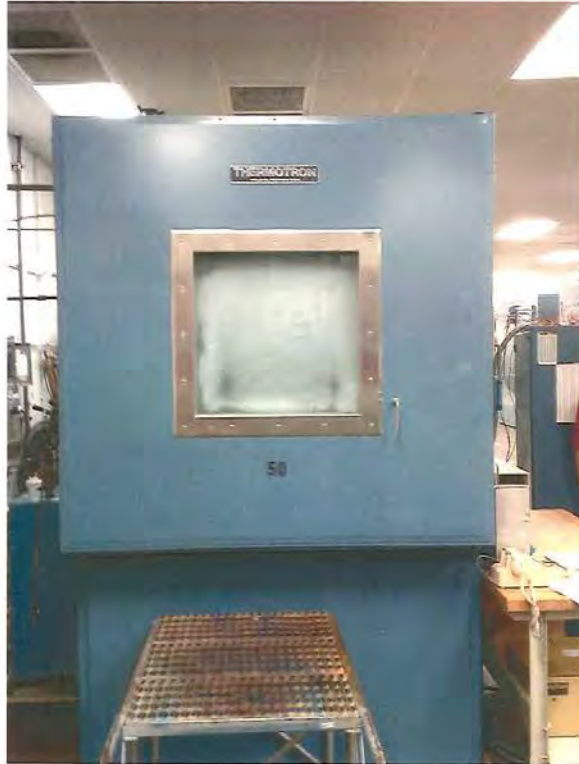
| During the Humidity test being performed between May 25, 2012 – June 04, 2012, the Humidity Chamber suffered a controller failure on May 29, 2012. When the it was observed that the required environment could not be maintained, the test was halted and the units where removed from the failing chamber. A post-operational test was performed on all 4 UUT that where being tested in the humidity chamber at the time of said failure. Photographs were taken of the testing site. Testing was rescheduled to be performed between June 01, 2012 – June 11, 2012 in a alternate humidity chamber. | | | |

| A final disposition is not required by the client, due to the categorization of this failure as Test Equipment. Wyle comments that the humidity chamber failure will be investigated and rectified prior to future testing with said chamber. | | | |

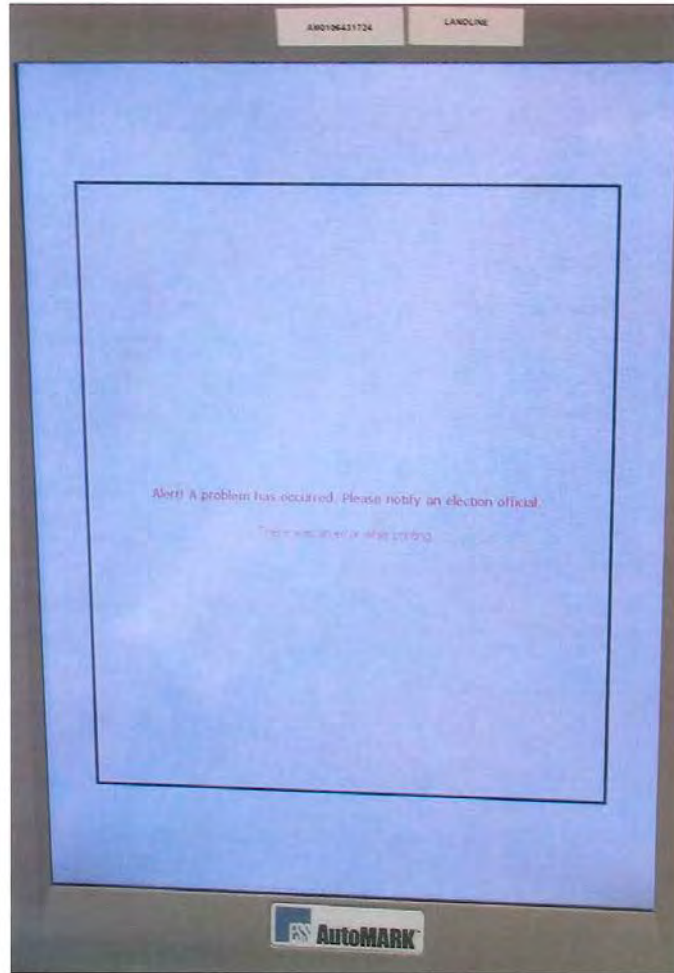
| After the being subjected to the Humidity test being performed between June 01, 2012 – June 11, 2012, the A100 failed to function properly during the Post Operating Status Check. When the it was observed that the UUT could not successfully mark 5 consecutive ballots, it was at that time that the A100 portion of the Humidity test was identified as a failure. Photographs were taken of the testing site. The reoccurring message during the failure was "Alert! A problem has occurred. Please notify an election official. There was an error while printing". | | |

| The final disposition is pending a root cause analysis to be presented by the client. | | |

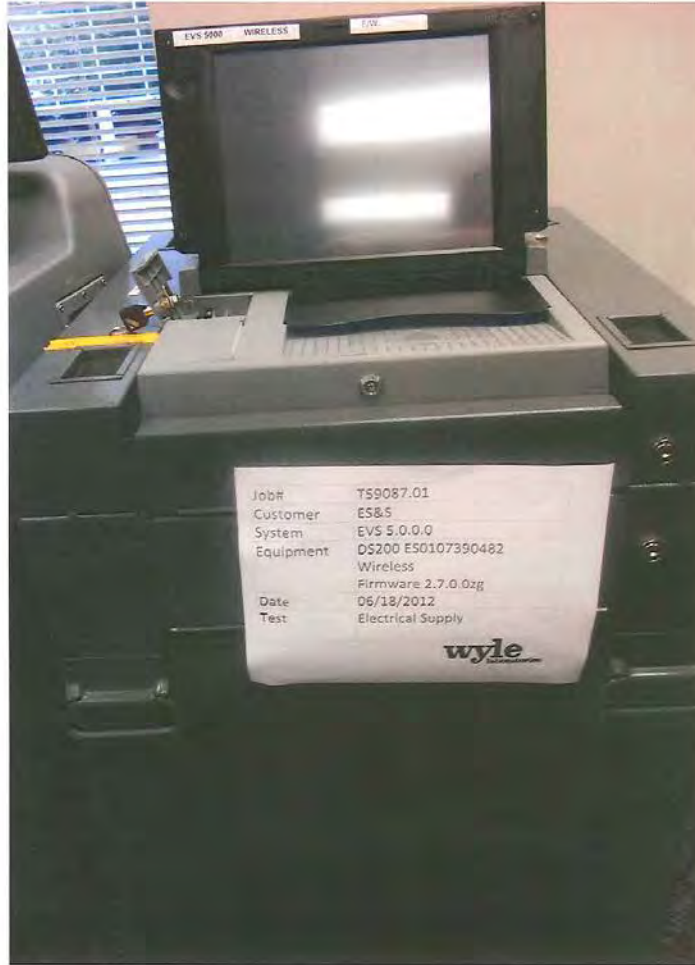
| <p>After the being subjected to the Electrical Supply test being performed on June 19, 2012 the DS200's battery was depleted after only 1 hour, 37 minutes and 20 seconds. When the it was observed that the UUT shutdown prior to completing the 2 hour requirement, the Electrical Supply Test of the DS200 was identified as a failure. Photographs were taken of the testing site.</p> | | | | |

| The final disposition is pending a root cause analysis to be presented by the client. | | | | |

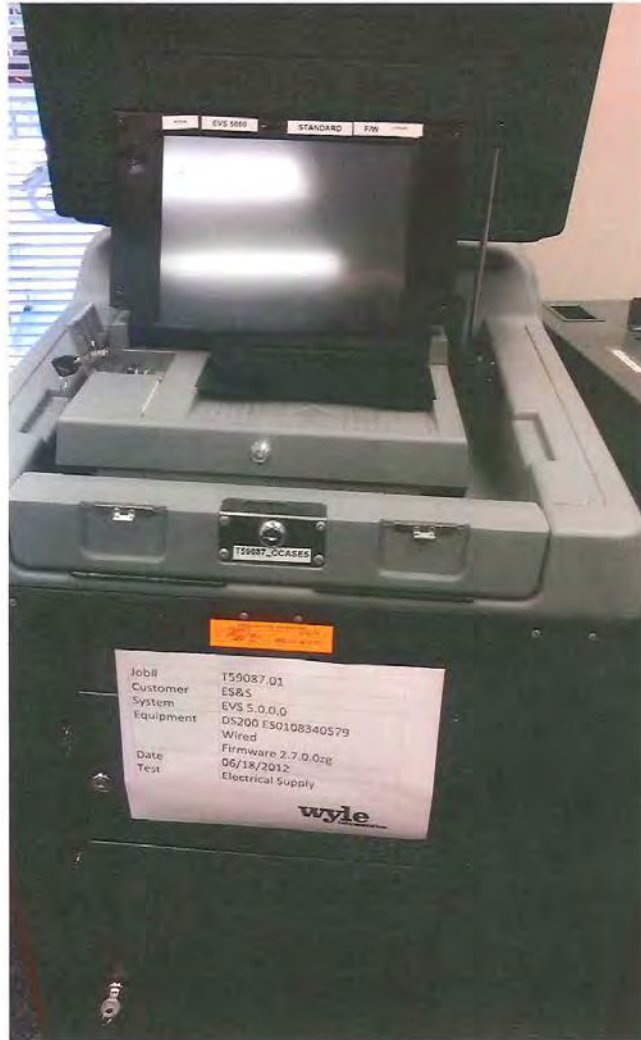
| <p>After the being subjected to the Electrical Supply test being performed on June 19, 2012 the DS200's battery was depleted after only 1 hour, 43 minutes and 6 seconds. When the it was observed that the UUT shutdown prior to completing the 2 hour requirement, the Electrical Supply Test of the DS200 was identified as a failure. Photographs were taken of the testing site.</p> | | | | |

| The final disposition is pending a root cause analysis to be presented by the client. | | | | |

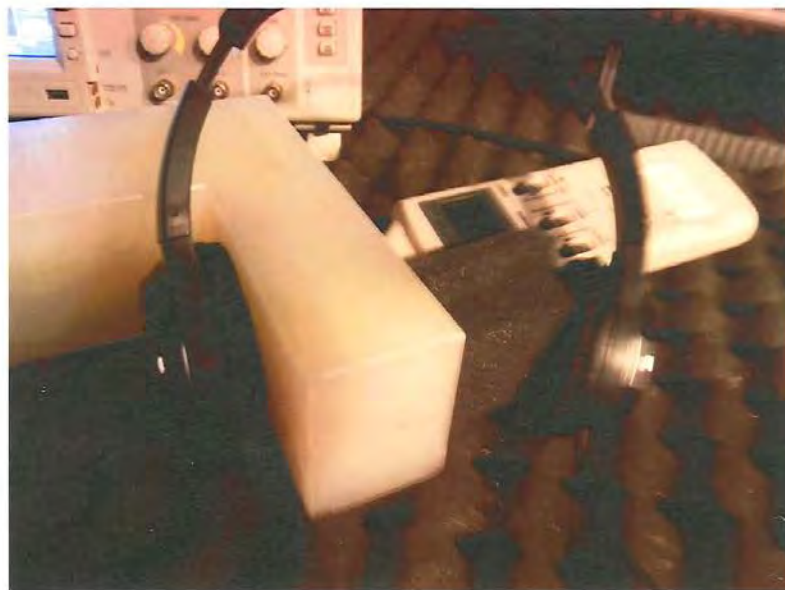
After the being subjected to the Acoustic Noise Level Test and Hearing Aid Compatibility as performed on June 19, 2012. When it was observed that the A100 failed to achieve the required 100 dB SPL, it was at that time that the A100 portion of the Acoustic Noise Level Test and Hearing Aid Compatibility was identified as a failure. The highest volume produced by the UUT was 75 dB. Photographs were taken of the testing site.

The final disposition is pending a root cause analysis to be presented by the client.

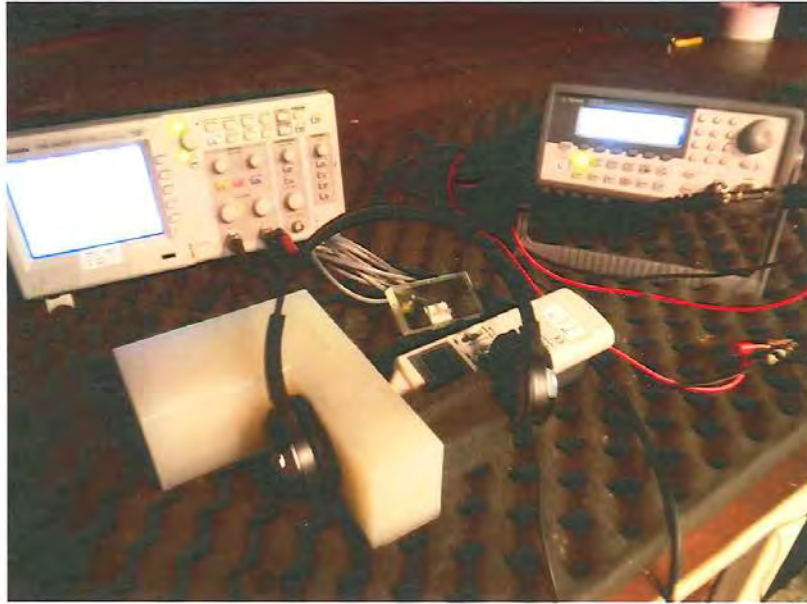
| <p>DESCRIPTION OF ANOMALY:</p> <p>After the being subjected to the Acoustic Noise Level Test and Hearing Aid Compatibility as performed on June 19, 2012. When it was observed that the A200 failed to achieve the required 100 dB SPL, it was at that time that the A200 portion of the Acoustic Noise Level Test and Hearing Aid Compatibility was identified as a failure. The highest volume produced by the UUT was 75 dB. Photographs were taken of the testing site.</p> | | |

| <p>DISPOSITION • COMMENTS • RECOMMENDATIONS:</p> <p>The final disposition is pending a root cause analysis to be presented by the client.</p> | | |

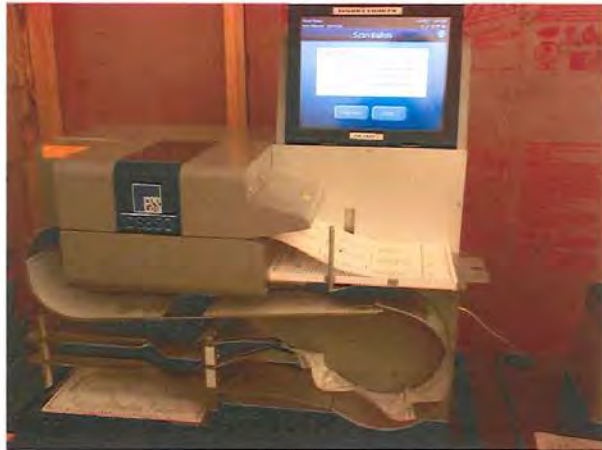
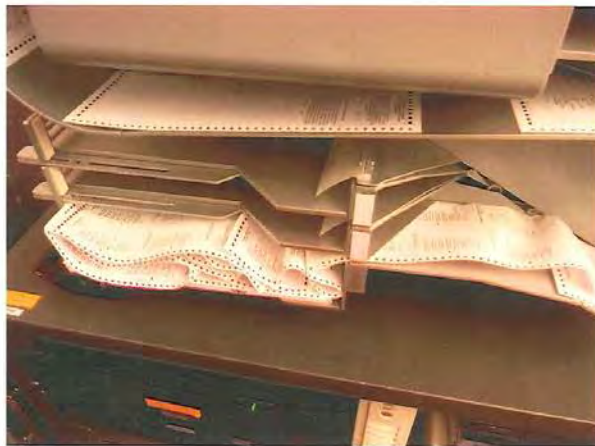
| <p>Following the Operating Environmental Test performed on June 26, 2012, the Unit Under Test was examined for anomalies that may have occurred during testing. After completing 18 hours of the scheduled 85 hours of testing, 6 ballot jams had occurred on the UUT and the testing was halted due to the quantity and frequency of failures achieved during the test. It was discovered, by the vendor during a root cause analysis phase that the UUT required a metal shim to be installed in the UUT. Digital images were taken of the test site and UUT.</p> | | |

| <p>The final disposition is pending a root cause analysis to be presented by the client.</p> | | |

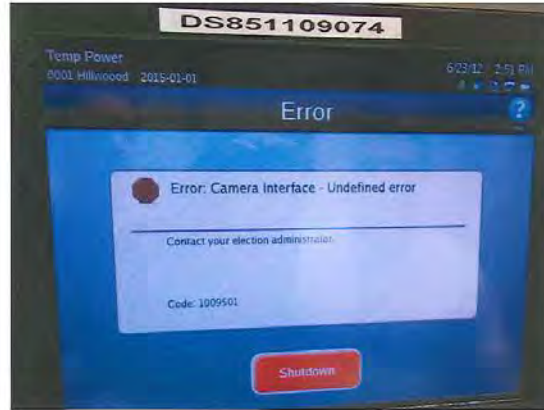
| <p>Following the Operating Environmental Test performed on June 29, 2012, the Unit Under Test was examined for anomalies that may have occurred during testing. After completing 18 hours of the scheduled 85 hours of testing, "Camera Interface Error" had occurred on the UUT. Following the System Operating Procedure, the UUT was Shutdown and restarted. Upon logging into the UUT, it was observed that "Camera Interface Error" occurred again. It was at this time that testing was halted due to the inability to proceed with the UUT, after it was determined that the UUT suffered "degradation of performance such that the device is unable to perform its intended function for longer than 10 seconds" as identified in VVSG Volume 1, 4.3.3 Reliability. ES&S personnel advised, Wyle Personnel to take note that the Image Processing Board possessed one blinking green light and 2 solid green lights. Digital images were taken of the test site and UUT.</p> | | |

Error: Camera Interface

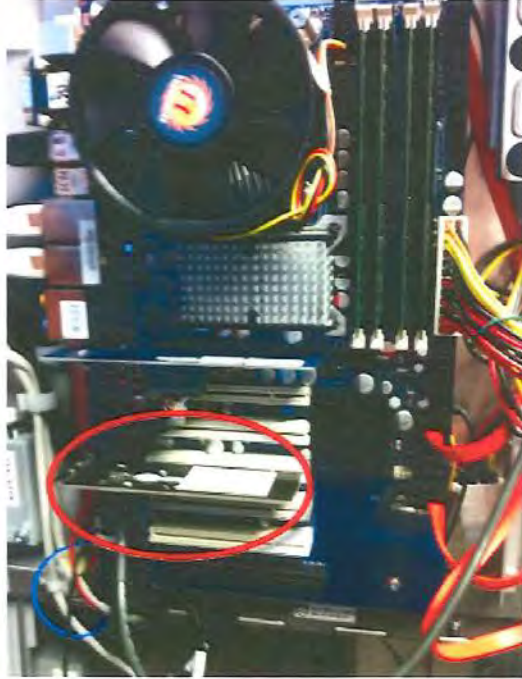
USB board – circled in Red.
