Introduction

This report presents the results of the engineering analysis for Engineering Change Orders (ECO) and Engineering Approval Change (EAC) submitted by Unisyn Voting Solutions, Inc. to be implemented into the OpenElect Voting System (OVS), Version 1.0. The primary purpose of the engineering analysis was to determine if the changes submitted for the OVS are "De Minimis" changes according to the U.S. EAC Testing and Certification Manual, or are considered a modification.

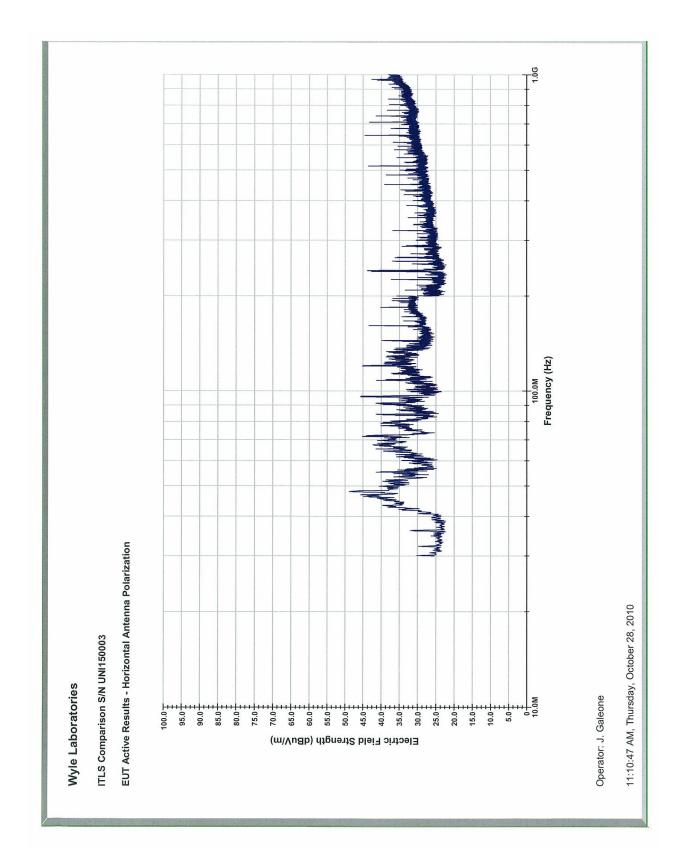
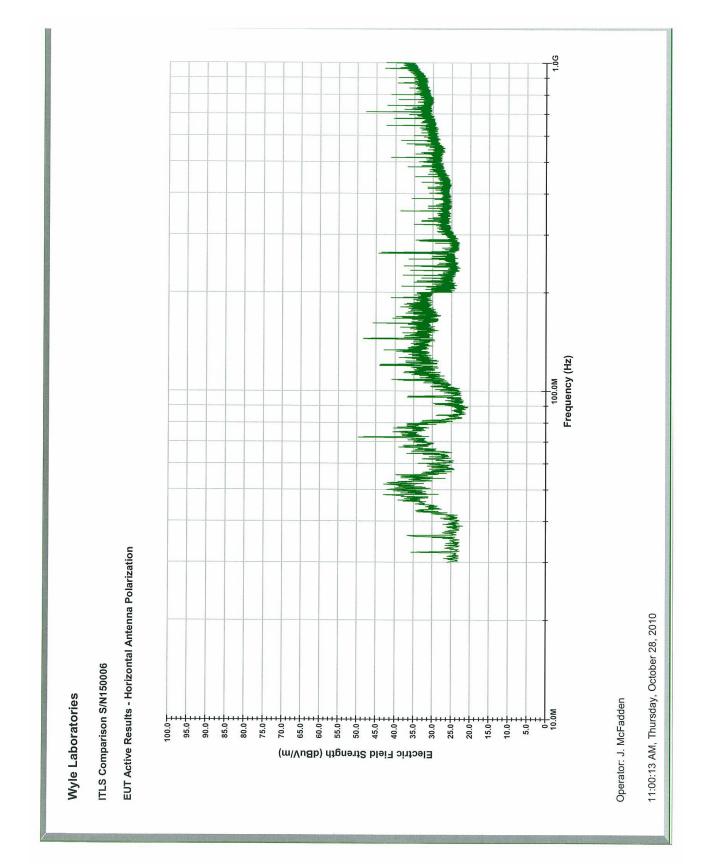
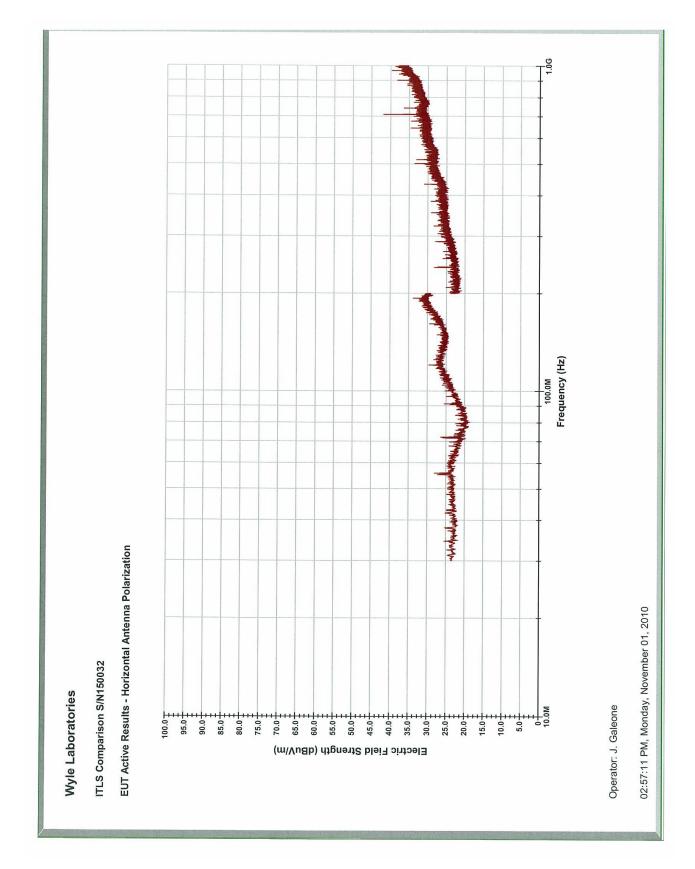
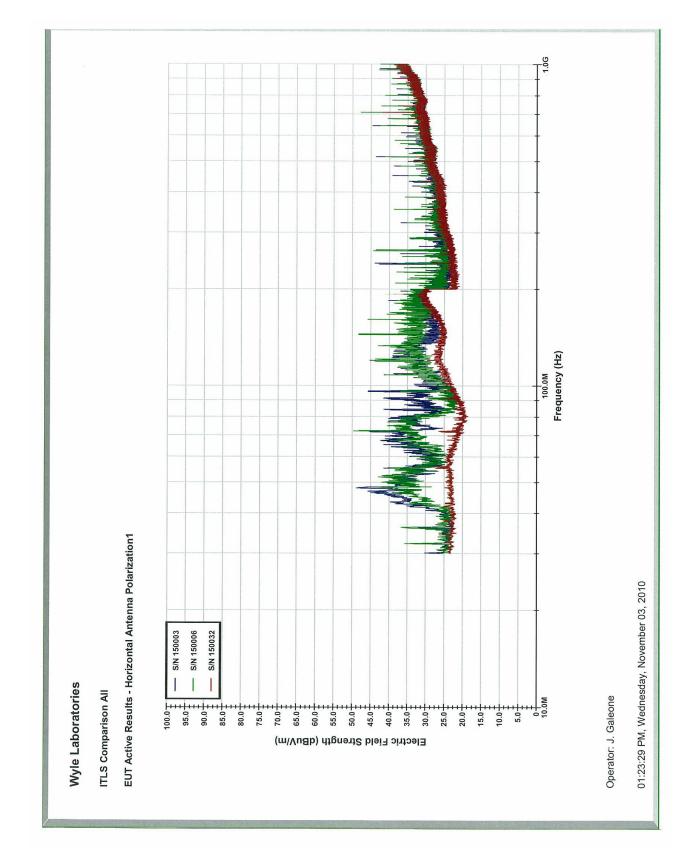
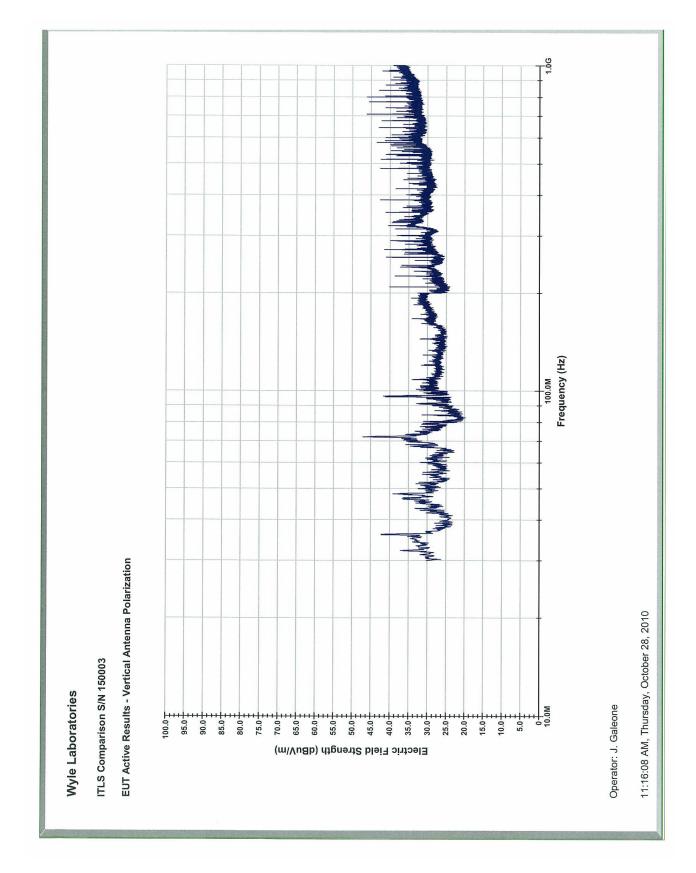
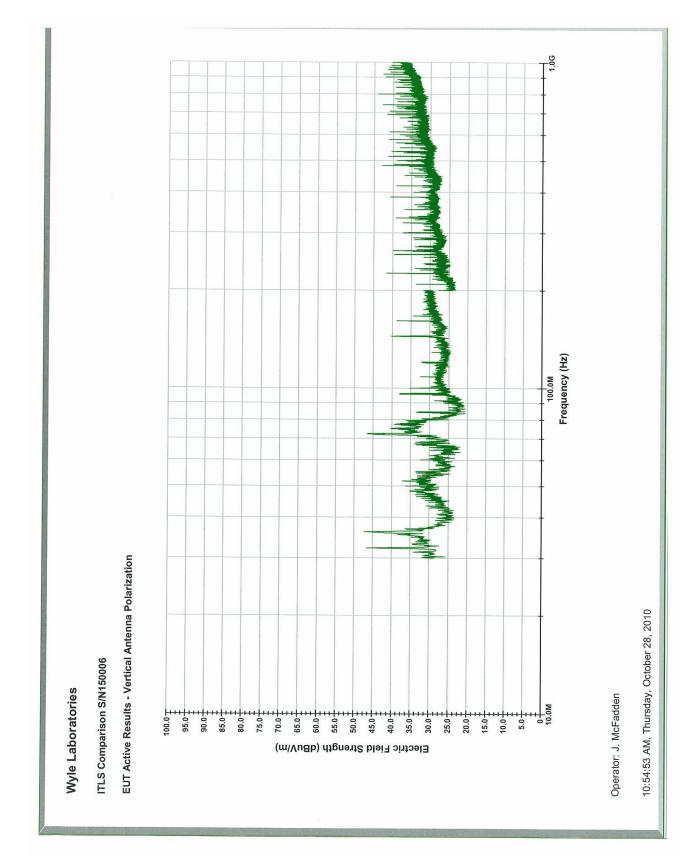
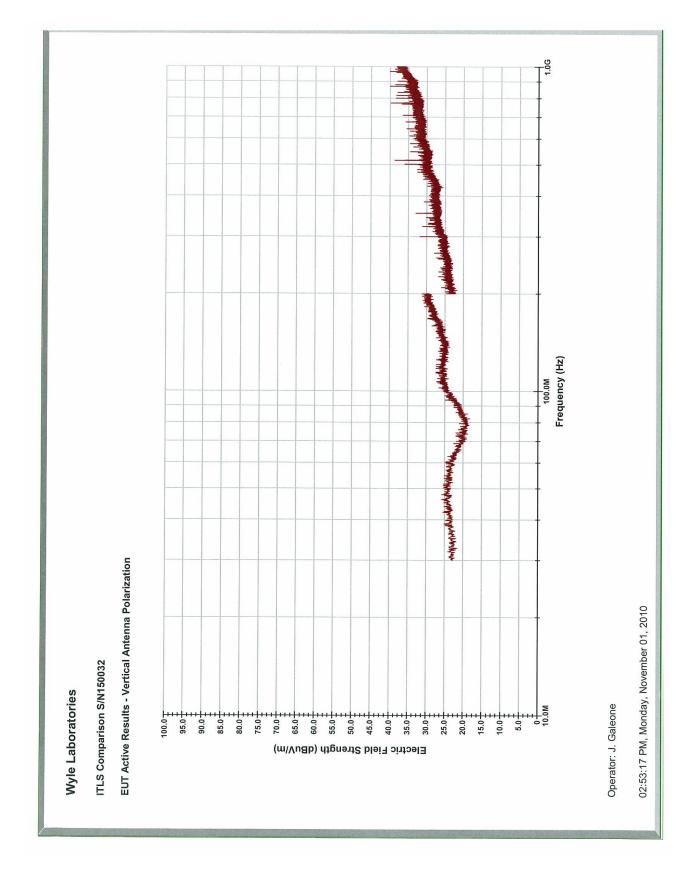
APPENDIX A

These three scans provided Wyle with enough data to make the assessment that the hardware updates are not significant and to suggest these changes be considered minor. The scans revealed there is a greater difference between units than the difference of a single unit with the different hardware components. The results of this scan are presented in Appendix A.
