Page No. C-1 of 25 Test Report No. T71013.01-01

ATTACHMENT C NON-OPERATING ENVIRONMENTAL TEST DATA

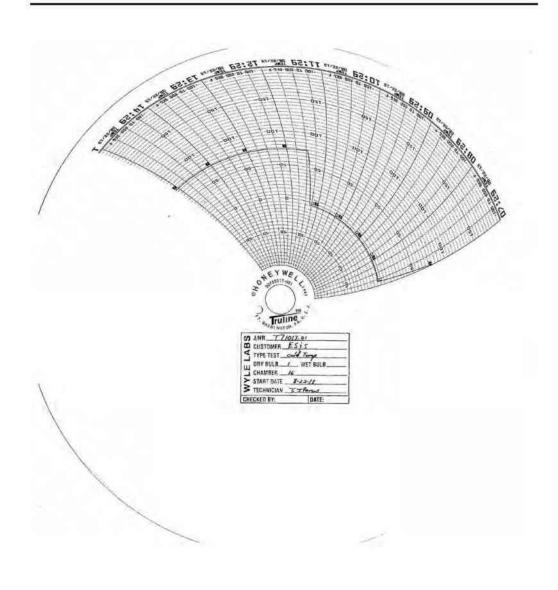
Page No. C-3 of 25 Test Report No. T71013.01-01

Page No. C-2 of 25 Test Report No. T71013.01-01 LOW TEMPERATURE TEST DATA WYLE LABORATORIES, INC. **Huntsville Facility**

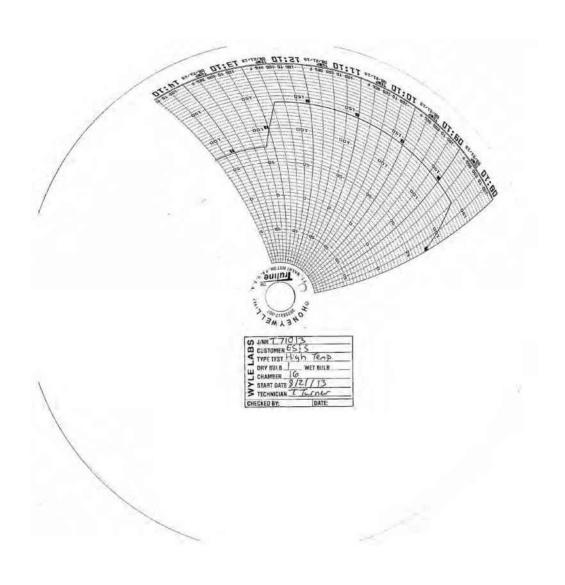
Page No. C-5 of 25 Test Report No. T71013.01-01

Page No. C-4 of 25 Test Report No. T71013.01-01 HIGH TEMPERATURE TEST DATA WYLE LABORATORIES, INC. **Huntsville Facility**

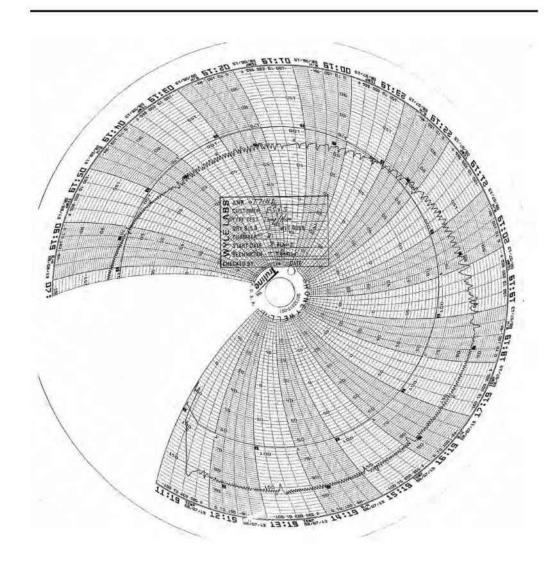
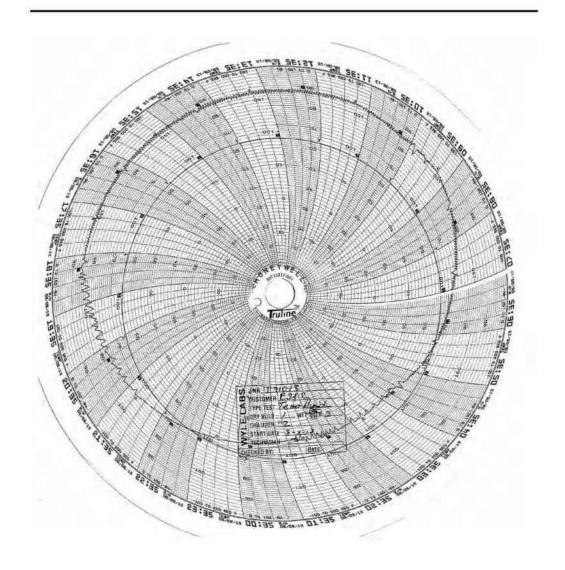
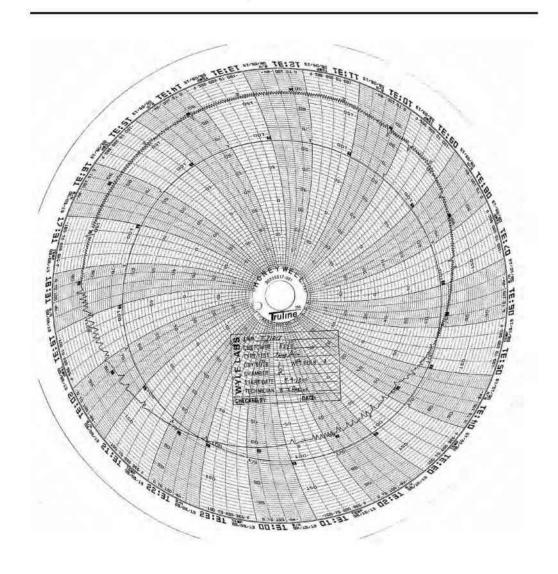
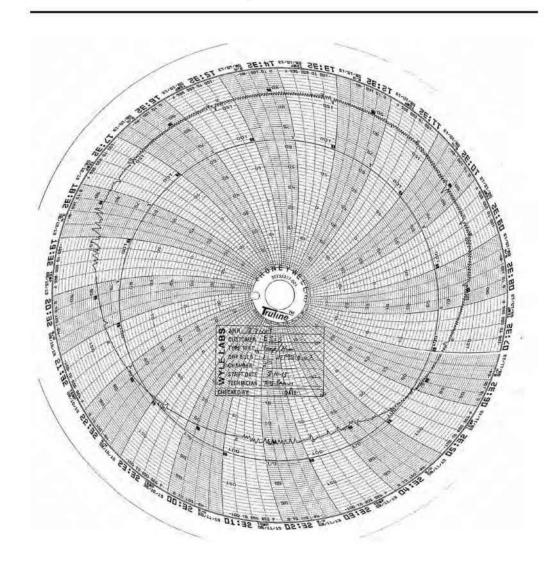
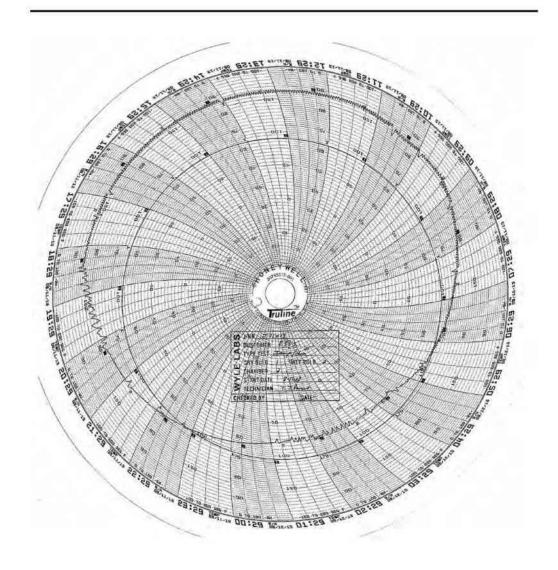
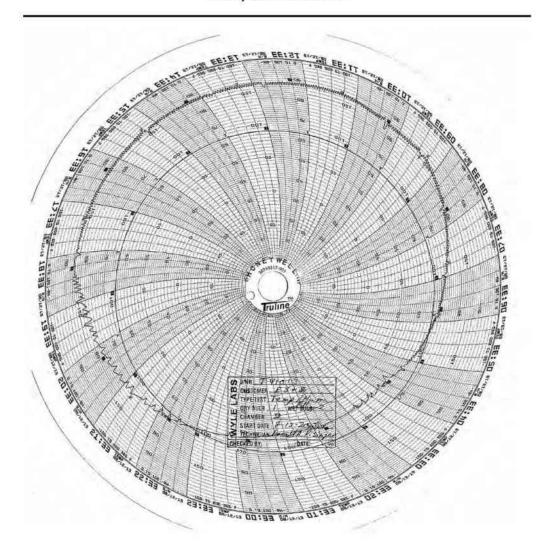
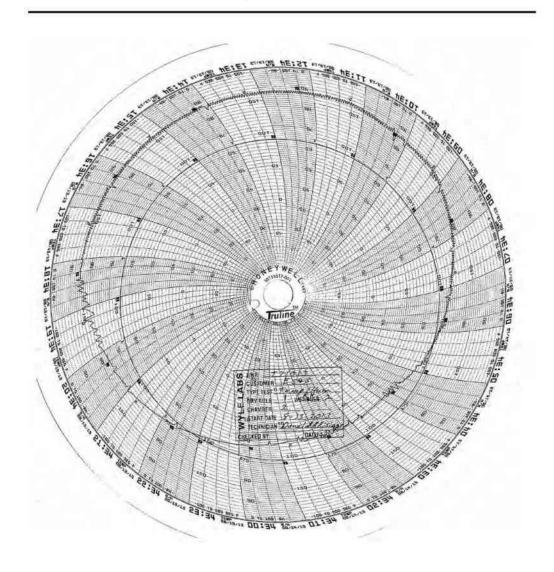
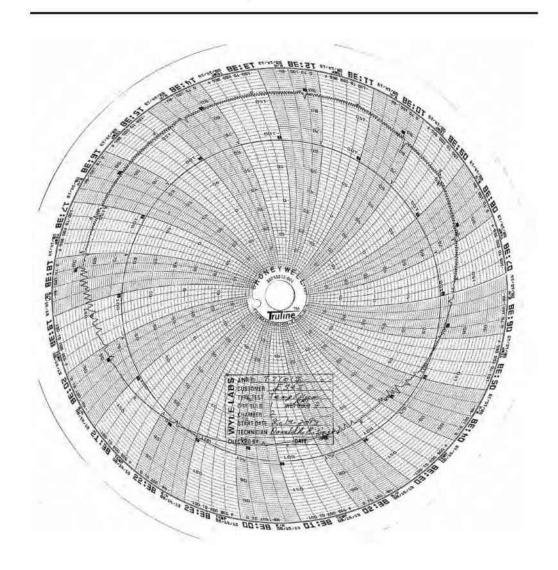
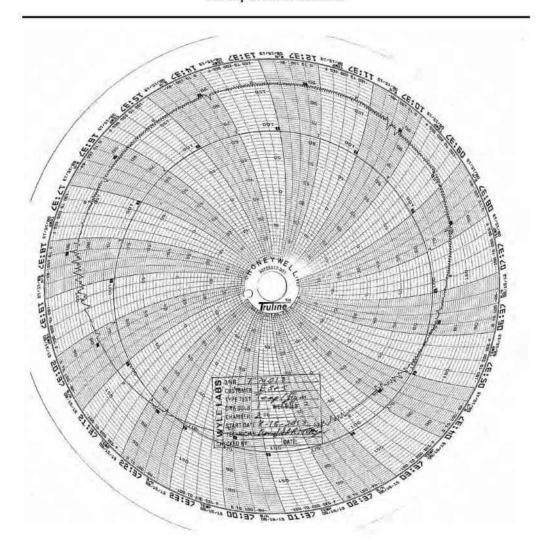
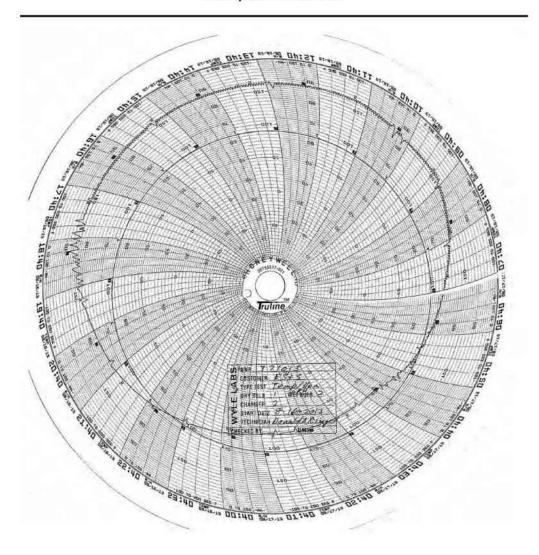
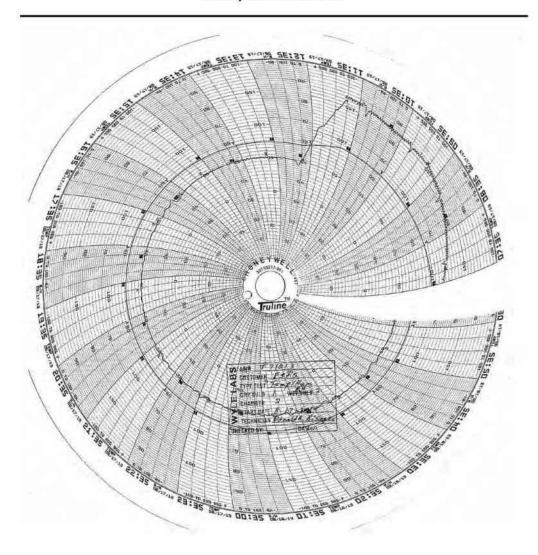
Page No. C-14 of 25 Test Report No. T71013.01-01 HUMIDITY TEST DATA WYLE LABORATORIES, INC. **Huntsville Facility**
