National Technical Systems Test Report for Environmental Testing of the DS300

Pro V&V, Inc. | 6705 Odyssey Drive, Suite C | Huntsville, AL 35806

National Technical Systems | 1601 Dry Creek Drive, Suite 2000 | Longmont, CO 80503 | 303-776-7249 | www.nts.com

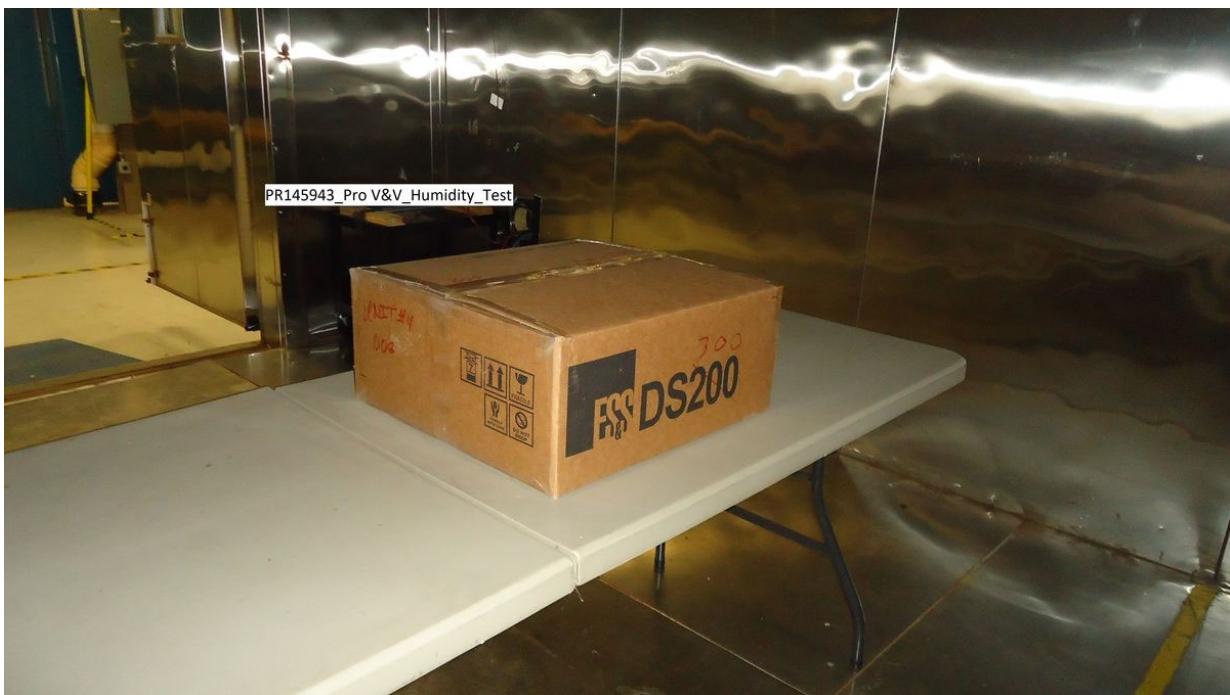
5.1.4 Test Photographs

No visible evidence of damage or anomalies were noted as a result of the test.

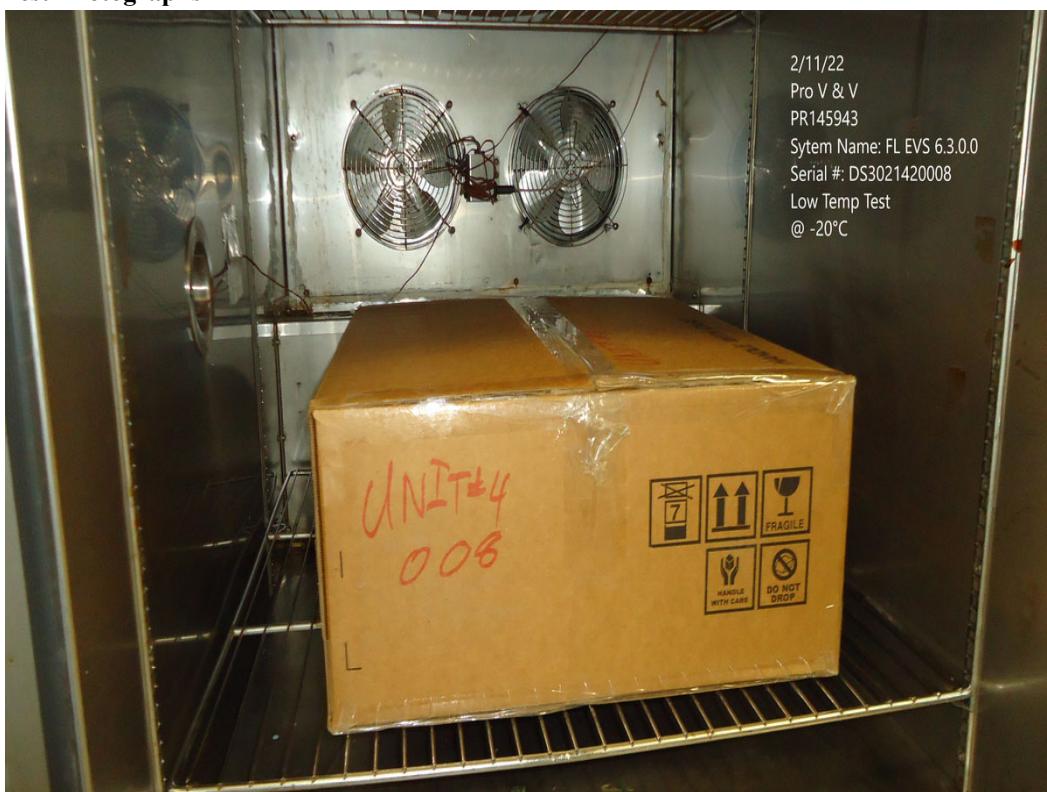
5.2.4 Test Photographs

No visible evidence of damage or anomalies were noted as a result of the test.

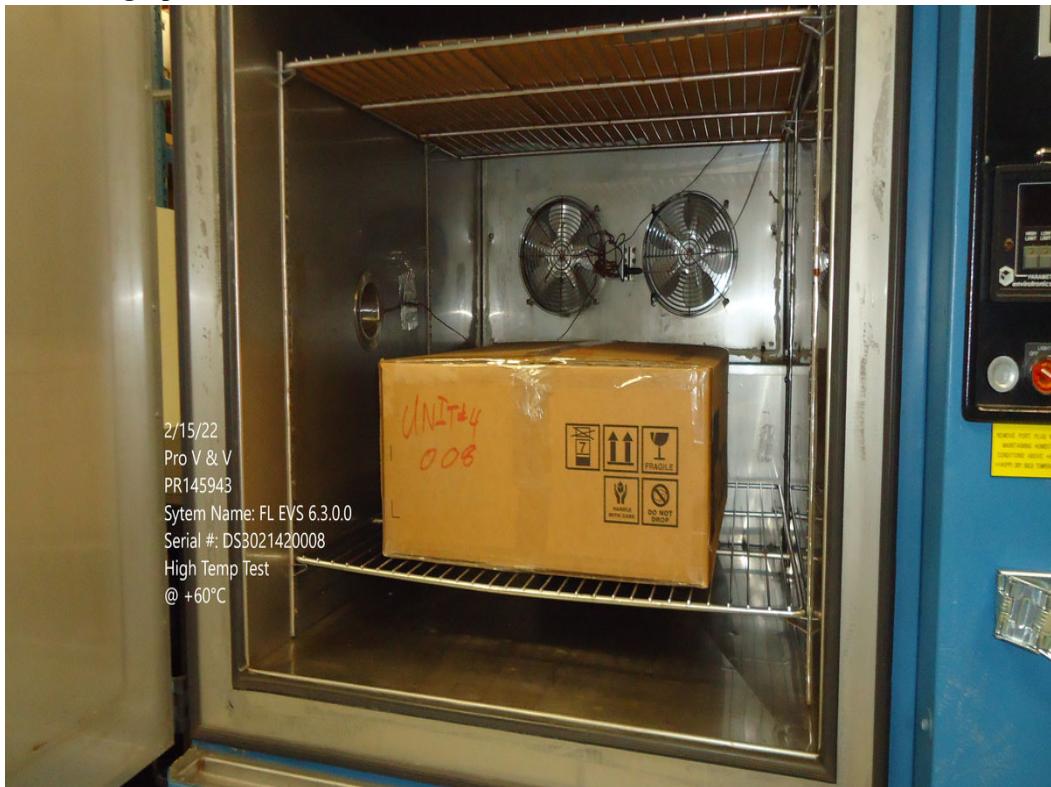
5.3.4 Test Photographs

No visible evidence of damage or anomalies were noted as a result of the test.

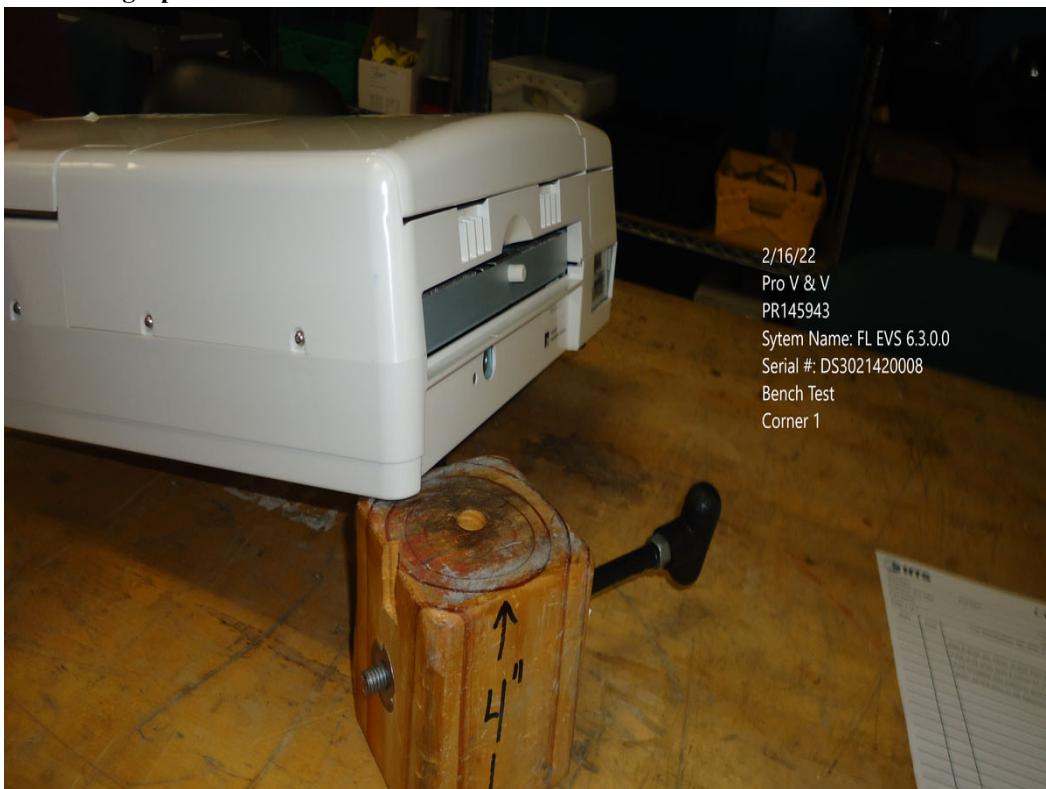
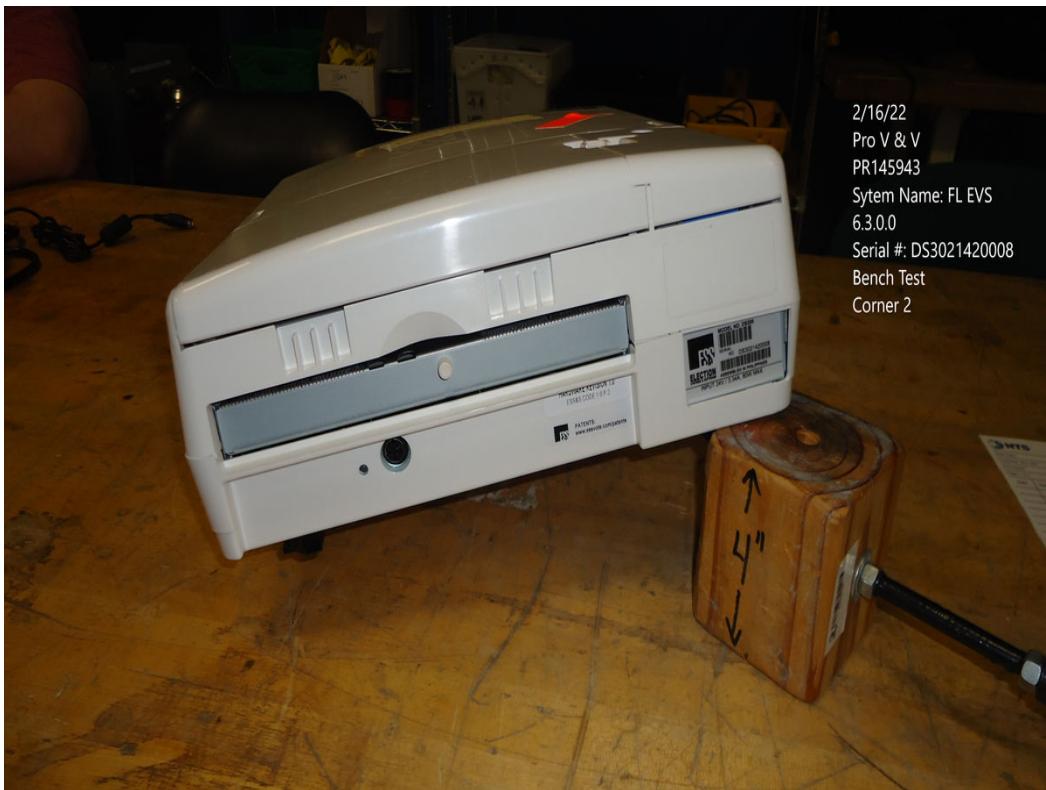
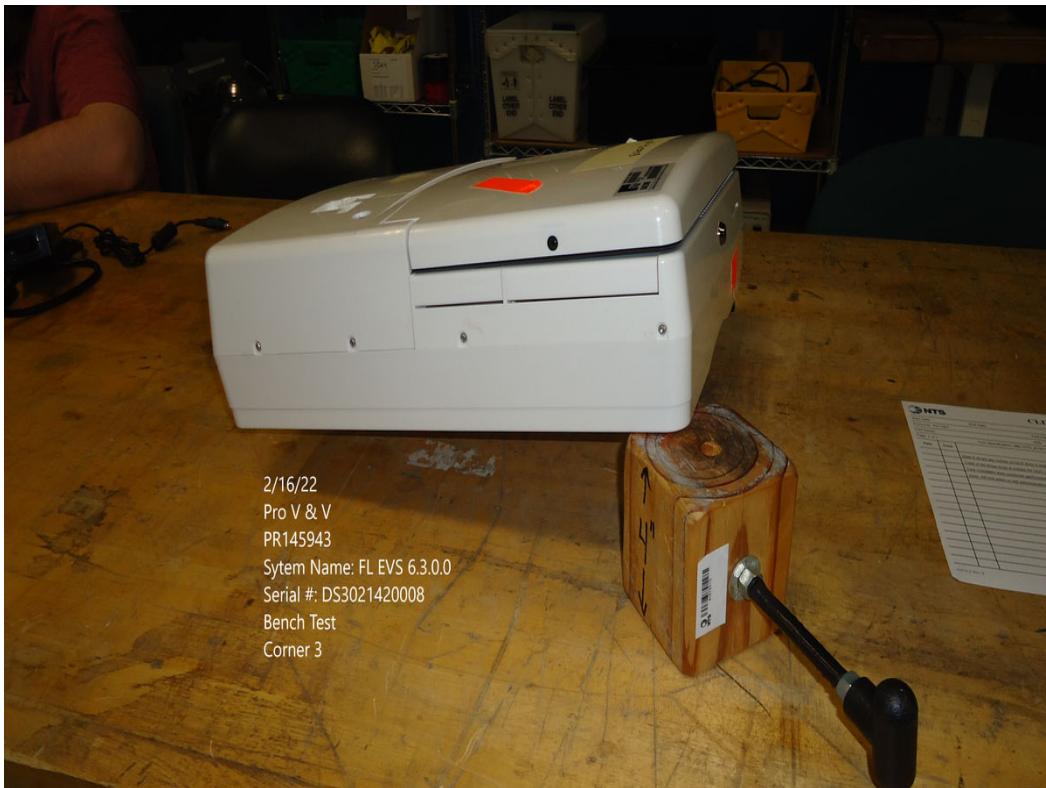
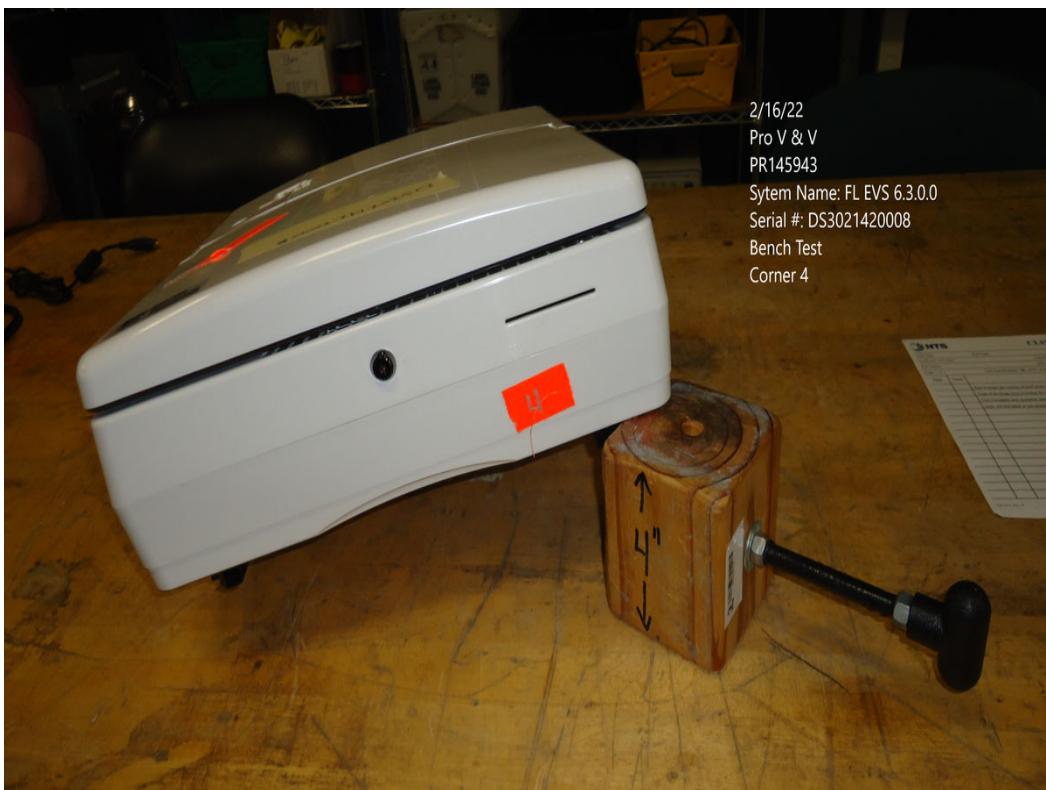
5.4.4 Test Photographs

No visible evidence of damage or anomalies were noted as a result of the test.

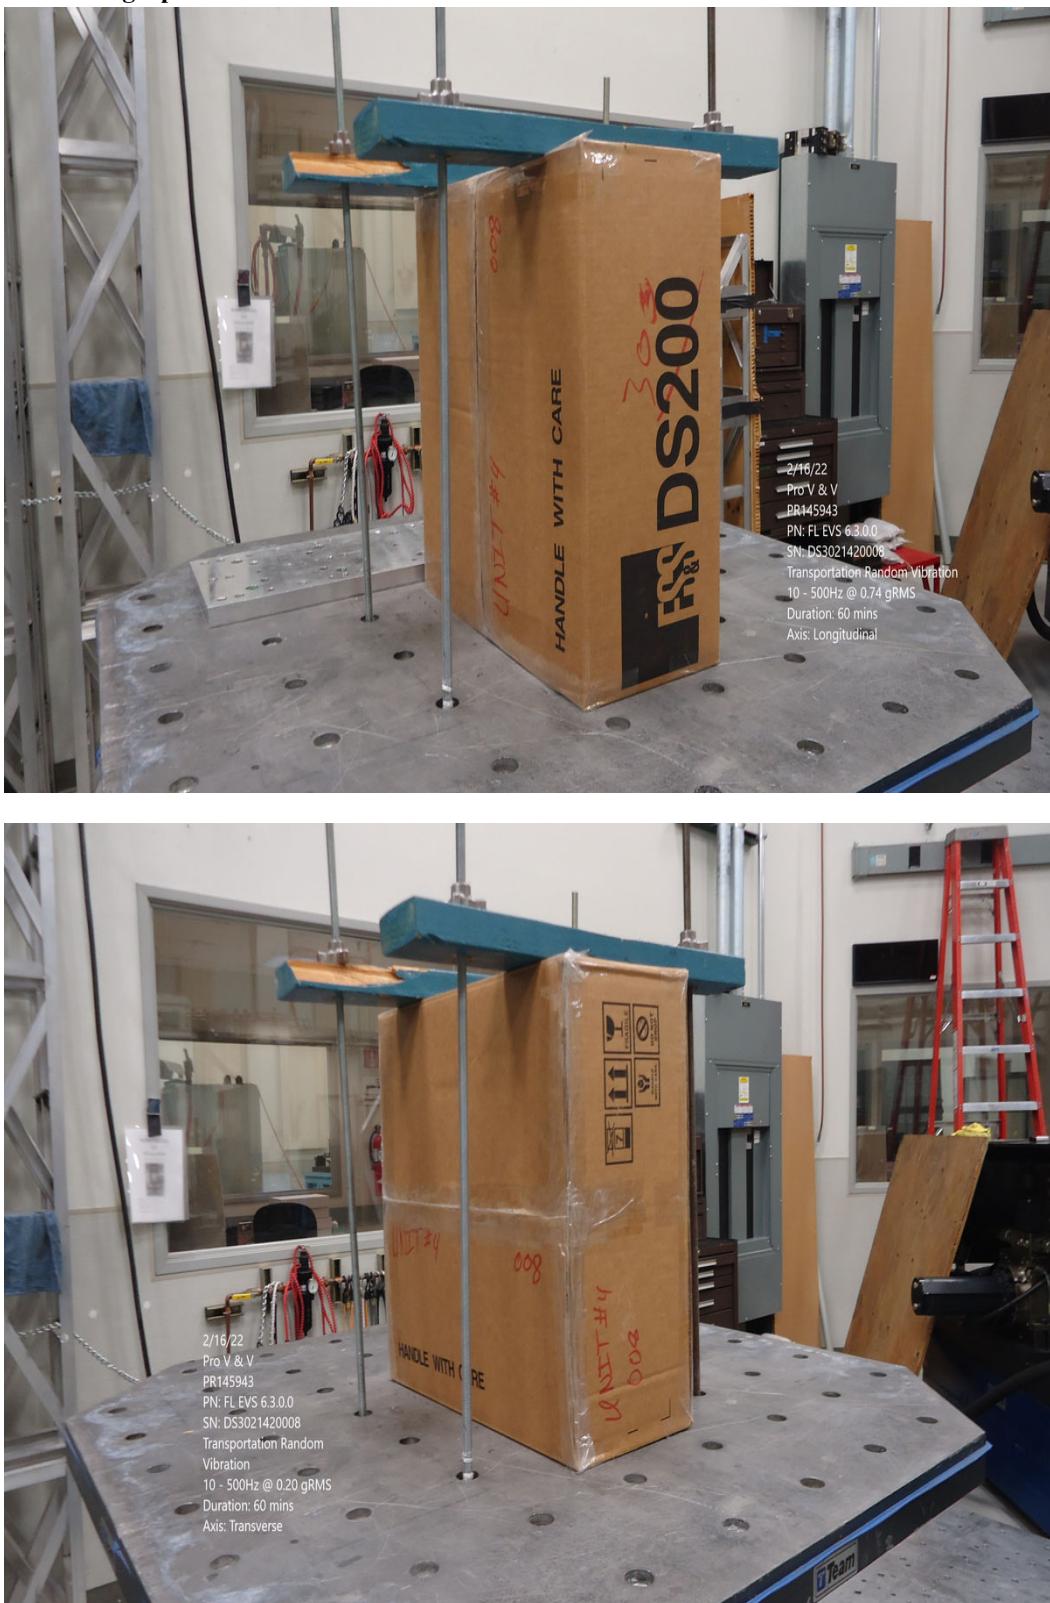
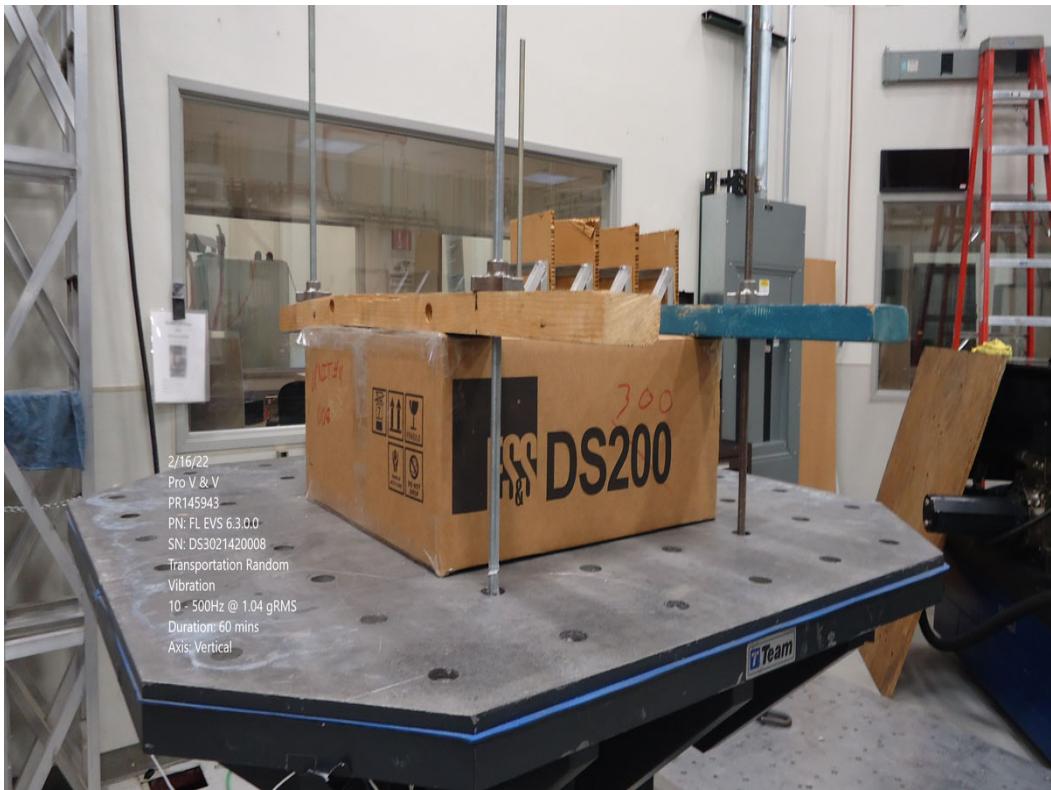
5.5.4 Test Photographs

No visible evidence of damage or anomalies were noted as a result of the test.

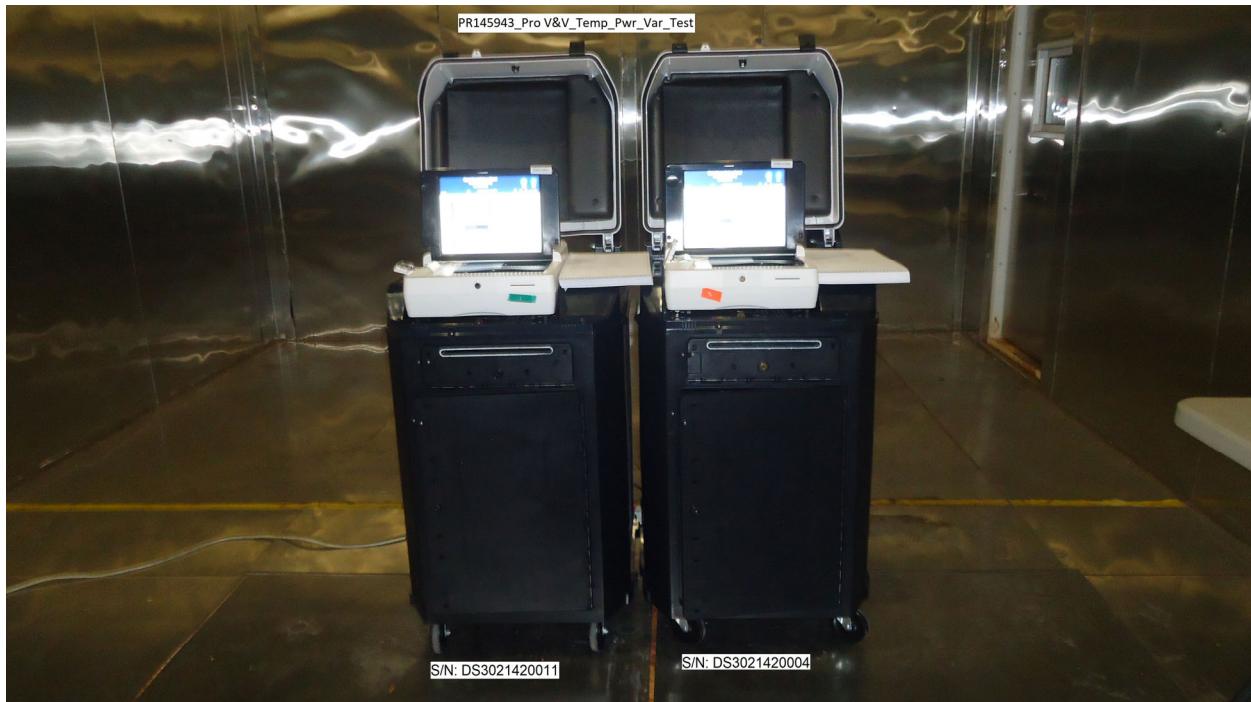
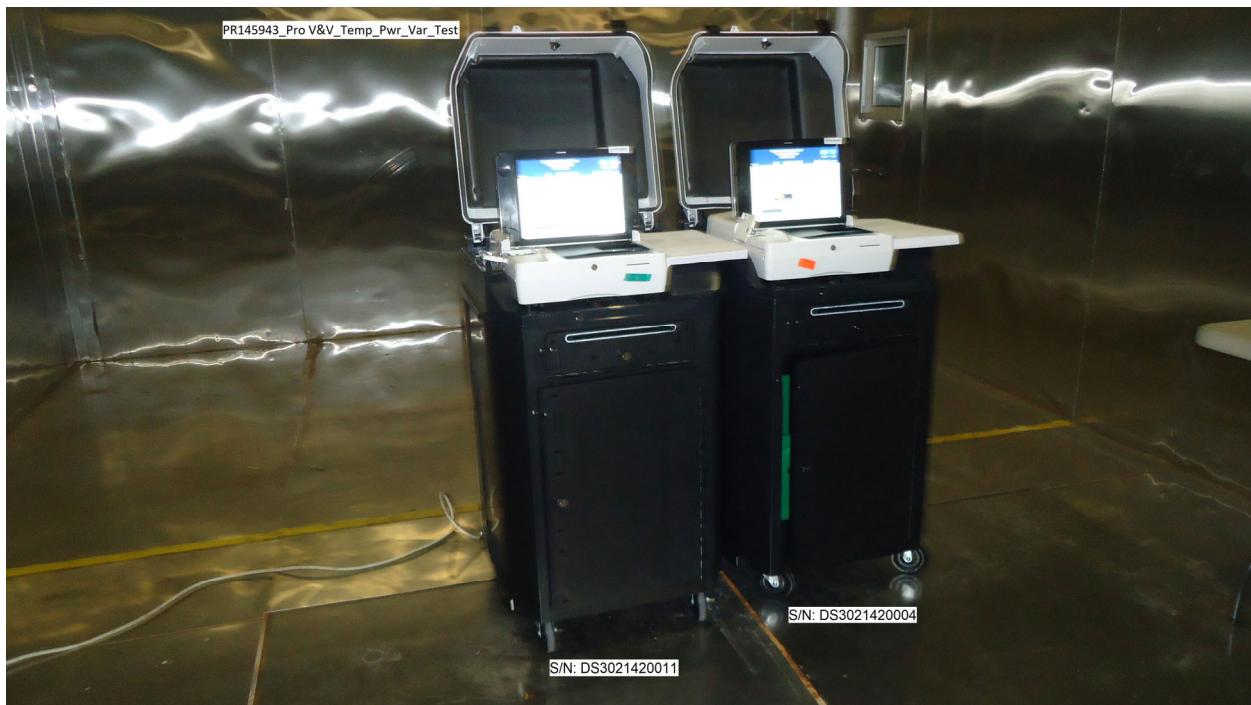
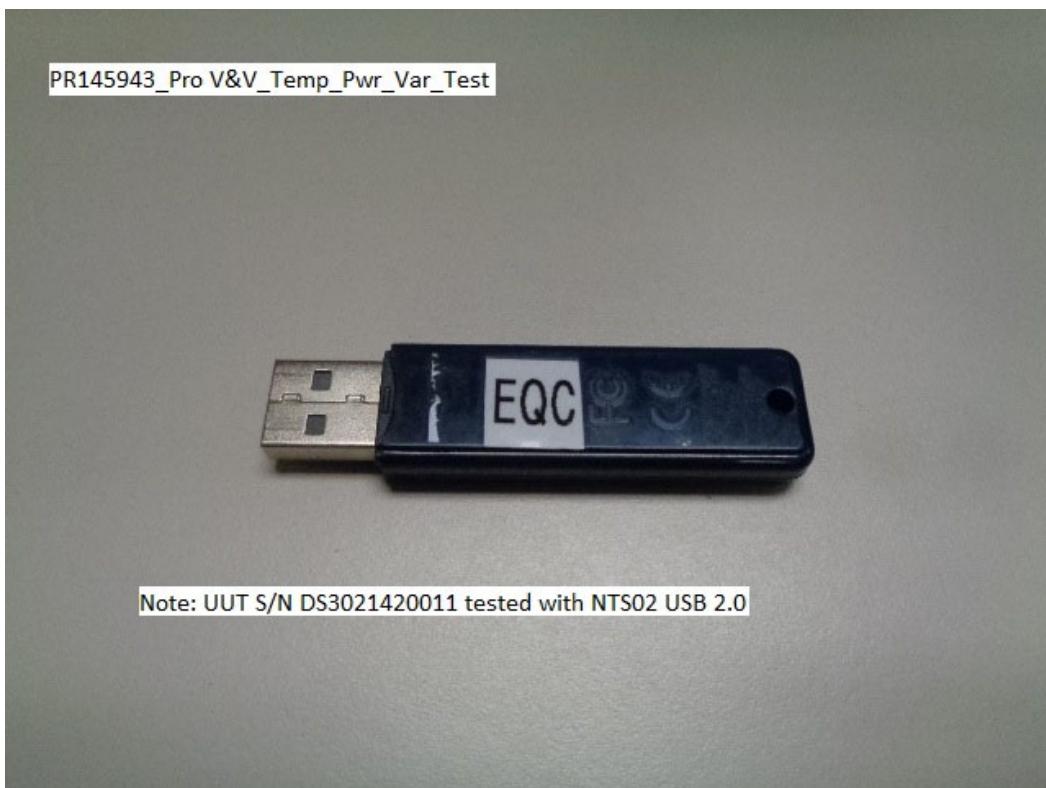
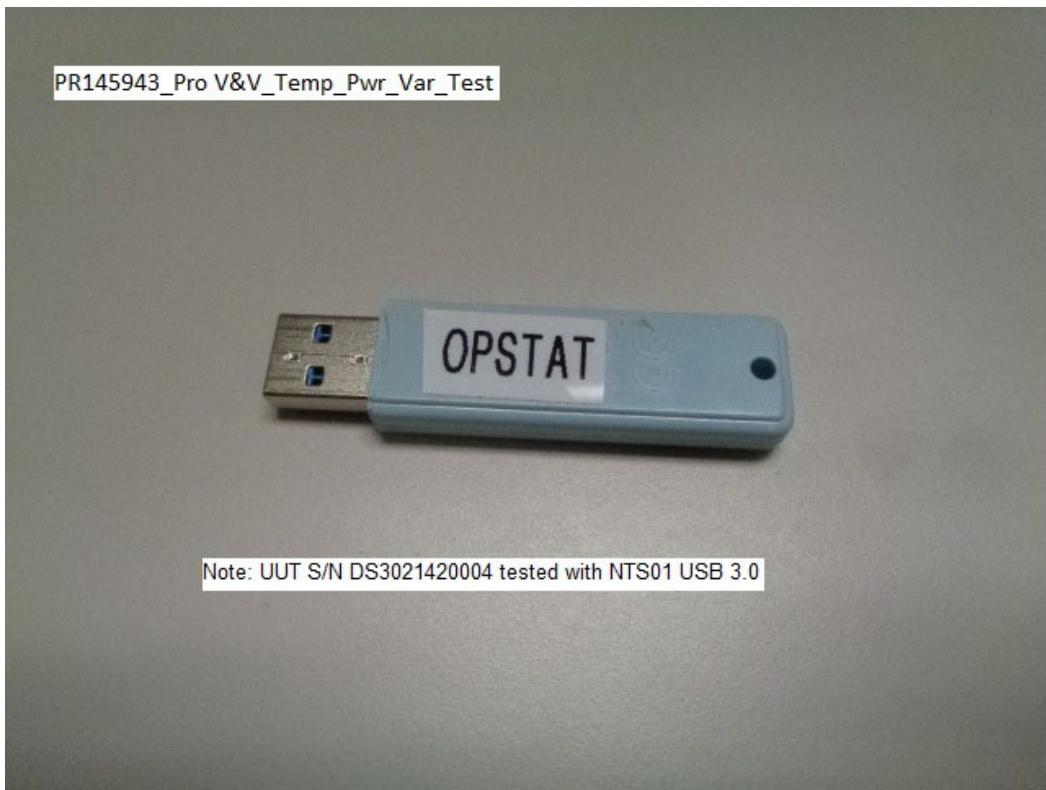
5.6.4 Test Photographs

Temperature/Power Variation

No visible evidence of damage or anomalies were noted as a result of the test.

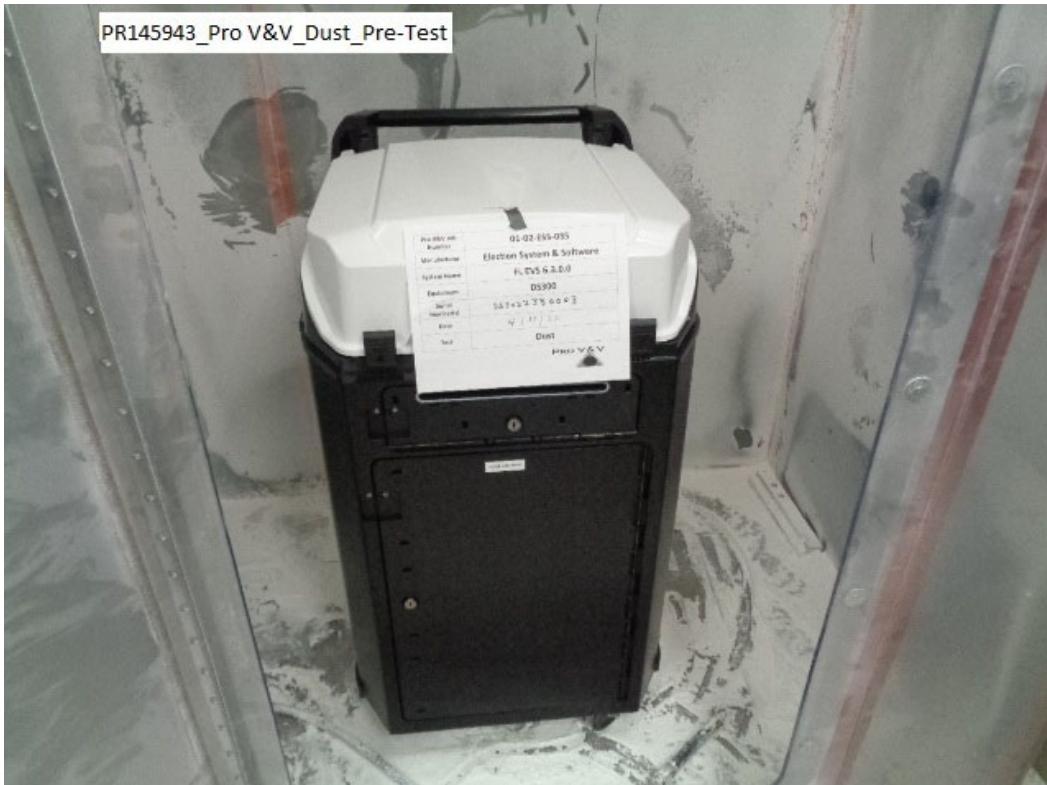
Dust Pre-Test

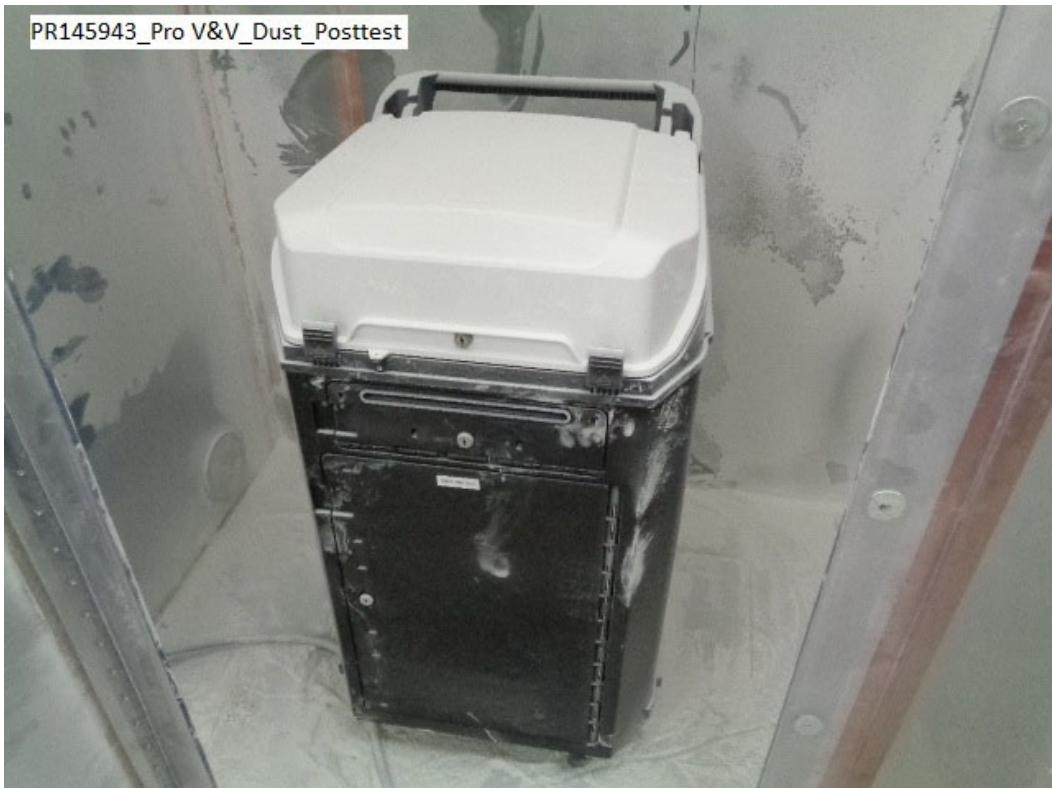
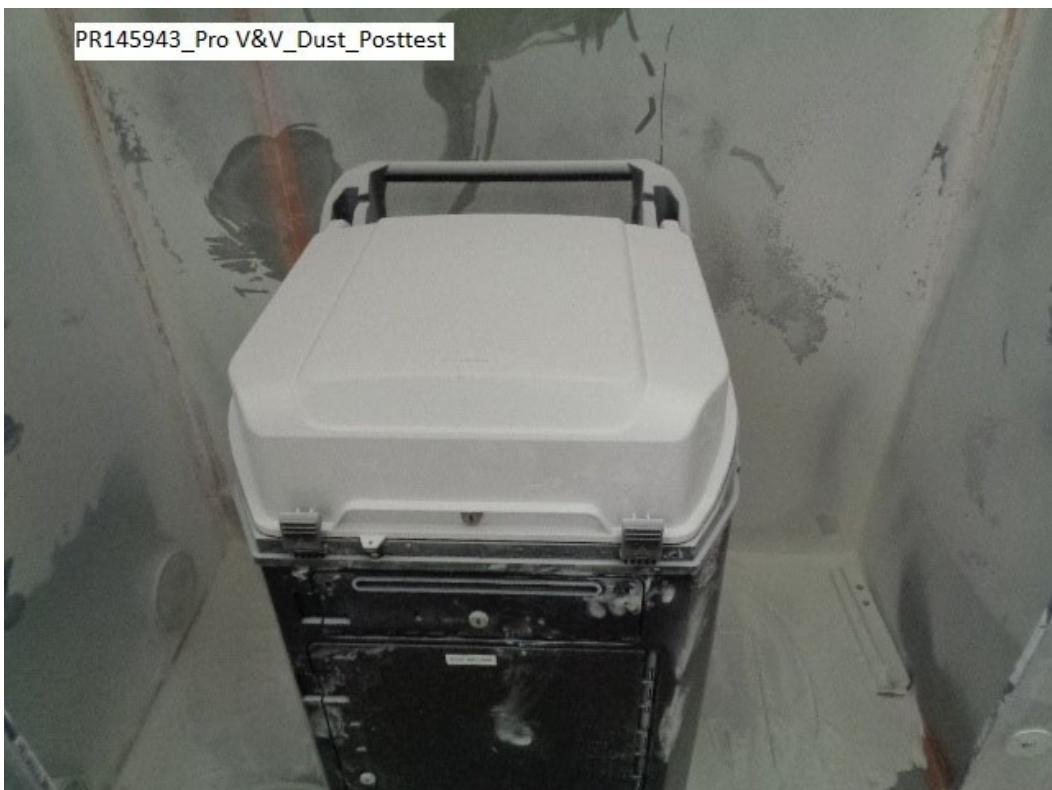
There was no visible evidence of damage noted as a result of the test.

Dust Post-Test

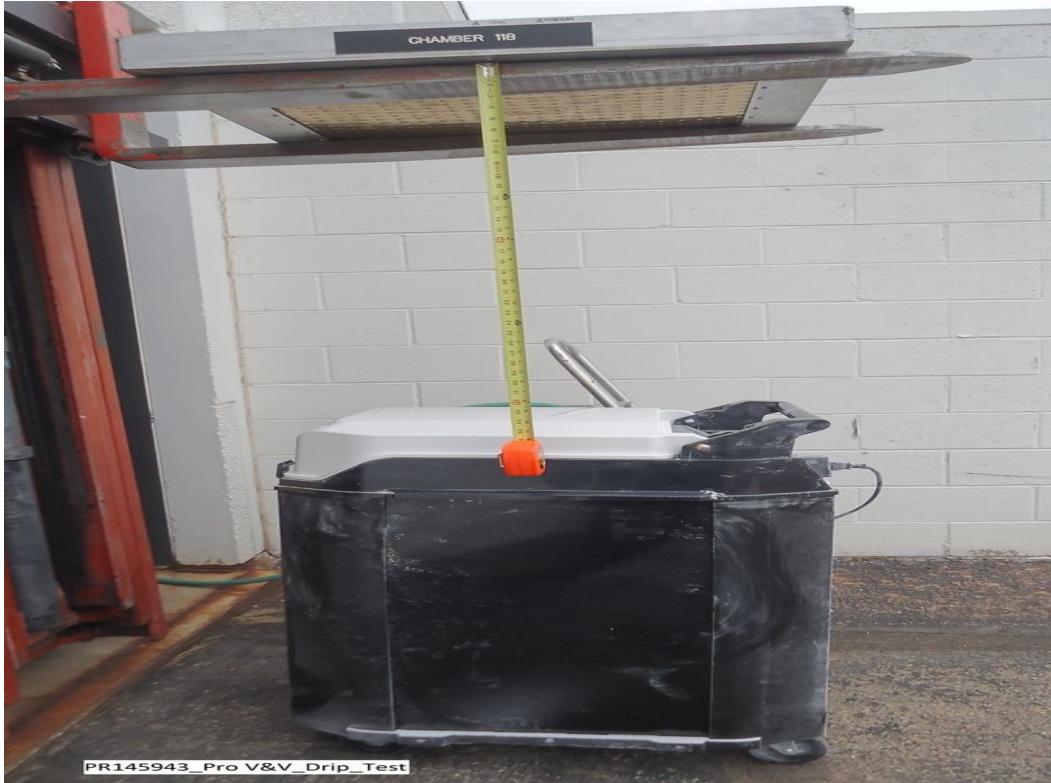
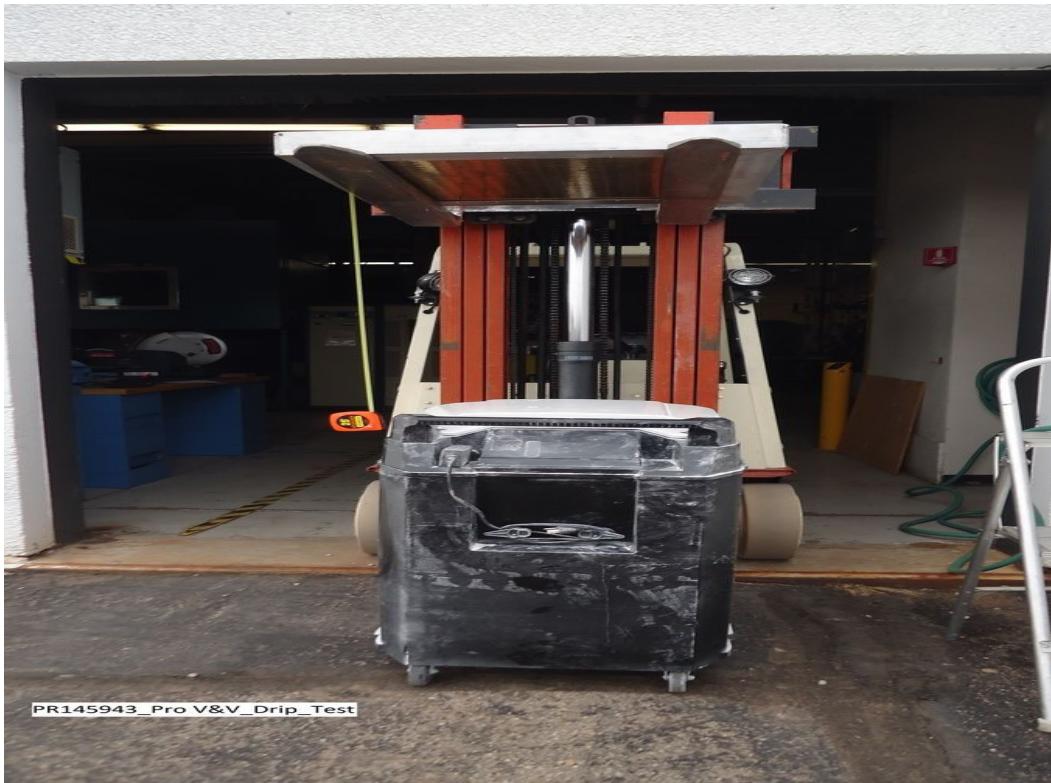
Drip Setup
