## Pro V&V Voting Machine Testing

Report/Quotation Number: PVV-5028.00 (CM380832205802.0)  
Revision Number of Report: 0

Perform MIL-STD-810D environmental testing on supplied Pro V & V (Dominion) Voting system components, as per quotation CM380832205802, and customer's additional instructions by email.

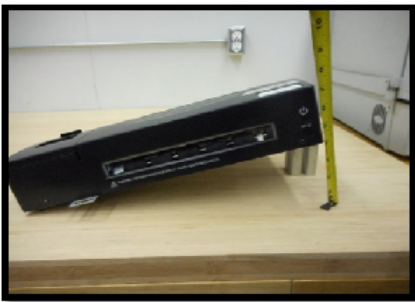
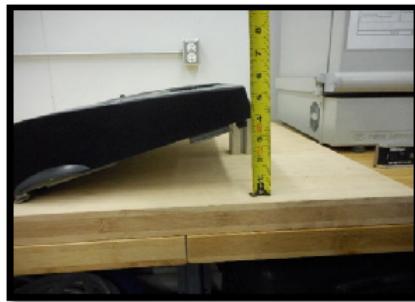
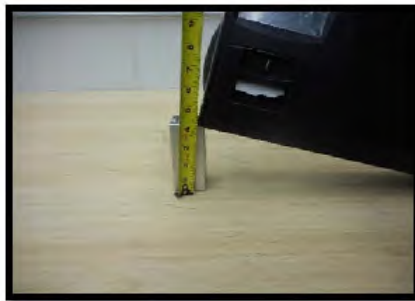
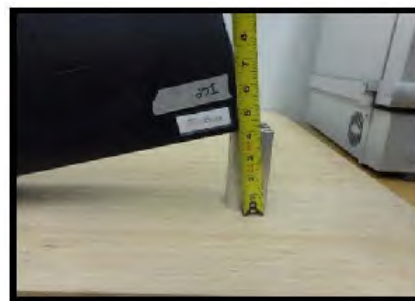
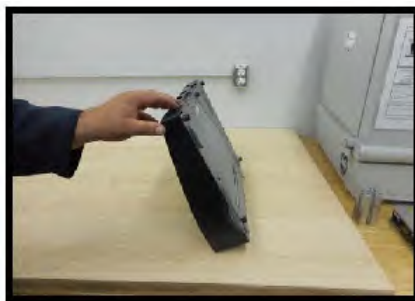
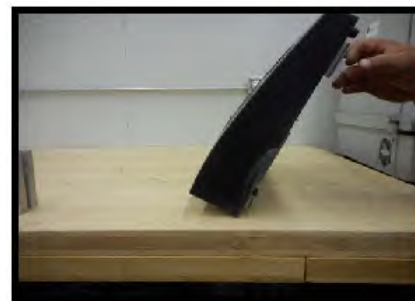
**Setup Photographs**

Sample Description	Voting Machine Systems
Number of samples	4
Sample Number(s)	5028-1 (ICP) ,5028-2 (ICX 15"), 5028-5 (ICX 21") , 5028-6 (ICX Samsung )
Specification	MIL-STD-810D, Military Standard Environmental Test Methods and Engineering Guidelines
Section	II-3.8 Procedure VI- Bench Handling
Test Description	Using one edge as a pivot, lift the opposite edge of the chassis unit one of the following conditions occur,45° with horizontal bench top or 4 inches above bench top. Repeat using other practical edges of the same horizontal face as a pivot point for a total of four drops.
Data to be Provided	Test Data Sheets and photographs
Requirement	No Visual damage , must remain functional during customers checks.

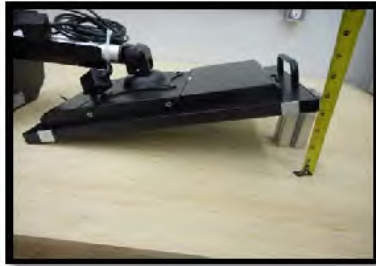
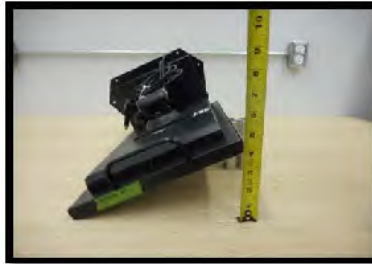
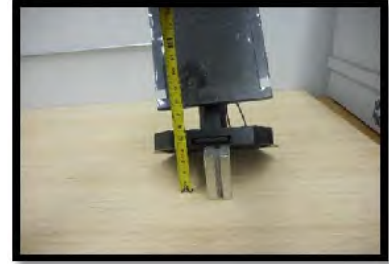
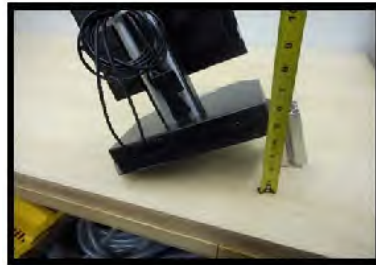
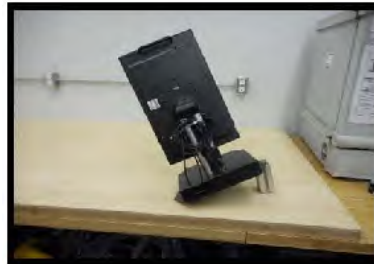
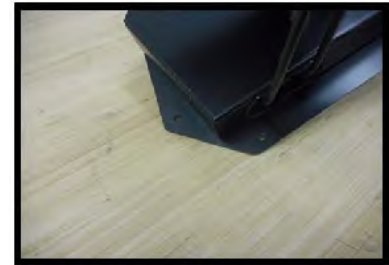
**Setup Photographs**

Sample Description	Voting Machine Systems
Number of samples	4
Sample Number(s)	5028-1 (ICP) , <b>5028-2 (ICX 15")</b> , 5028-5 (ICX 21") , 5028-6 (ICX Samsung )
Specification	MIL-STD-810D, Military Standard Environmental Test Methods and Engineering Guidelines
Section	II-3.8 Procedure VI- Bench Handling
Test Description	Using one edge as a pivot, lift the opposite edge of the chassis unit one of the following conditions occur, 45° with horizontal bench top or 4 inches above bench top. Repeat using other practical edges of the same horizontal face as a pivot point for a total of four drops.
Data to be Provided	Test Data Sheets and photographs
Requirement	No Visual damage , must remain functional during customers checks.

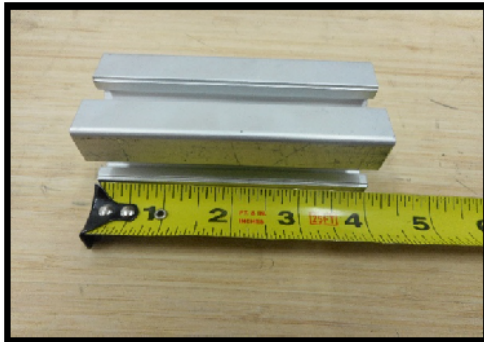
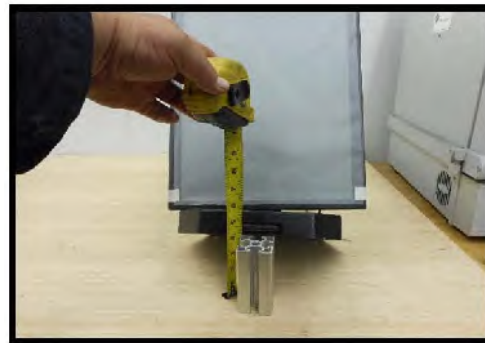
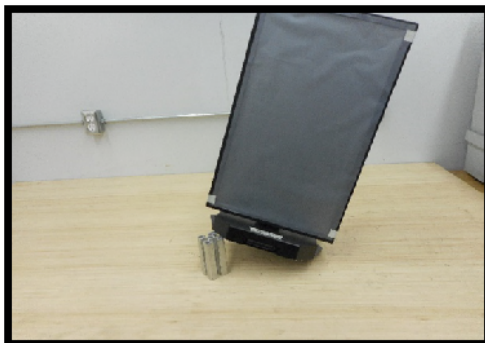
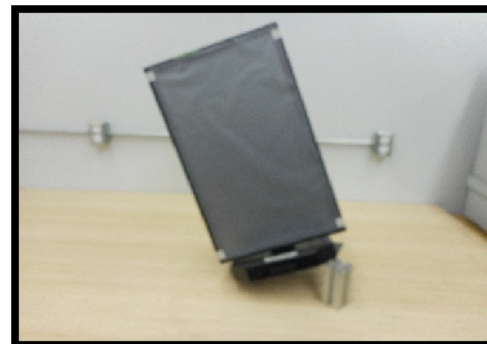
**Setup Photographs**

Sample Description	Voting Machine Systems
Number of samples	4
Sample Number(s)	5028-1 (ICP) ,5028-2 (ICX 15"), <b>5028-5 (ICX 21")</b> , 5028-6 (ICX Samsung )
Specification	MIL-STD-810D, Military Standard Environmental Test Methods and Engineering Guidelines
Section	II-3.8 Procedure VI- Bench Handling
Test Description	Using one edge as a pivot, lift the opposite edge of the chassis unit one of the following conditions occur,45° with horizontal bench top or 4 inches above bench top. Repeat using other practical edges of the same horizontal face as a pivot point for a total of four drops.
Data to be Provided	Test Data Sheets and photographs
Requirement	No Visual damage , must remain functional during customers checks.

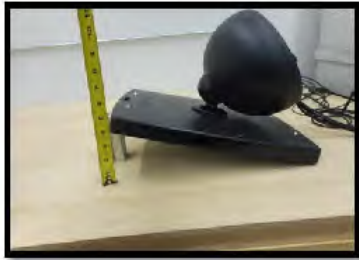
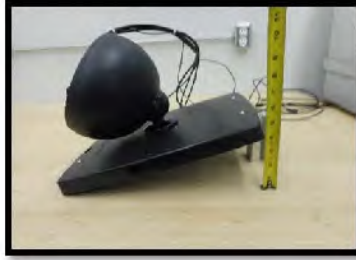
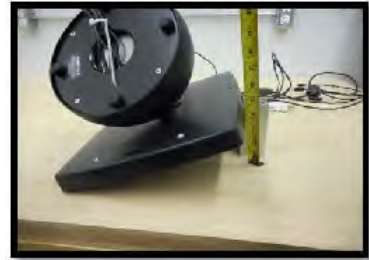
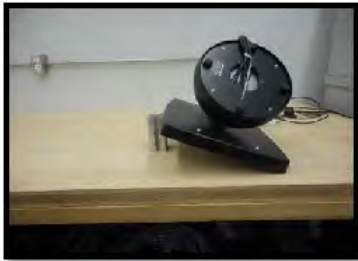
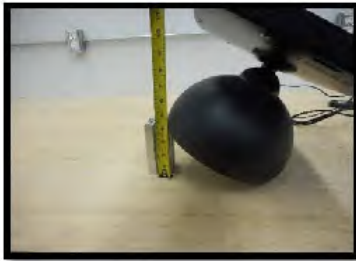
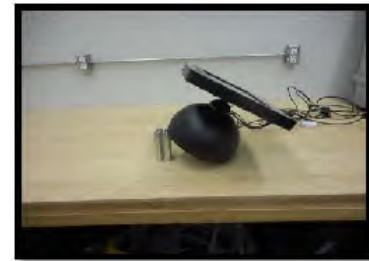
**Setup Photographs**

Sample Description	Voting Machine Systems
Number of samples	4
Sample Number(s)	5028-1 (ICP) ,5028-2 (ICX 15"), 5028-5 (ICX 21") , <b>5028-6 (ICX Samsung )</b>
Specification	MIL-STD-810D, Military Standard Environmental Test Methods and Engineering Guidelines
Section	II-3.8 Procedure VI- Bench Handling
Test Description	Using one edge as a pivot, lift the opposite edge of the chassis unit one of the following conditions occur,45° with horizontal bench top or 4 inches above bench top. Repeat using other practical edges of the same horizontal face as a pivot point for a total of four drops.
Data to be Provided	Test Data Sheets and photographs
Requirement	No Visual damage , must remain functional during customers checks.

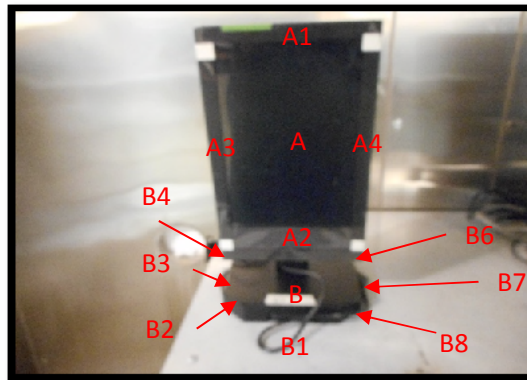
**Shock - Bench Handling - Data - ICX 15"**

Face A = Monitor

Face B = Base

Sample Number	Face	Pivot Edge	Impact Edge	4 inch or 45°	Sample still Functional?	Any Visual Damage ?	Initials	Gauges	
5028-2 (ICX 15")	A	A1	A2	4"	yes	No	P.F	DP-360-02 TM-025-01	
	A	A2	A1	4"	yes	No	P.F		
	A	A3	A4	4"	yes	No	P.F		
	A	A4	A3	4"	yes	No	P.F		
5028-2 (ICX 15")	B	B1	B5	Balance	yes	No	P.F	DP-360-02 TM-025-01	
	B	B5	B1	4"	yes	No	P.F		
	B	B2	B6	4"	yes	No	P.F		
	B	B6	B2	4"	yes	No	P.F		
	B	B3	B7	4"	yes	No	P.F		
	B	B7	B3	4"	yes	No	P.F		
	B	B4	B8	4"	yes	No	P.F		
	B	B8	B4	4"	yes	No	P.F

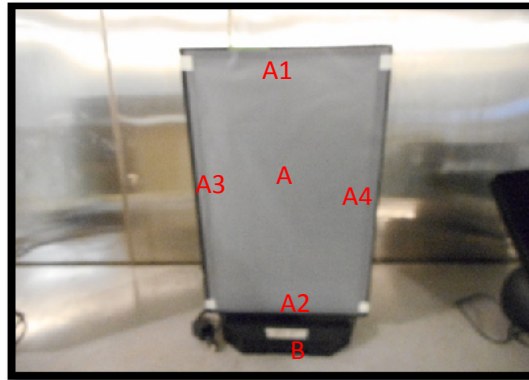
**Shock - Bench Handling - Data - ICX 21"**

Face A = Monitor

Face B = Base

Sample Number	Face	Pivot Edge	Impact Edge	4 inch or 45°	Sample still Functional?	Any Visual Damage ?	Initials	Gauges	
5028-5 (ICX 21")	A	A1	A2	4"	Yes	No	P.F	DP-360-02 TM-025-01	
	A	A2	A1	4"	Yes	No	P.F		
	A	A3	A4	4"	Yes	No	P.F		
	A	A4	A3	4"	Yes	No	P.F		
5028-5 (ICX 21")	B	B1	B5	4"	Yes	No	P.F	DP-360-02 TM-025-01	
	B	B5	B1	Balance	Yes	No	P.F		
	B	B2	B6	4"	Yes	No	P.F		
	B	B6	B2	Balance	Yes	No	P.F		
	B	B3	B7	Balance	Yes	No	P.F		
	B	B7	B3	Balance	Yes	No	P.F		
	B	B4	B8	Balance	Yes	No	P.F		
	B	B8	B4	4"	Yes	No	P.F

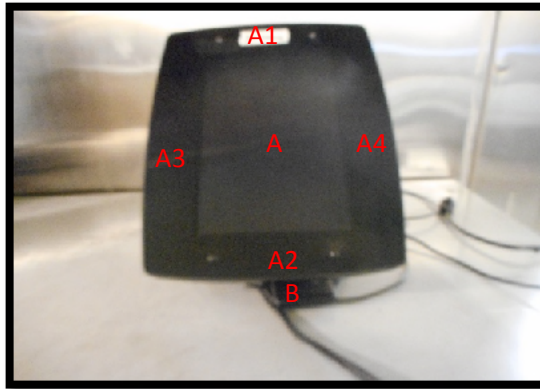
**Shock - Bench Handling - Data - ICX Samsung**

Face A = Monitor

Face B = Base

Sample Number	Face	Pivot Edge	Impact Edge	4 inch or 45°	Sample still Functional?	Any Visual Damage ?	Initials	Gauges
5028-6(ICX Samsung)	A	A1	A2	4"	Yes	No	P.F	DP-360-02 TM-025-01
	A	A2	A1	4"	Yes	No	P.F	
	A	A3	A4	4"	Yes	No	P.F	
	A	A4	A3	4"	Yes	No	P.F	
5028-6(ICX Samsung)	B	B1	B2	4"	Yes	No	P.F	DP-360-02 TM-025-01
	B	B2	B1	4"	Yes	No	P.F	
	B	B3	B4	4"	Yes	No	P.F	
	B	B4	B3	4"	Yes	No	P.F

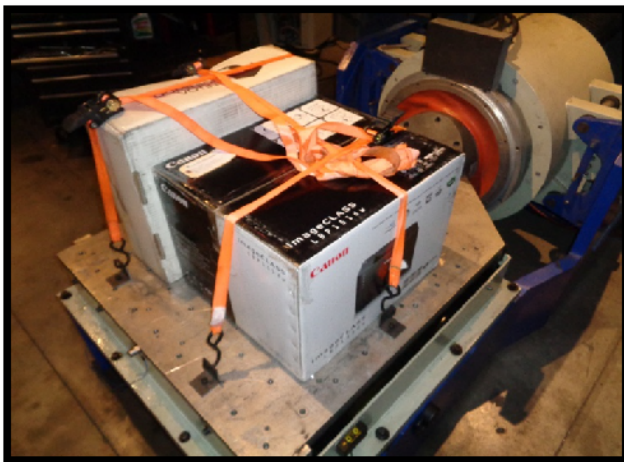
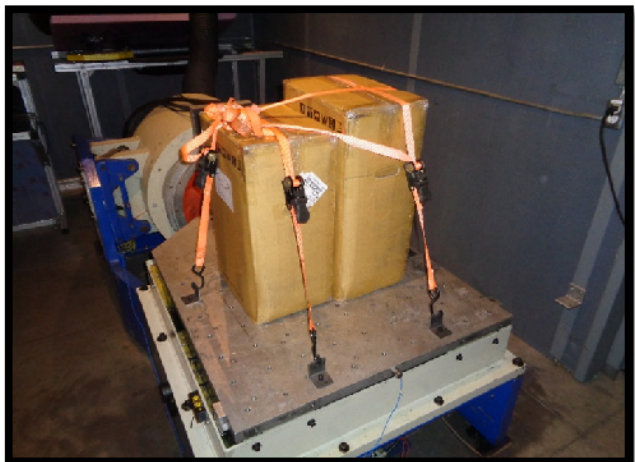
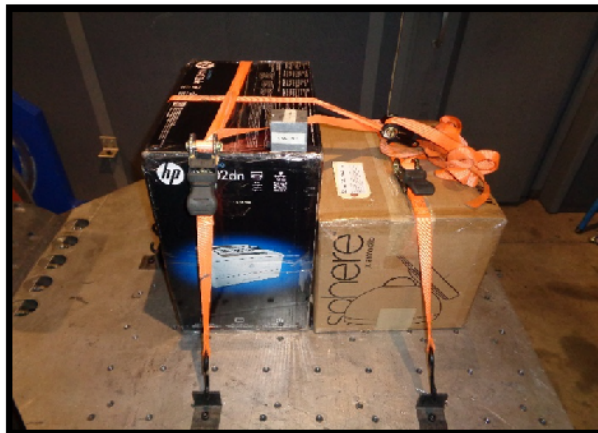
**Setup Photographs**

BREF	POINTS	FREQ	PSD VALU	10	.00013	20	.00065	30	.00065	78	.00002	79	.00019	120	.00019	500	.00001	Test Temperature	20°C +/-4°C
		BREF	POINTS																		
		FREQ	PSD VALU																		
		10	.00013																		
20	.00065																				
30	.00065																				
78	.00002																				
79	.00019																				
120	.00019																				
500	.00001																				
Relative Humidity	N/a																				
Atmospheric Pressure	N/a																				
Test Axes	X	Duration per Axis	30 minutes per axis

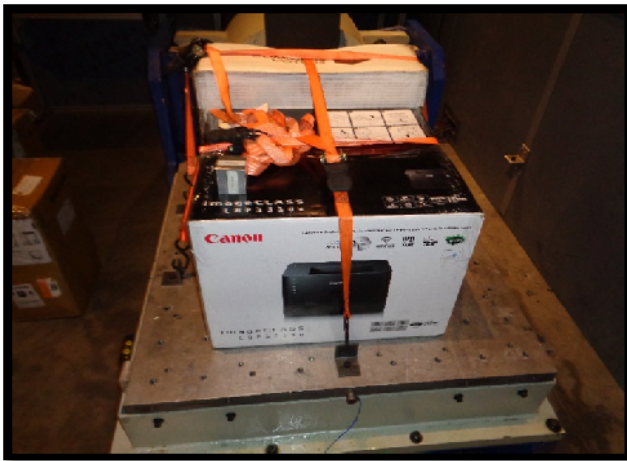
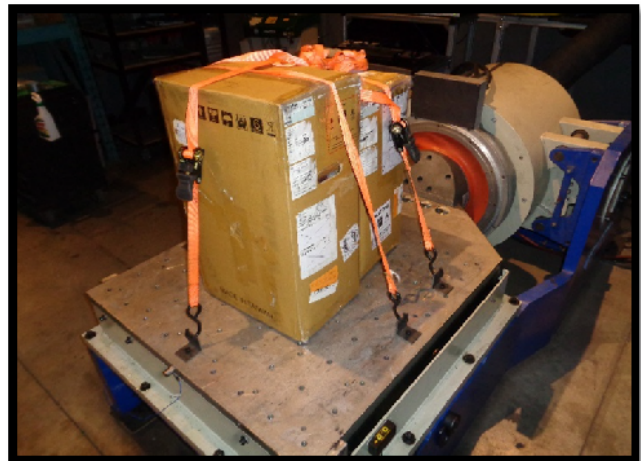
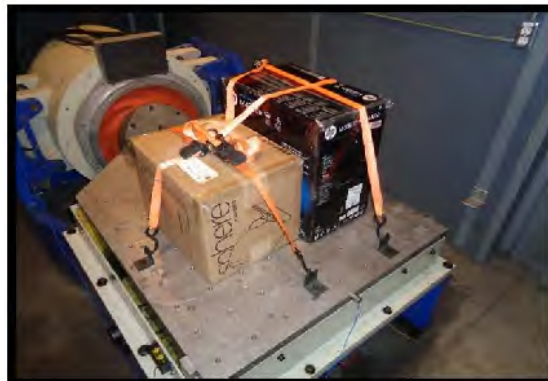
**Setup Photographs**

BREAKPOINTS		FREQ	PSD VALUE	10	.00650	20	.00650	120	.00020	121	.00300	200	.00300	240	.00150	340	.00003	500	.00015	Test Temperature	20°C +/-4°C
		BREAKPOINTS																					
		FREQ	PSD VALUE																				
10	.00650																						
20	.00650																						
120	.00020																						
121	.00300																						
200	.00300																						
240	.00150																						
340	.00003																						
500	.00015																						
Relative Humidity	N/a																						
Atmospheric Pressure	N/a																						
Test Axes	Y	Duration per Axis	30 minutes per axis

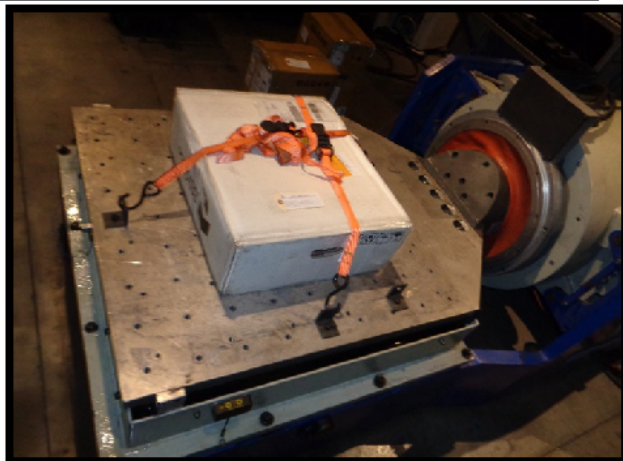
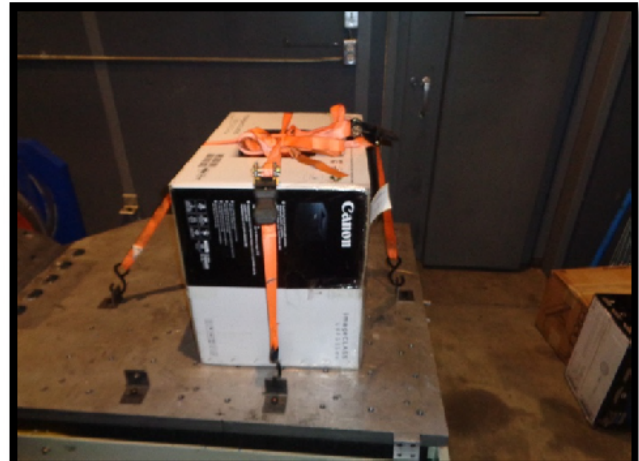
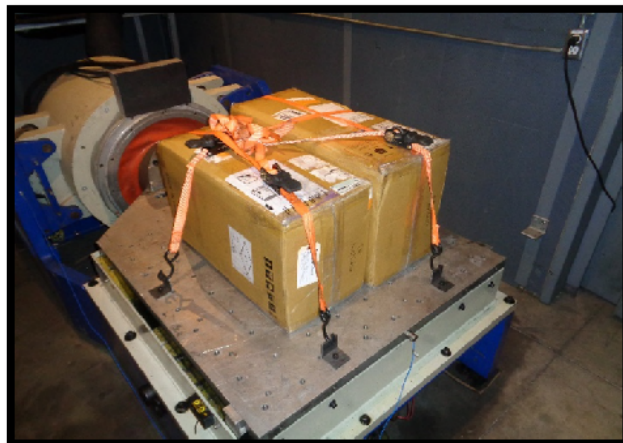
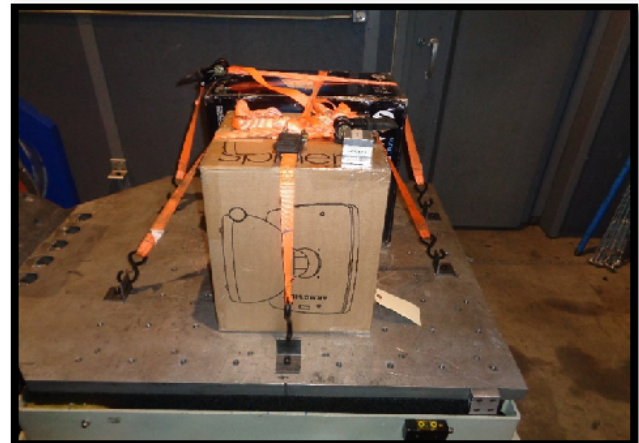
**Setup Photographs**

Random Profile	<b>BREAKPOINTS</b> <b>FREQ            PSD VALUE</b> <b>10                .01500</b> <b>40                .01500</b> <b>500               .00015</b>	Test Temperature	20°C +/-4°C
		Relative Humidity	N/a
		Atmospheric Pressure	N/a
Test Axes	Z	Duration per Axis	30 minutes per axis

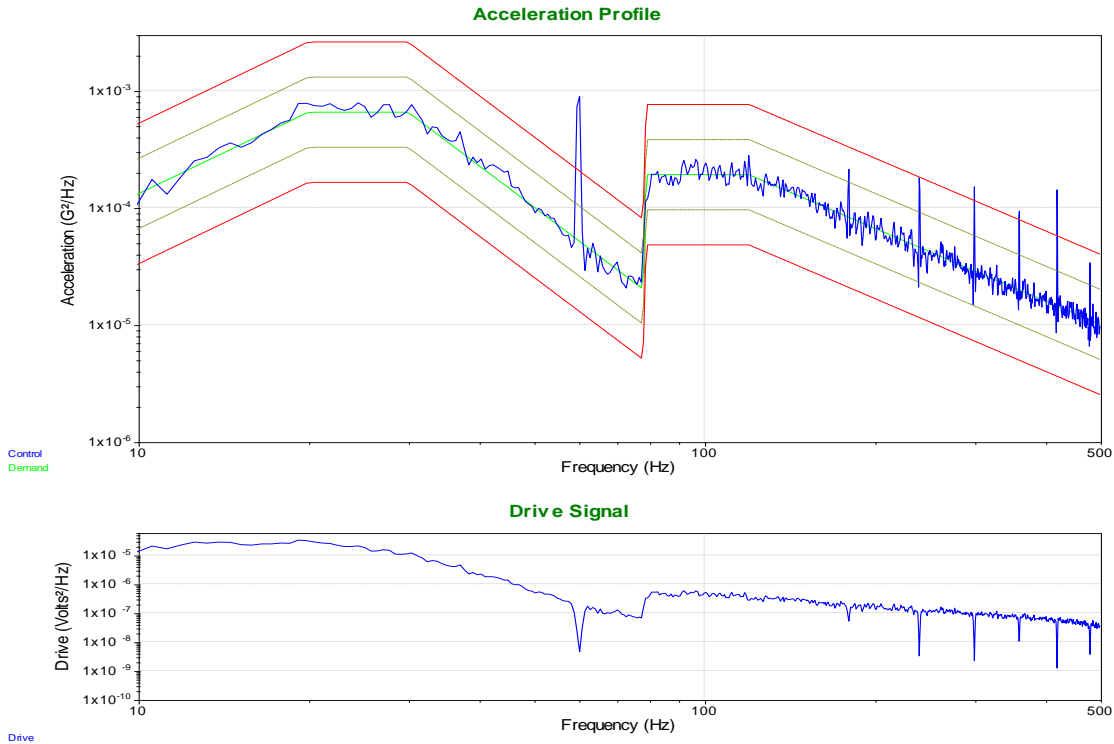
Customer: PVV-5028 Voting Machine Vibration  
 Job#: Samples 1 and 3 X-Axis

Frequency	G²/Hz	dB/Octave
10 Hz	0.00013	6.99
20 Hz	0.00065	0
30 Hz	0.00065	-10.97
78 Hz	2e-005	532
79 Hz	0.00019	0
120 Hz	0.00019	-6.211
500 Hz	1e-005

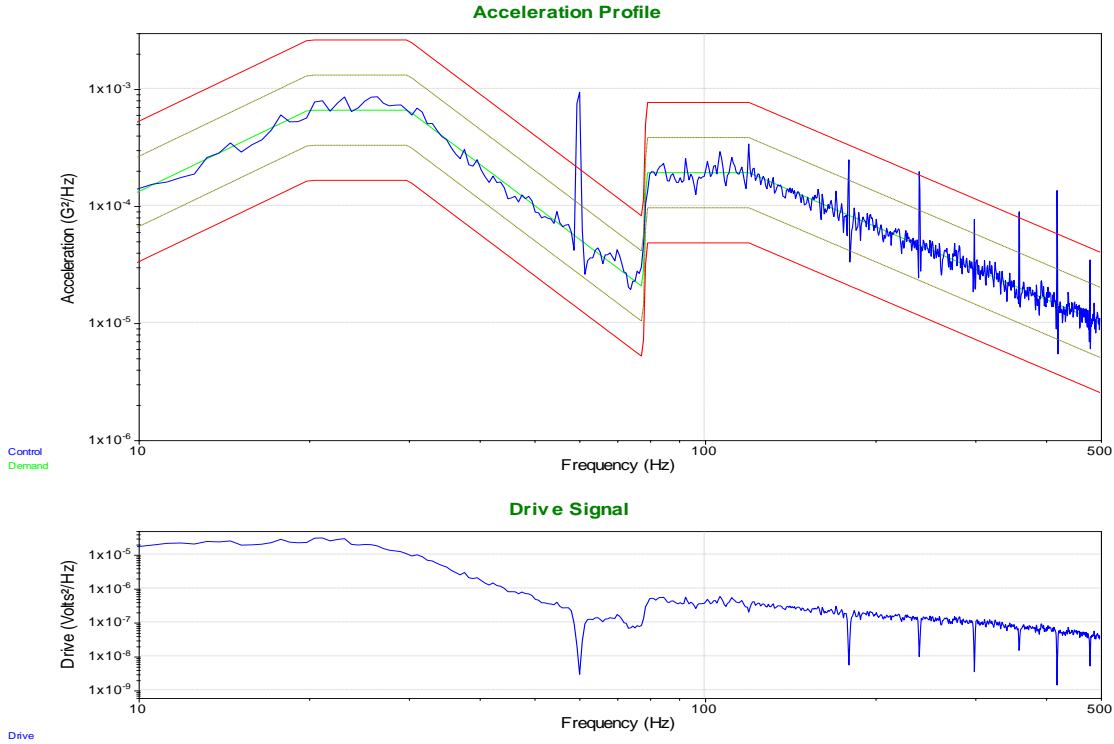
Data: C:\VibeSuite\Data\2016-06\2016Jun10-1405-0001.vrd  
 Test: C:\Documents and Settings\User\Desktop\TUV Test Jobs\PVV-5028\X-Axis Random (Transverse).vrp  
 Data stored on Jun 10, 2016 14:36:01

Frequency	G²/Hz	dB/Octave
10 Hz	0.00013	6.99
20 Hz	0.00065	0
30 Hz	0.00065	-10.97
78 Hz	2e-005	532
79 Hz	0.00019	0
120 Hz	0.00019	-6.211
500 Hz	1e-005

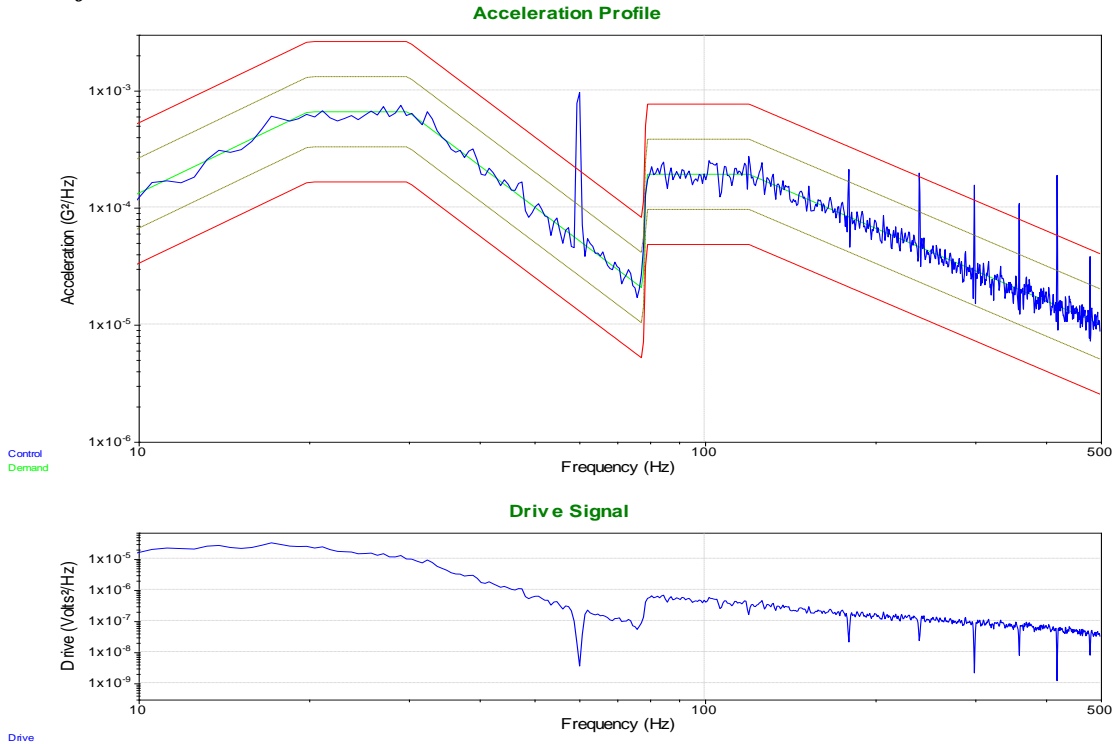
Data: C:\VibeSuite\Data\2016-06\2016Jun09-1203-0001.vrd  
 Test: C:\Documents and Settings\User\Desktop\TUV Test Jobs\PVV-5028\X-Axis Random (Transverse).vrp  
 Data stored on Jun 09, 2016 12:34:16

Frequency	G <sup>2</sup> /Hz	dB/Octave
10 Hz	0.00013	6.99
20 Hz	0.00065	0
30 Hz	0.00065	-10.97
78 Hz	2e-005	532
79 Hz	0.00019	0
120 Hz	0.00019	-6.211
500 Hz	1e-005

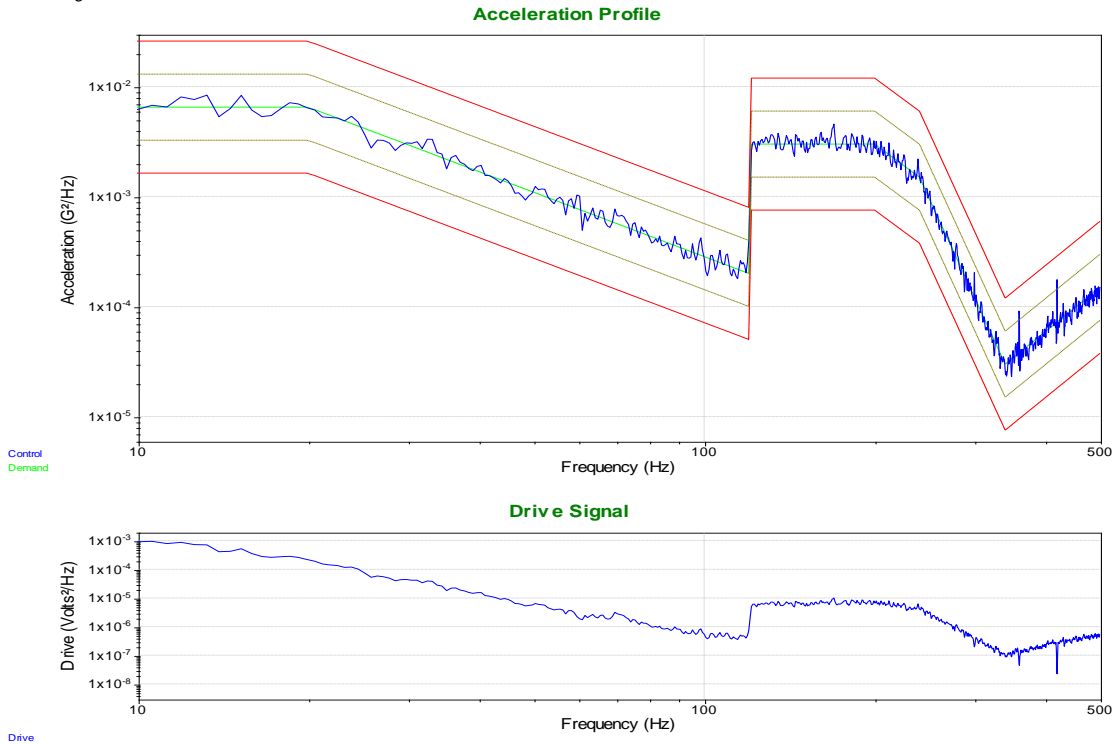
Data: C:\VibeSuite\Data\2016-06\2016Jun09-1543-0001.vrd  
 Test: C:\Documents and Settings\User\Desktop\TUV Test Jobs\PVV-5028\Y-Axis Random (Longitudinal).vrp  
 Data stored on Jun 09, 2016 16:13:27

Frequency	G <sup>2</sup> /Hz	dB/Octave
10 Hz	0.0065	0
20 Hz	0.0065	-5.849
120 Hz	0.0002	982.3
121 Hz	0.003	0
200 Hz	0.003	-11.44
240 Hz	0.0015	-33.81
340 Hz	3e-005	12.56
500 Hz	0.00015

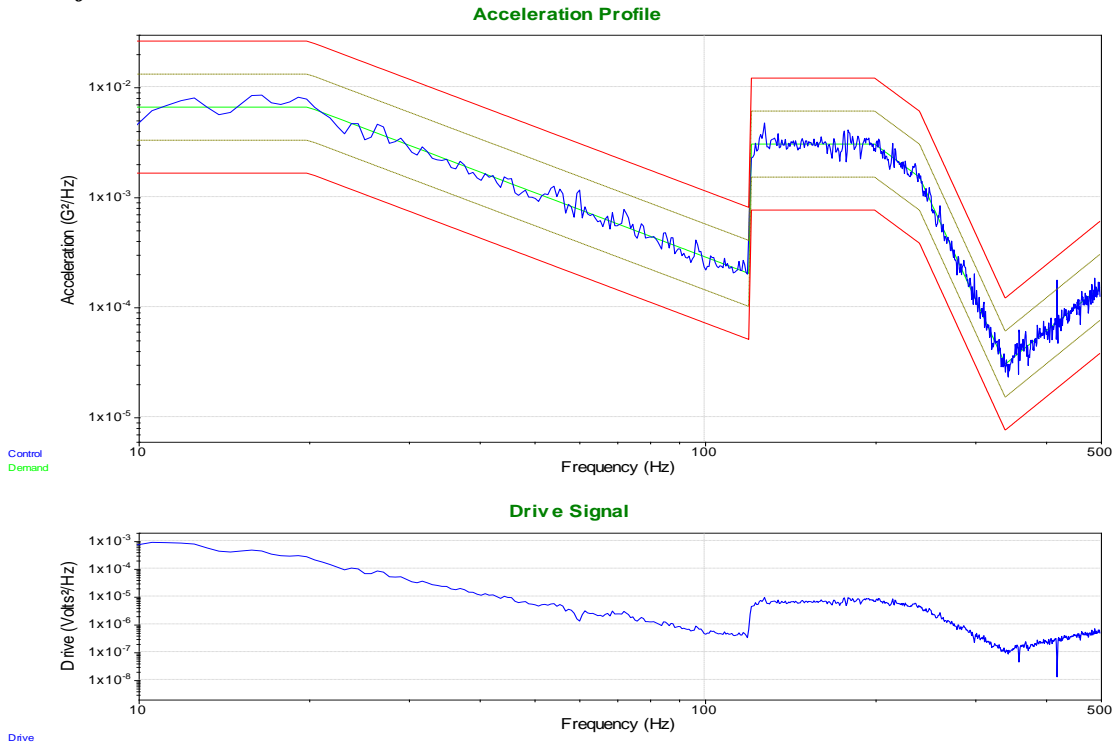
Data: C:\VibeSuite\Data\2016-06\2016Jun10-1309-0001.vrd  
 Test: C:\Documents and Settings\User\Desktop\TUV Test Jobs\PVV-5028\Y-Axis Random (Longitudinal).vrp  
 Data stored on Jun 10, 2016 13:40:13

Frequency	G <sup>2</sup> /Hz	dB/Octave
10 Hz	0.0065	0
20 Hz	0.0065	-5.849
120 Hz	0.0002	982.3
121 Hz	0.003	0
200 Hz	0.003	-11.44
240 Hz	0.0015	-33.81
340 Hz	3e-005	12.56
500 Hz	0.00015

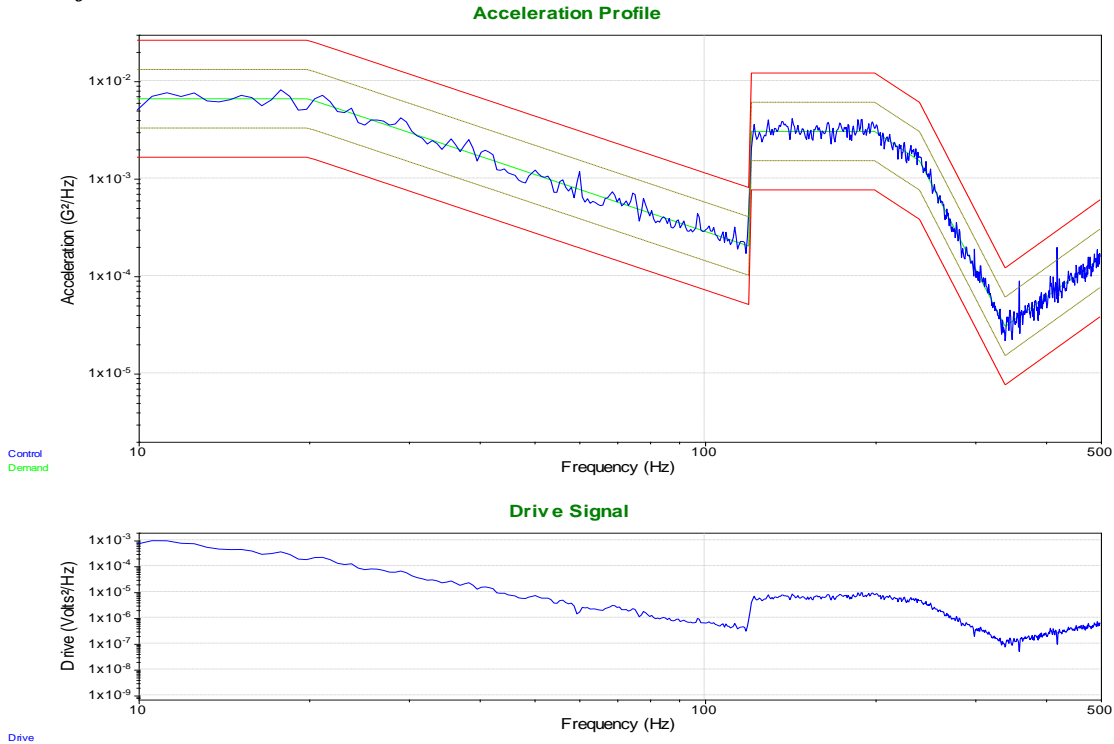
Data: C:\VibeSuite\Data\2016-06\2016Jun09-1332-0001.vrd  
 Test: C:\Documents and Settings\User\Desktop\TUV Test Jobs\PVV-5028\Y-Axis Random (Transverse).vrp  
 Data stored on Jun 09, 2016 14:02:28

Frequency	G <sup>2</sup> /Hz	dB/Octave
10 Hz	0.0065	0
20 Hz	0.0065	-5.849
120 Hz	0.0002	982.3
121 Hz	0.003	0
200 Hz	0.003	-11.44
240 Hz	0.0015	-33.81
340 Hz	3e-005	12.56
500 Hz	0.00015

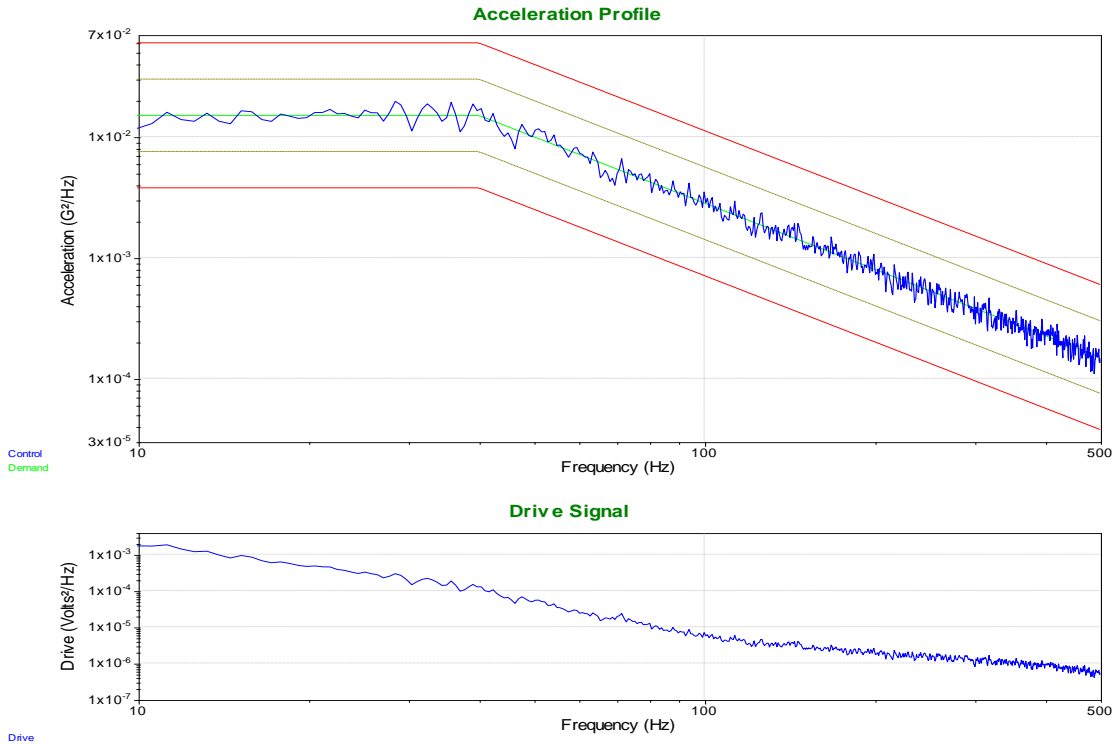
Data: C:\VibeSuite\Data\2016-06\2016Jun10-1057-0001.vrd  
 Test: C:\Documents and Settings\User\Desktop\TUV Test Jobs\PVV-5028\Z-Axis Random (Vertical).vrp  
 Data stored on Jun 10, 2016 11:27:52

Frequency	G²/Hz	dB/Octave
10 Hz	0.015	0
40 Hz	0.015	-5.489
500 Hz	0.00015

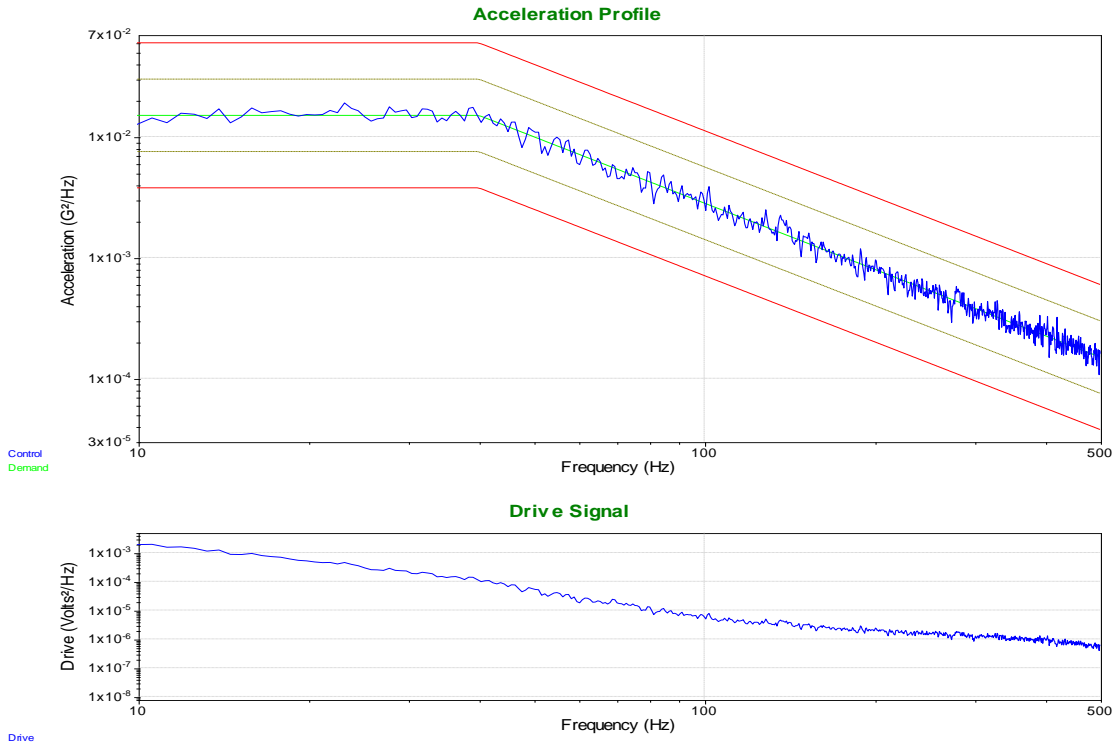
Data: C:\VibeSuite\Data\2016-06\2016Jun10-1459-0001.vrd  
 Test: C:\Documents and Settings\User\Desktop\TUV Test Jobs\PVV-5028\Z-Axis Random (Vertical).vrp  
 Data stored on Jun 10, 2016 15:29:24

Frequency	G²/Hz	dB/Octave
10 Hz	0.015	0
40 Hz	0.015	-5.489
500 Hz	0.00015

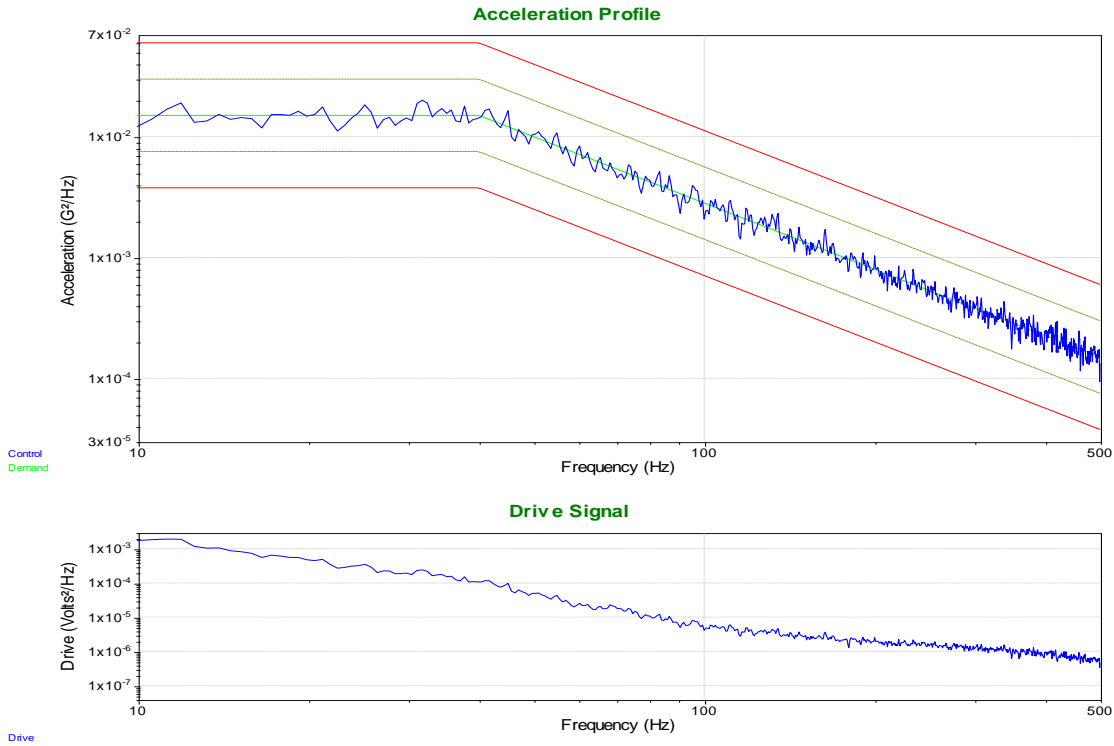
Data: C:\VibeSuite\Data\2016-06\2016Jun09-1626-0001.vrd  
 Test: C:\Documents and Settings\User\Desktop\TUV Test Jobs\PVV-5028\Z-Axis Random (Vertical).vrp  
 Data stored on Jun 09, 2016 16:56:27

Frequency	G²/Hz	dB/Octave
10 Hz	0.015	0
40 Hz	0.015	-5.489
500 Hz	0.00015

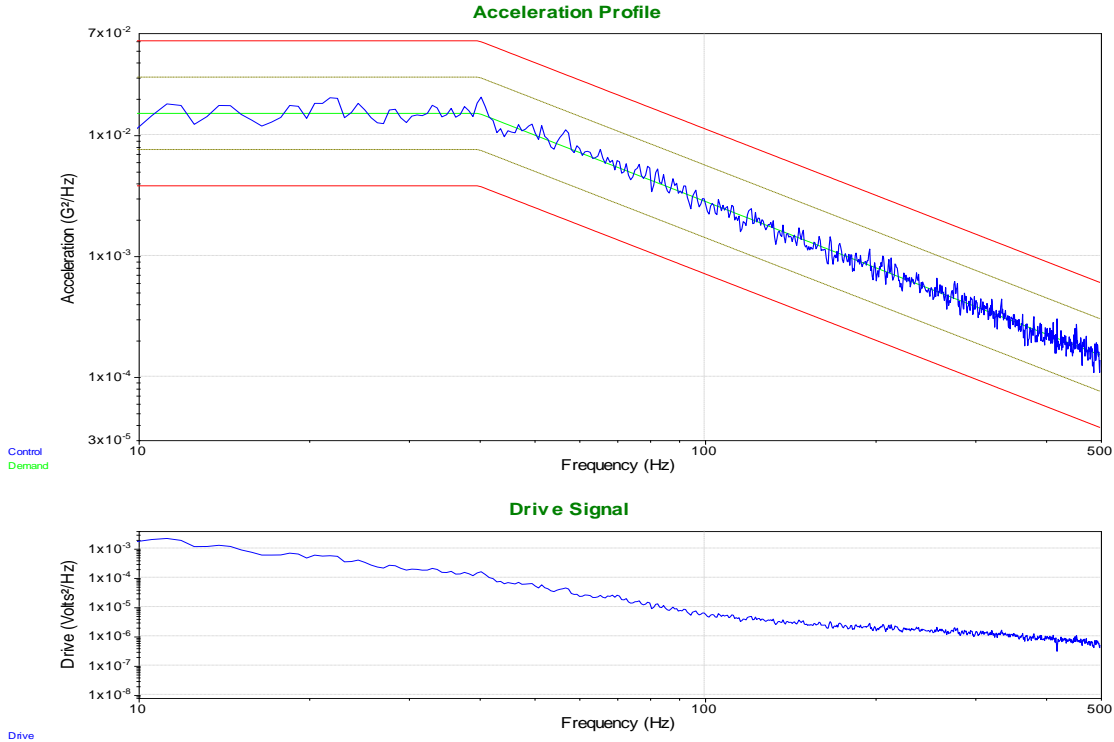
Data: C:\VibeSuite\Data\2016-06\2016Jun09-1411-0001.vrd  
 Test: C:\Documents and Settings\User\Desktop\TUV Test Jobs\PVV-5028\Z-Axis Random (Vertical).vrp  
 Data stored on Jun 09, 2016 14:41:34

Frequency	G²/Hz	dB/Octave
10 Hz	0.015	0
40 Hz	0.015	-5.489
500 Hz	0.00015

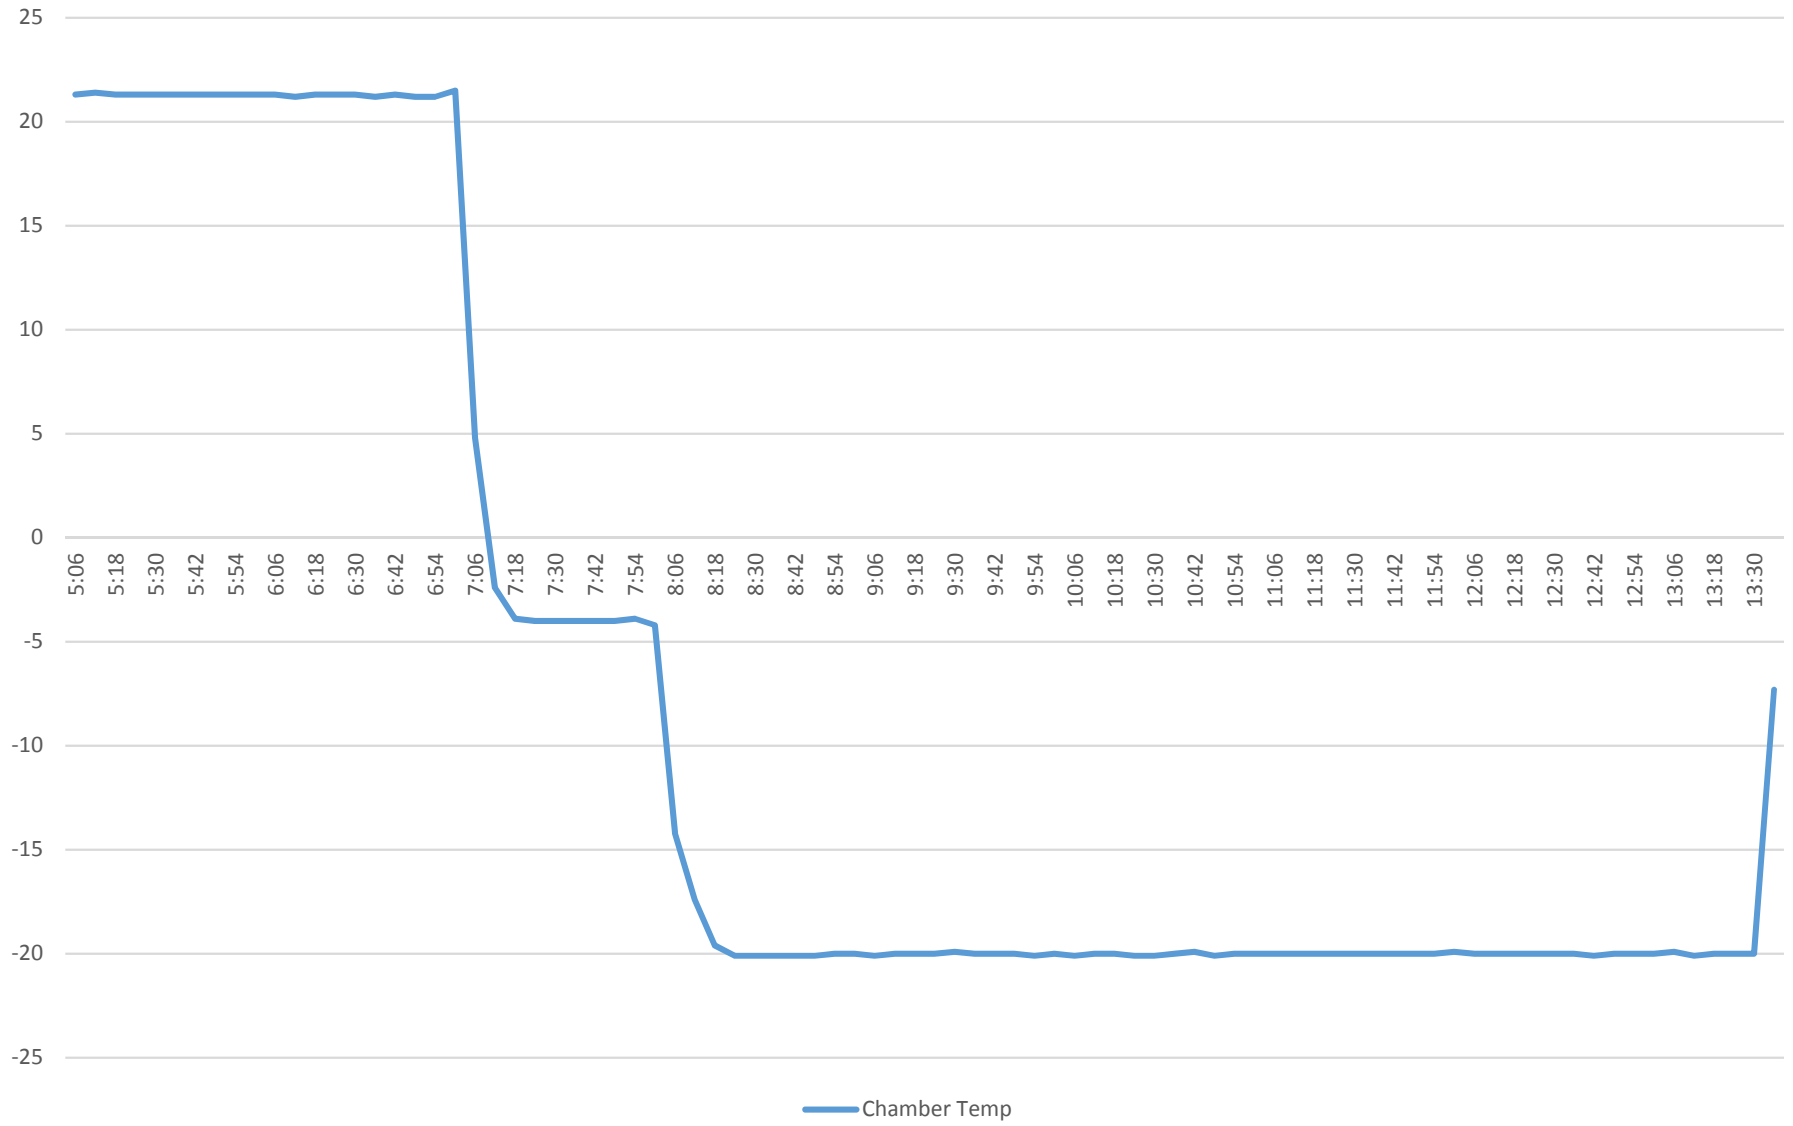
Project : Pro-V&V  
Job : PVV-5028  
Description : 4HRS @ -20°C

Pro V&V samples 1 to 24 (plus accessories) were used for Low Temperature - Storage testing. Samples completed the required soak without any signs of visual damage, and customer stated they remained functional. Refer to Appendix C: Low Temperature Setup and Data.

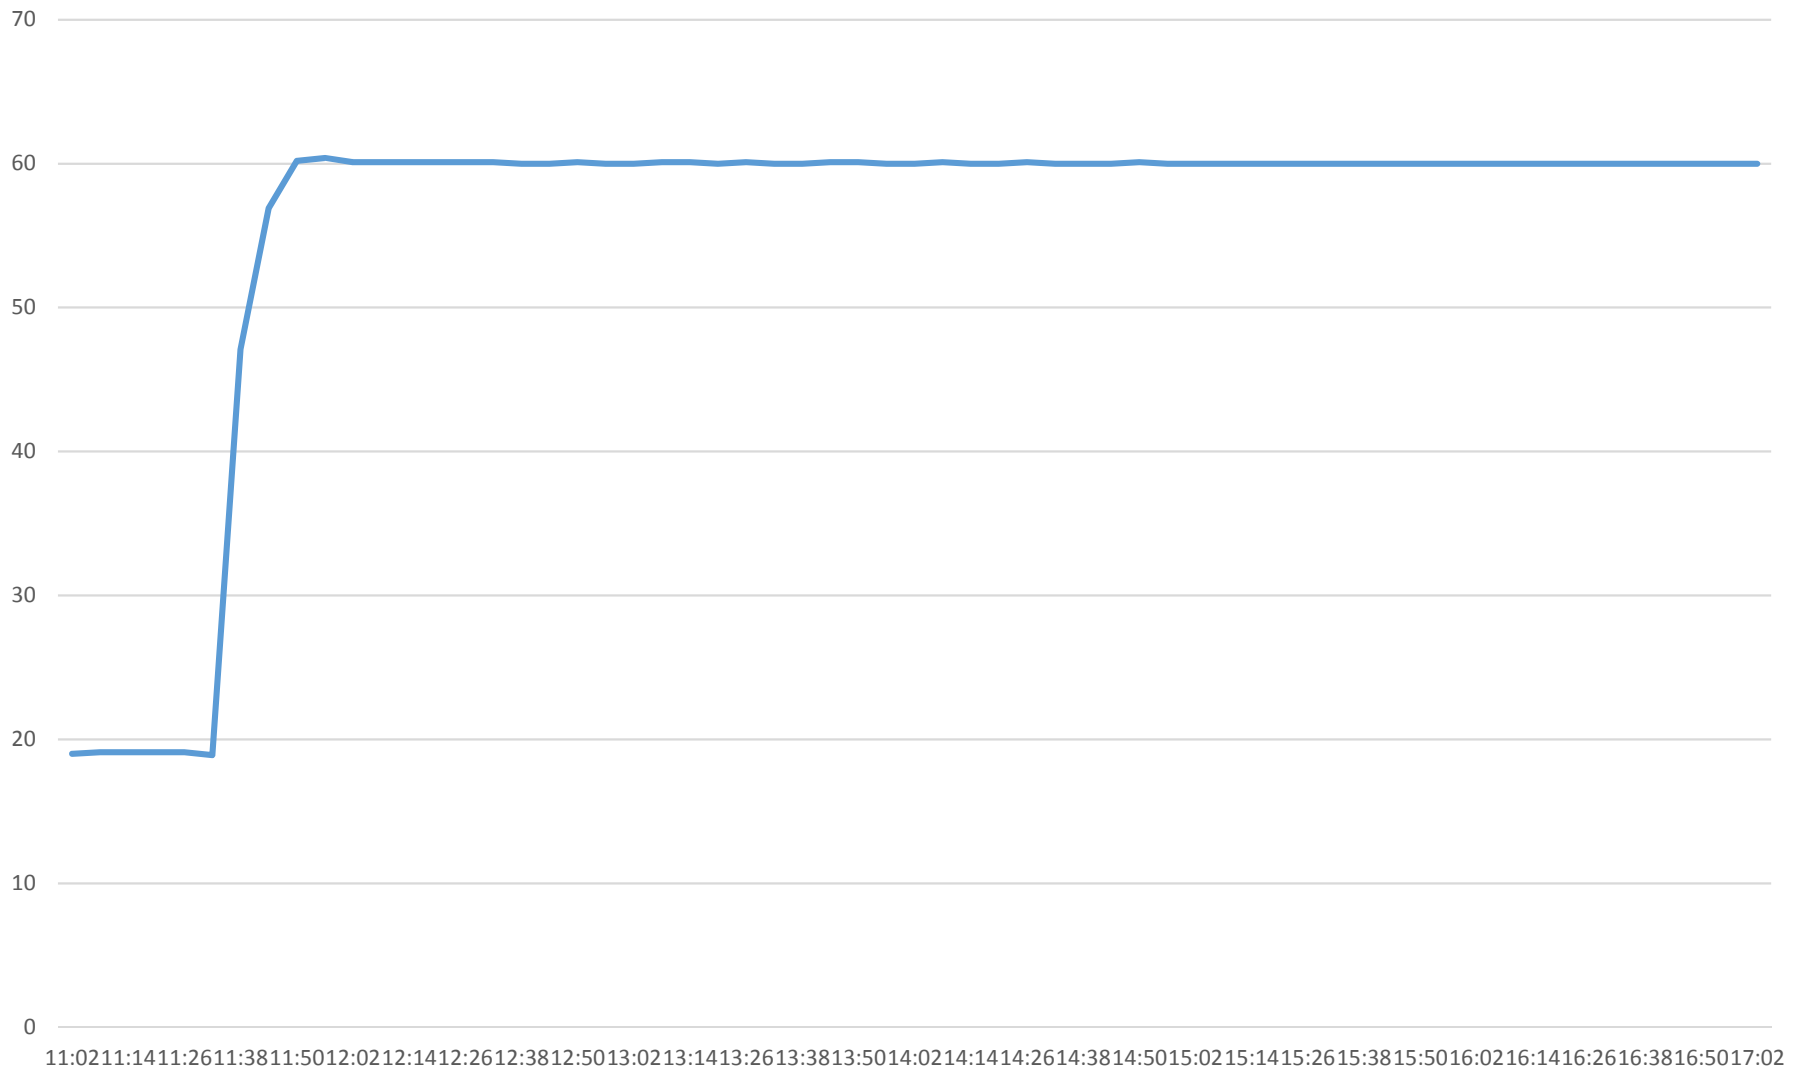
Project: Pro V&V  
Job : PVV-5028  
Description : 60°C (4 Hours)

— Chamber temp

Pro V&V samples 1 to 24 (plus accessories) were used for High Temperature - Storage testing as per procedure I. Samples completed the required soak without any signs of visual damage, and customer stated they remained functional. Refer to Appendix D: High Temperature Setup and Data.

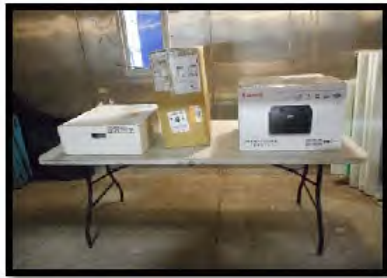
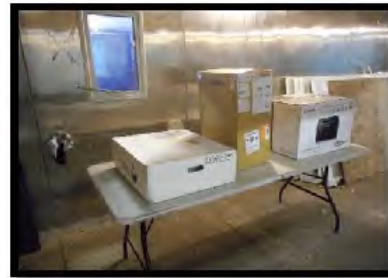
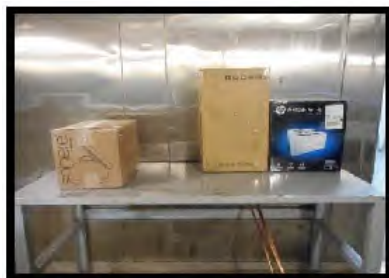
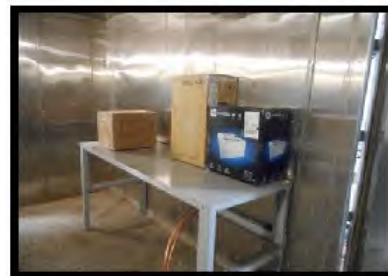
**Setup Photographs**

Sample Description	Voting Machine Systems
Number of samples	6 Samples
Sample Number(s)	5028-1 (ICP) ,5028-2 (ICX 15"), 5028-3 (Cannon Image LBP151DW) ,5028-4 (HP Laserjet M402dn), 5028-5 (ICX 21") , 5028-6 (ICX Samsung )
Specification	MIL-STD-810D, Military Standard Environmental Test Methods and Engineering Guidelines
Section	Method 507.2 Humidity - Procedure I - Natural (Hot-Humid, Cycle 1)
Test Description	Place the samples in an environmental walk-in chamber, and perform the Hot-Humid (Cycle 1) humidity profile outlined under MIL-STD-810D, Table 507.2-1 (Cycle 1), for a total of 10 cycles (240hrs).
Data to be Provided	Temperature and Humidity Data. Photographs of Setup Photographs of samples before and after test
Requirement	Completion of required humidity cycles. Customer to perform final operational check

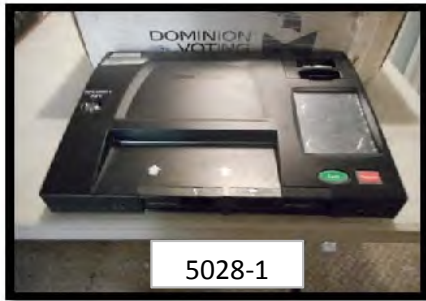
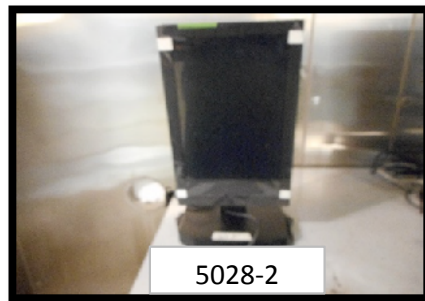
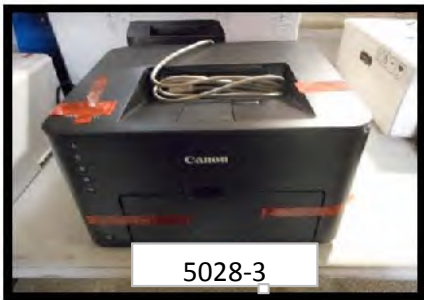
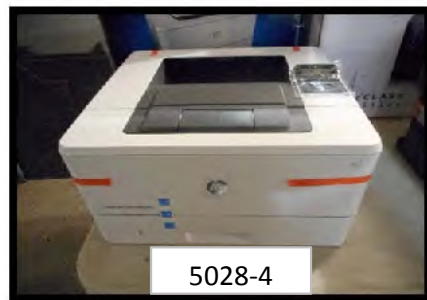
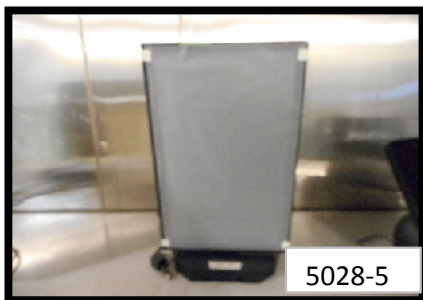
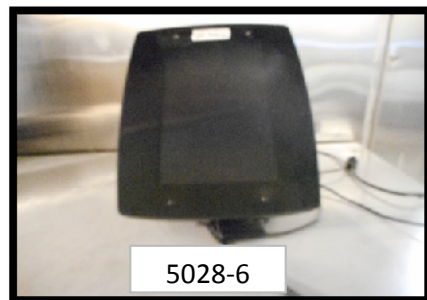
**Humidity Testing - Post Test Photographs**

Pro V&V samples 1 to 24 (plus accessories) were used for Humidity testing as per Procedure I – Hot/Humid. Samples completed the required soak without any signs of visual damage, and customer stated they remained functional. Refer to Appendix E: Humidity Setup and Data.
