## Pro V&V Voting Machine Testing

Report/Quotation Number: PVV-5028.00 (CM380832205802.0)  
Revision Number of Report: 0

Perform MIL-STD-810D environmental testing on supplied Pro V & V (Dominion) Voting system components, as per quotation CM380832205802, and customer's additional instructions by email.

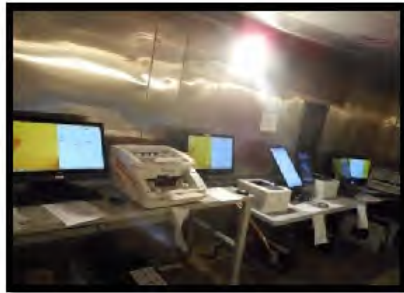
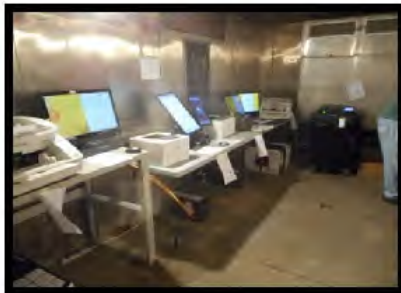
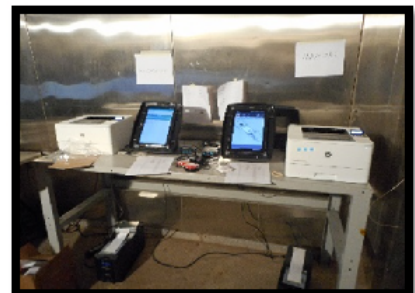
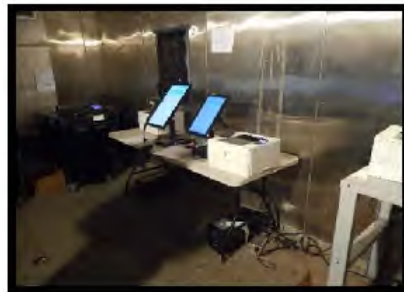
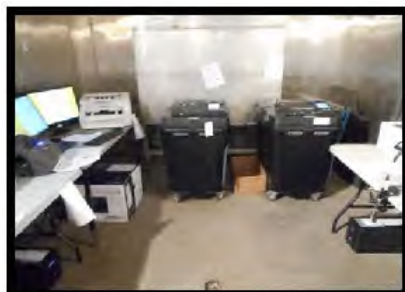
#### Pre Test Setup photograph

Data Acquisition Program & Worksheet: 4TC Logger App.vi			
Measurement Description	Data Aq. System	Data Aq. Freq.	Channel
Temperature Monitoring	DATA-AQ-13	10Hz	TC-01,

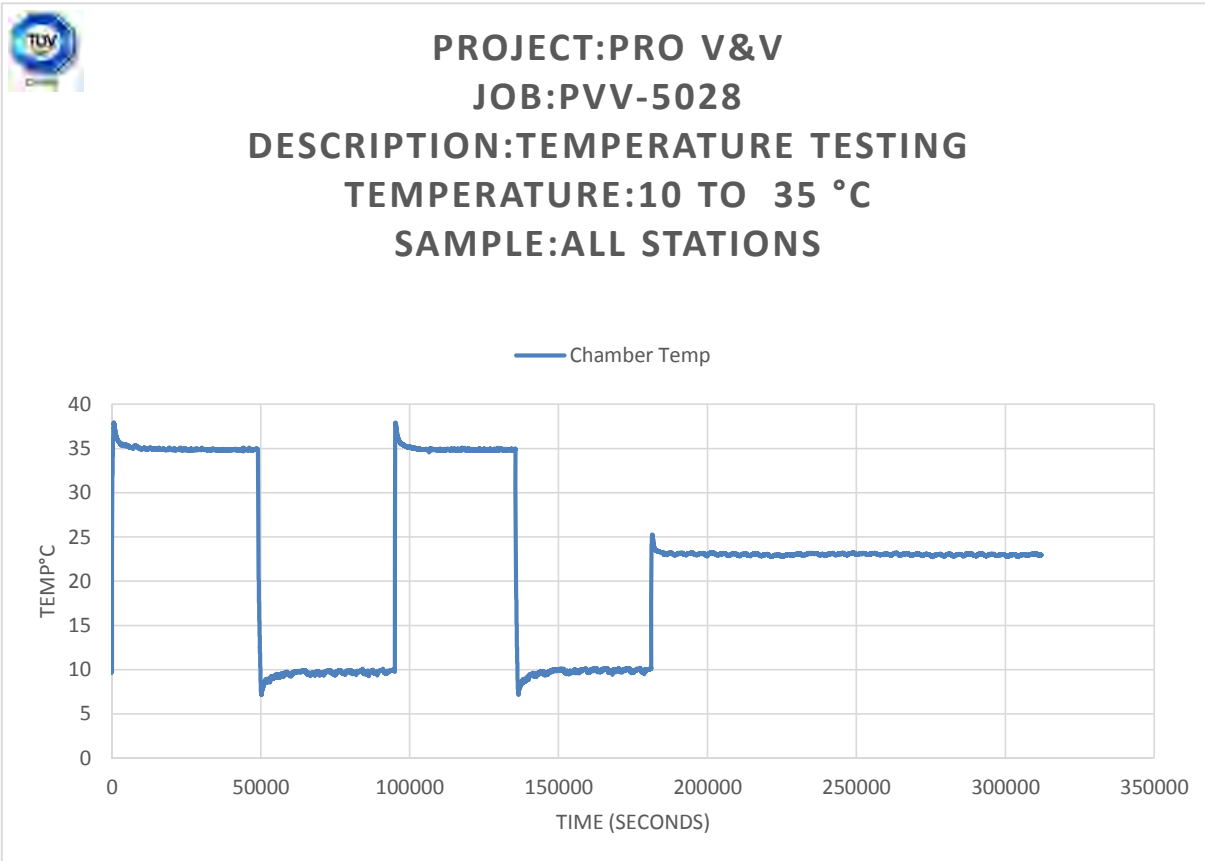
**Temperature Profile**

1- Ramp to 10°C
2- Hold 10°C for 12 hours
3- Ramp to 35°C over 1 hour
4- Hold 35°C for 12 hours
5- Ramp to 10°C over 1 hour
6- Repeat until 85 hours cycling at profile is achieved
7- Ramp to 35°C over 1 hour
8- Hold 35°C for 12 hours
9- Ramp to 23°C over 1 hour
10- Hold for duration of test

Pro V&V samples 1 to 24 (plus accessories) were used for Temp-Power Variation testing. Samples completed the required 85 hours without any signs of visual damage, and customer stated they remained functional for the entire duration of the cycle. Refer to Appendix F: Temp-Power Variation Setup and Data.
