<b>Report Number:</b>	ERB20419, Rev. A
<b>Report Type:</b>	Engineering-level
<b>Reference Standard:</b>	IEC 61000-4-3, Ed. 3.0 (2006-02) + A1 (2007-11) + A2 (2010-03) EN 61000-4-3: 2006 + A1: 2008 + A2: 2010
Date of Report:	4 May 2012
Product Name:	Assure 1.3 AccuVote - OS MRAM Memory Card (181-001004) Rev. 1
Model Number:	181-001004
Serial Number:	35935 (SE) (Model B)
Manufacturer:	Dominion Voting Systems, Inc.
<b>Representative:</b>	Darrick Forester (SLI Global Solutions)
Approved By:	Vincent w. But

This report outlines the engineering-level immunity testing that was performed on a piece of information technology equipment. The purpose of this test was to give a level of confidence that the new memory card in this unit complied with the RF immunity requirements of IEC/EN 61000-4-3.

The product name was the Assure 1.3 AccuVote - OS MRAM Memory Card (181-001004) Rev. 1 manufactured by Dominion Voting Systems, Inc. located in Denver, Colorado. The model number of the unit tested was 181-001004 and the serial number was 35935 (SE) (Model B). This product is 128Kb data storage card using MRAM based memory and specifically designed for use with the Dominion's AccuVote-OS optical scan

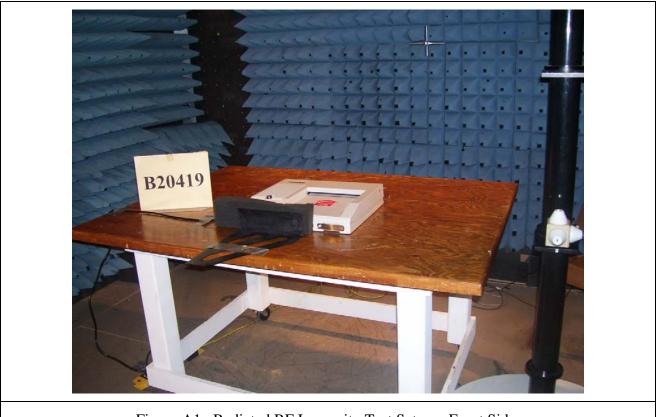
Figure A1. Radiated RF Immunity Test Setup – Front Side.

3.4 Radiated RF Immunity. Radiated RF immunity testing was performed on the UUT over the frequency range from 80 MHz to 1.0 GHz in 1% frequency increments. The UUT was a table-top device, which was placed on a non-conductive table 80 cm tall at a distance of 2 meters from the radiating antenna. The height of the antenna was 2 meters. The magnitude of the impinged field was 10 V/m and this field was amplitude modulated with a 1 kHz sine wave to a depth of 80%. The UUT was oriented such that all four sides were illuminated over the entire frequency range. Testing was performed for both vertical and horizontal polarities.

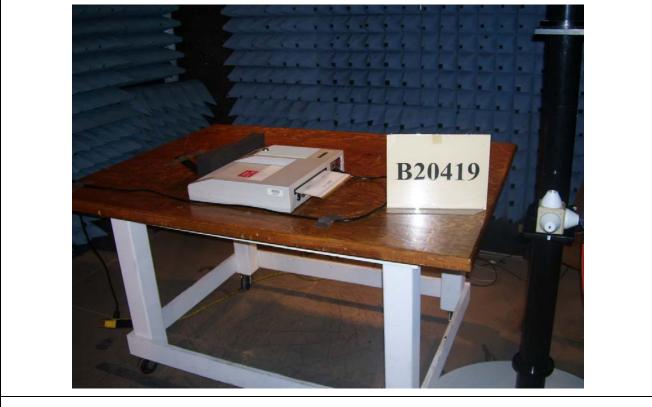
Figure A2. Radiated RF Immunity Test Setup – Right Side.

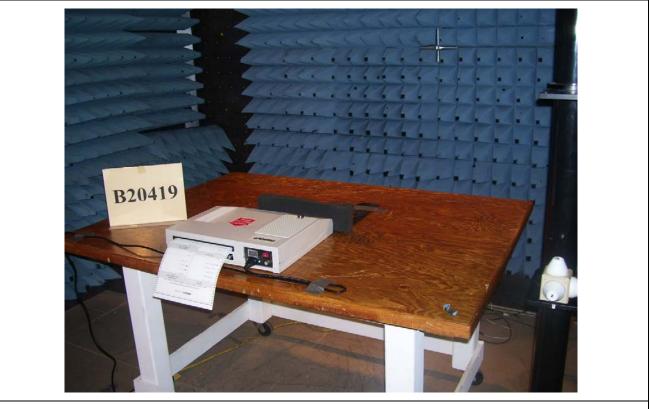
Figure A3. Radiated RF Immunity Test Setup – Back Side.

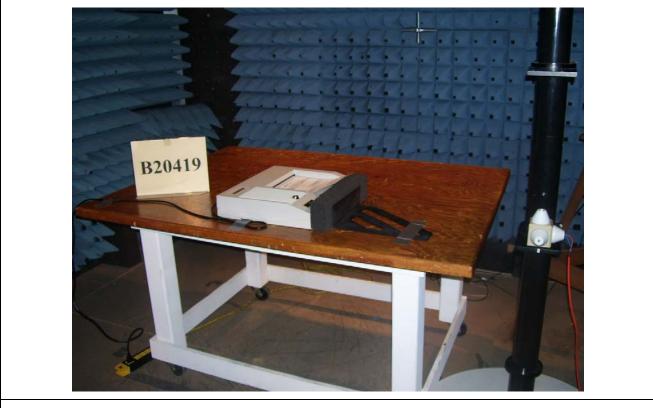
Figure A4. Radiated RF Immunity Test Setup – Left Side.
