# NTS Labs, LLC Test Report for EMI Immunity Testing of the ClearMark

**Prepared For**

Pro V&V, Inc | 1736 Vista View Drive | Longmont, CO 80504

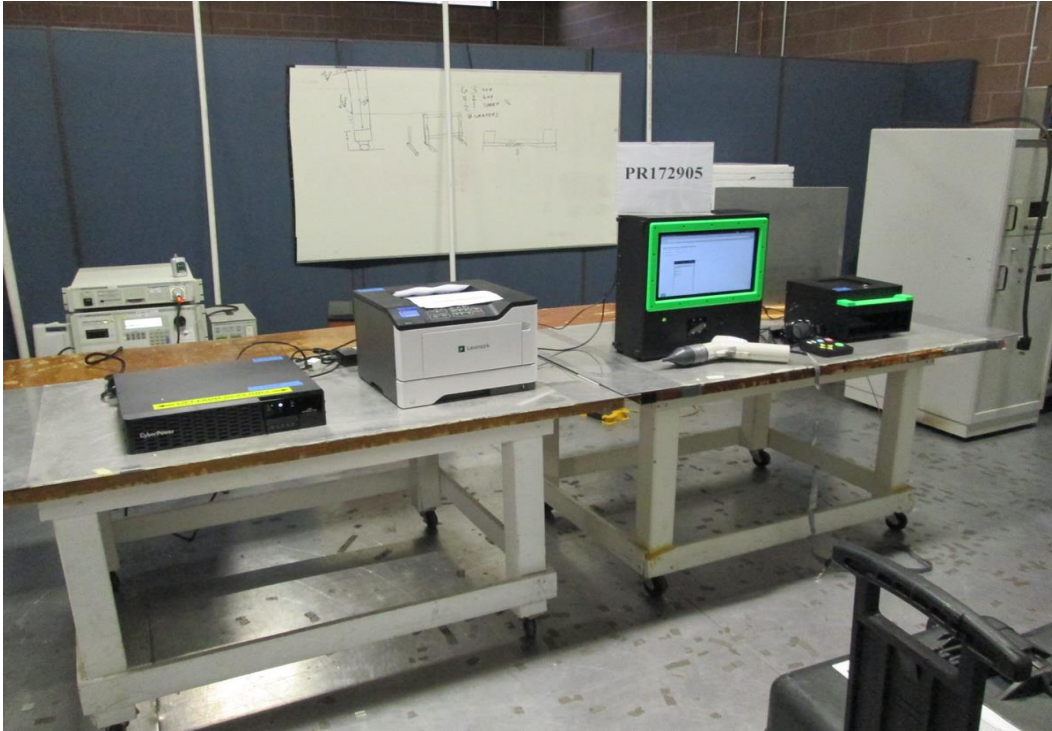
ESD Config 1 Setup

| Test Location | Voltage Level | Polarity | | Number of Pulses | Pulses Per Second | Comments | Criteria Met | Pass/Fail |
|---|---|---|---|---|---|---|---|---|
| ESD Config. 1 Setup | | | | | | | | |

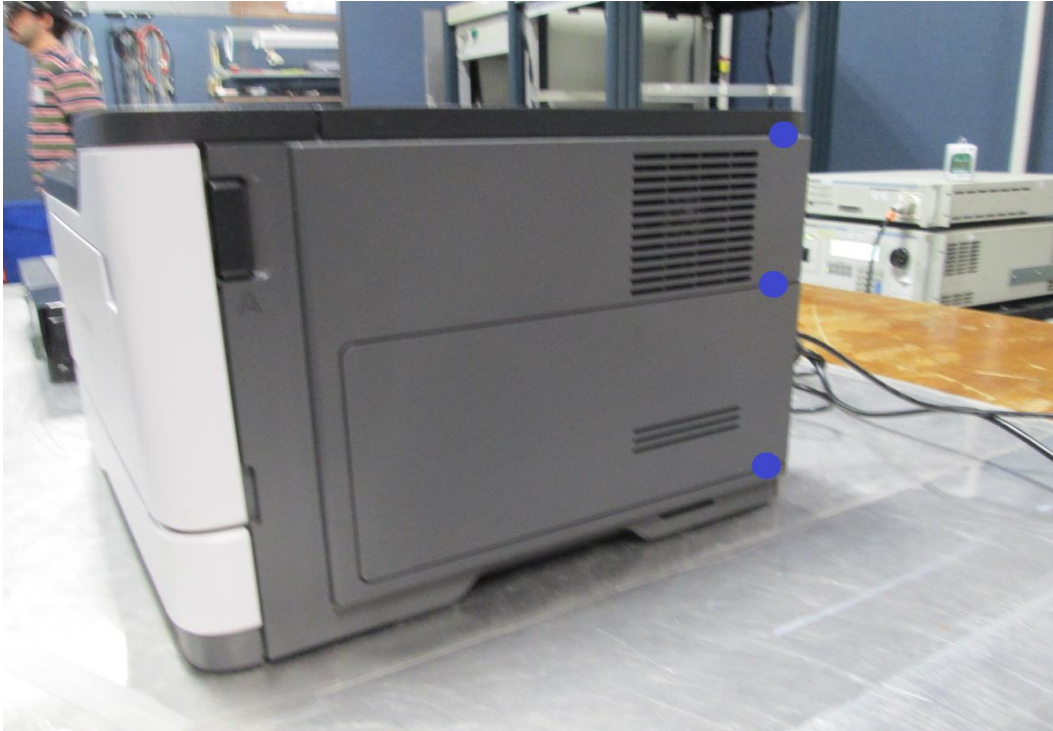
ESD Config 1 View 2

| Test Location | Voltage Level | Polarity | | Number of Pulses | Pulses Per Second | Comments | Criteria Met | Pass/Fail |
|---|---|---|---|---|---|---|---|---|
| ESD Config. 1 02 | 8 | X | X | 10 | 1 | | A | Pass |
| ESD Config. 1 02 | 2, 4, 8, 15 | X | X | 10 | 1 | +/-15kV Discharges occurred, No disruption in operation | A | Pass |

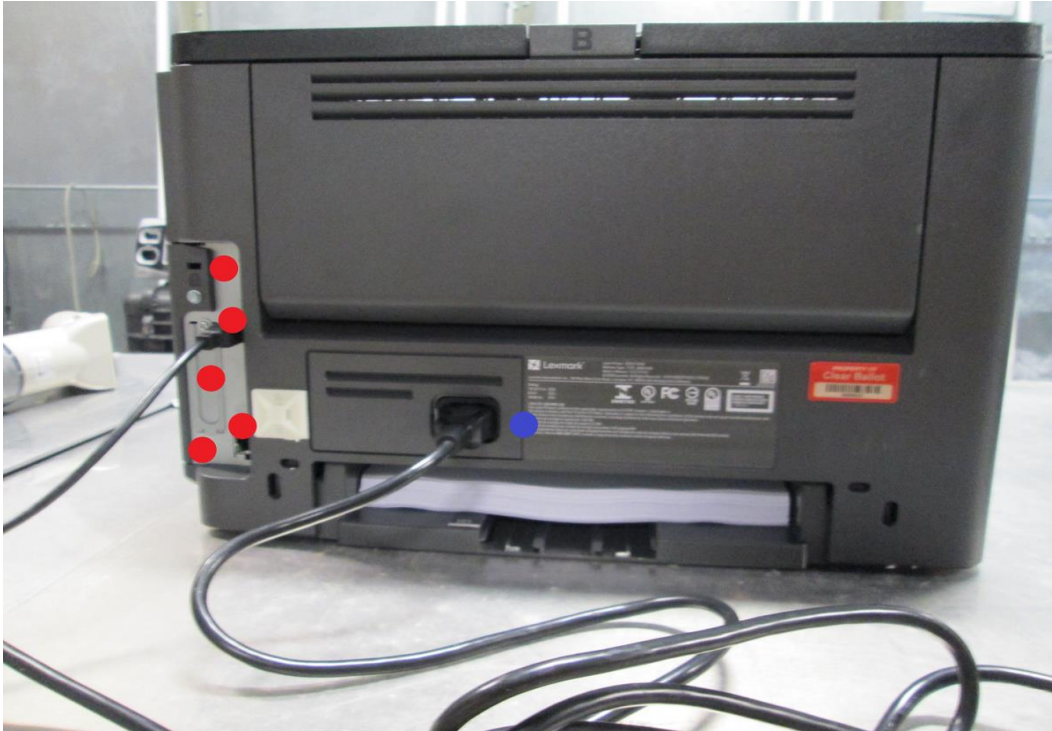
ESD Config 1 View 4

| Test Location | Voltage Level | Polarity | | Number of Pulses | Pulses Per Second | Comments | Criteria Met | Pass/Fail |
|---|---|---|---|---|---|---|---|---|
| ESD Config. 1 04 | 8 | X | X | 10 | 1 | | A | Pass |
| ESD Config. 1 04 | 2, 4, 8, 15 | X | X | 10 | 1 | +/-8,15kV Discharges occurred, No disruption in operation | A | Pass |

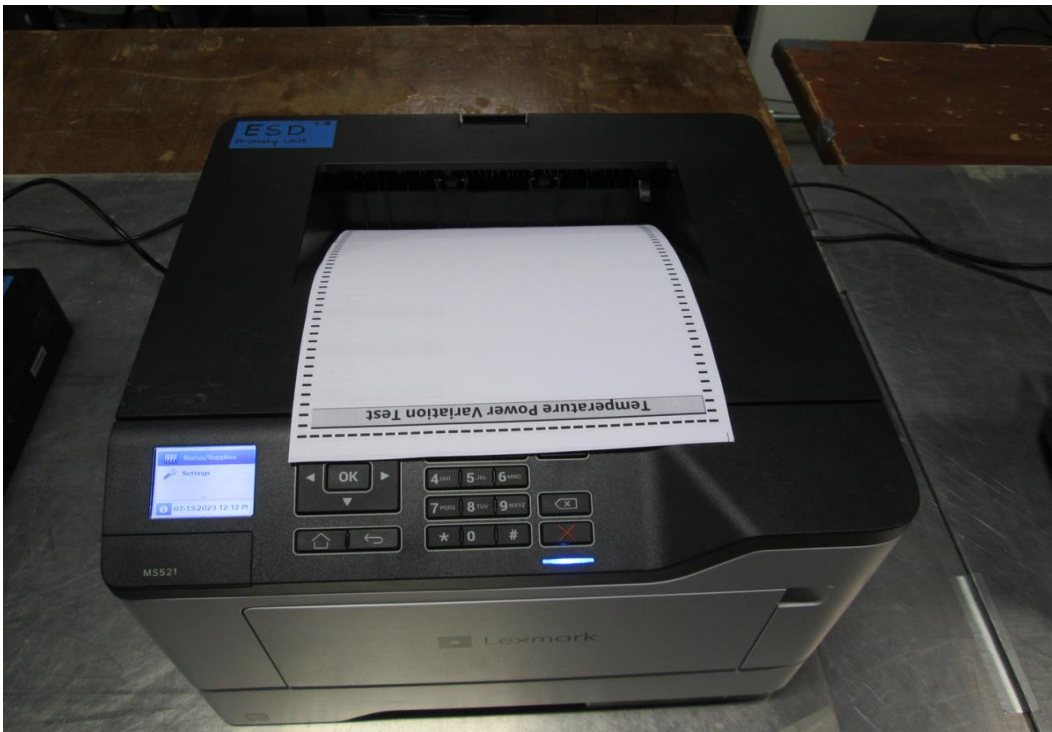
ESD Config 1 View 5

| Test Location | Voltage Level | Polarity | | Number of Pulses | Pulses Per Second | Comments | Criteria Met | Pass/Fail |
|---|---|---|---|---|---|---|---|---|
| ESD Config. 1 05 | 8 | X | X | 10 | 1 | | A | Pass |
| ESD Config. 1 05 | 2, 4, 8, 15 | X | X | 10 | 1 | ND | - | - |

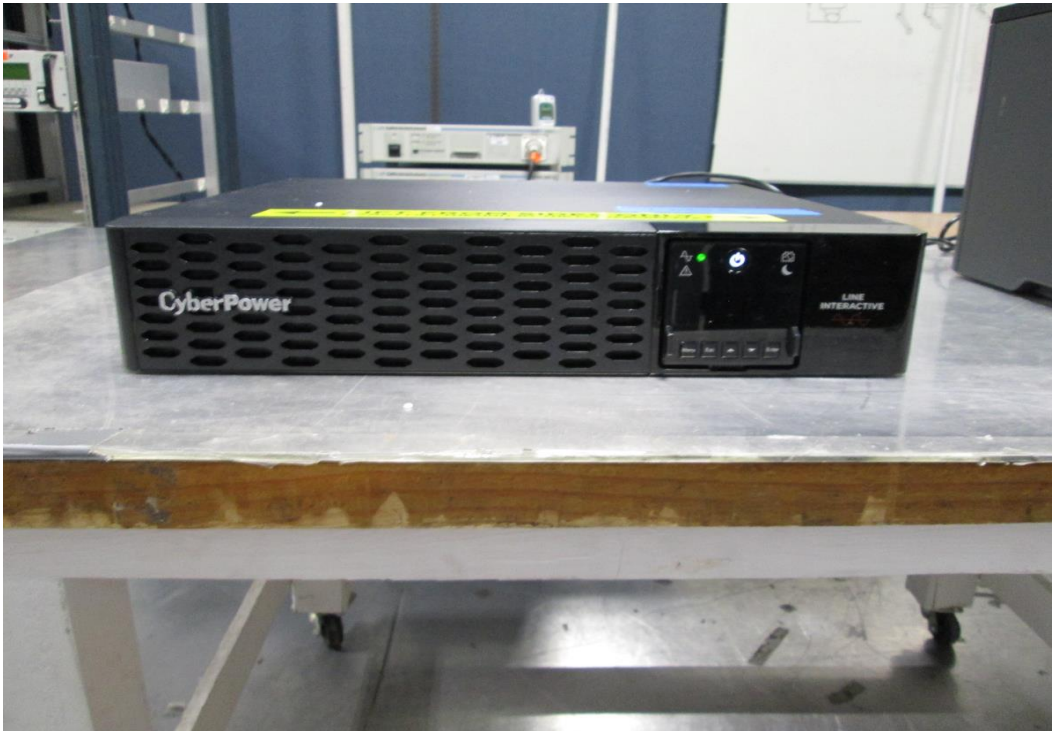
ESD Config 1 View 6

| Test Location | Voltage Level | Polarity | | Number of Pulses | Pulses Per Second | Comments | Criteria Met | Pass/Fail |
|---|---|---|---|---|---|---|---|---|
| ESD Config. 1 06 | 8 | X | X | 10 | 1 | | A | Pass |
| ESD Config. 1 06 | 2, 4, 8, 15 | X | X | 10 | 1 | ND | - | - |

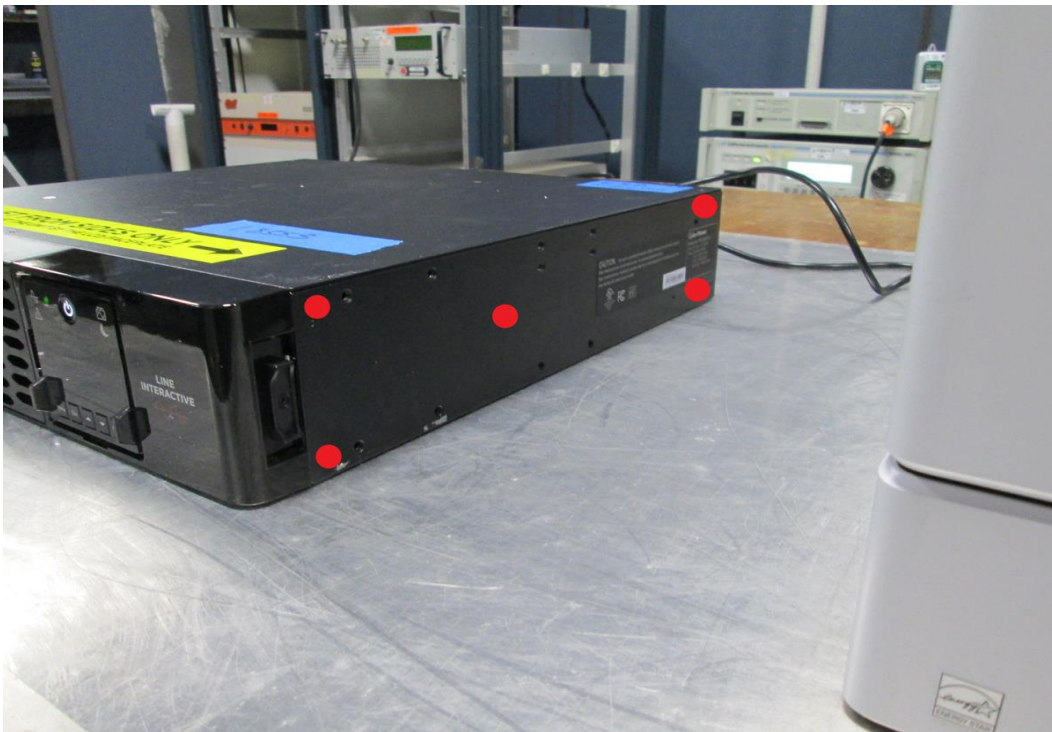
ESD Config 1 View 7

| Test Location | Voltage Level | Polarity | | Number of Pulses | Pulses Per Second | Comments | Criteria Met | Pass/Fail |
|---|---|---|---|---|---|---|---|---|
| ESD Config. 1 07 | 8 | X | X | 10 | 1 | | A | Pass |
| ESD Config. 1 07 | 2, 4, 8, 15 | X | X | 10 | 1 | ND | - | - |

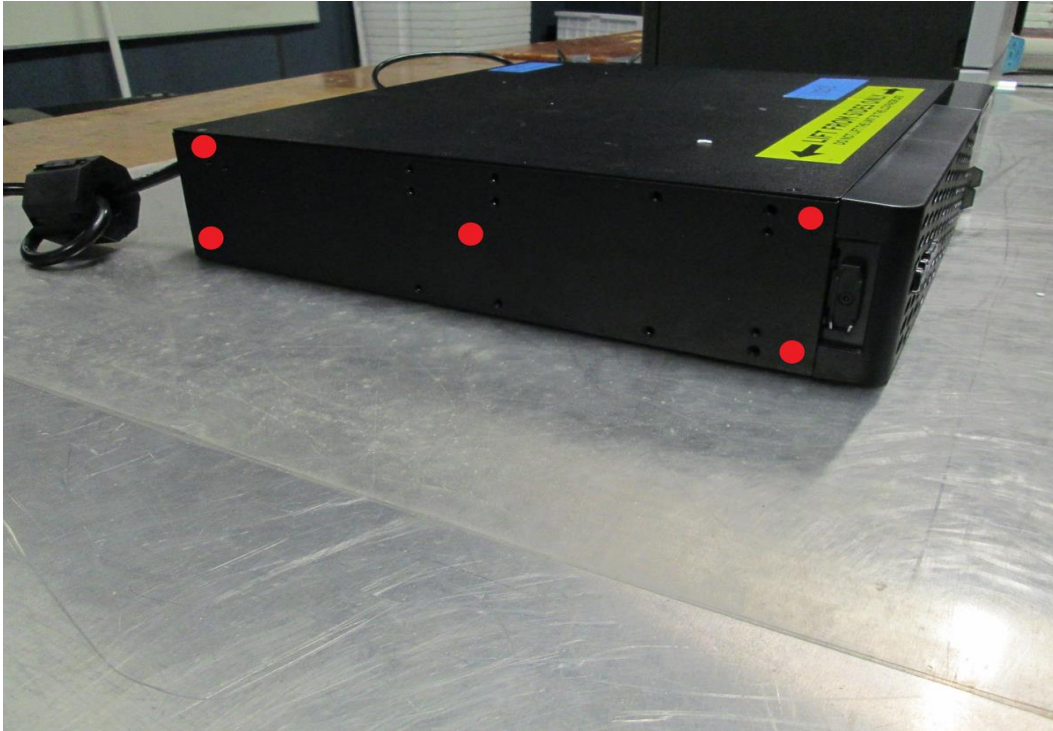
ESD Config 1 View 8

| Test Location | Voltage Level | Polarity | | Number of Pulses | Pulses Per Second | Comments | Criteria Met | Pass/Fail |
|---|---|---|---|---|---|---|---|---|
| ESD Config. 1 08 | 8 | X | X | 10 | 1 | | A | Pass |
| ESD Config. 1 08 | 2, 4, 8, 15 | X | X | 10 | 1 | ND | - | - |

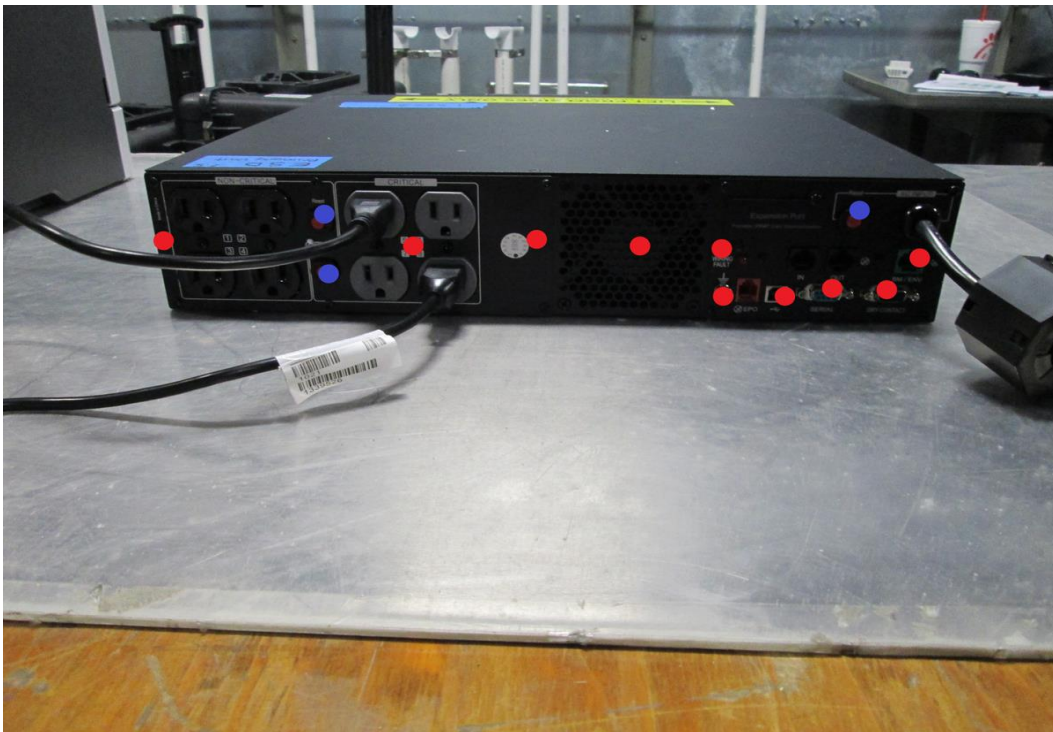
ESD Config 1 View 9

| Test Location | Voltage Level | Polarity | | Number of Pulses | Pulses Per Second | Comments | Criteria Met | Pass/Fail |
|---|---|---|---|---|---|---|---|---|
| ESD Config. 1 09 | 8 | X | X | 10 | 1 | | A | Pass |
| ESD Config. 1 09 | 2, 4, 8, 15 | X | X | 10 | 1 | +/-8,15kV Discharges occurred, No disruption in operation | - | Pass |

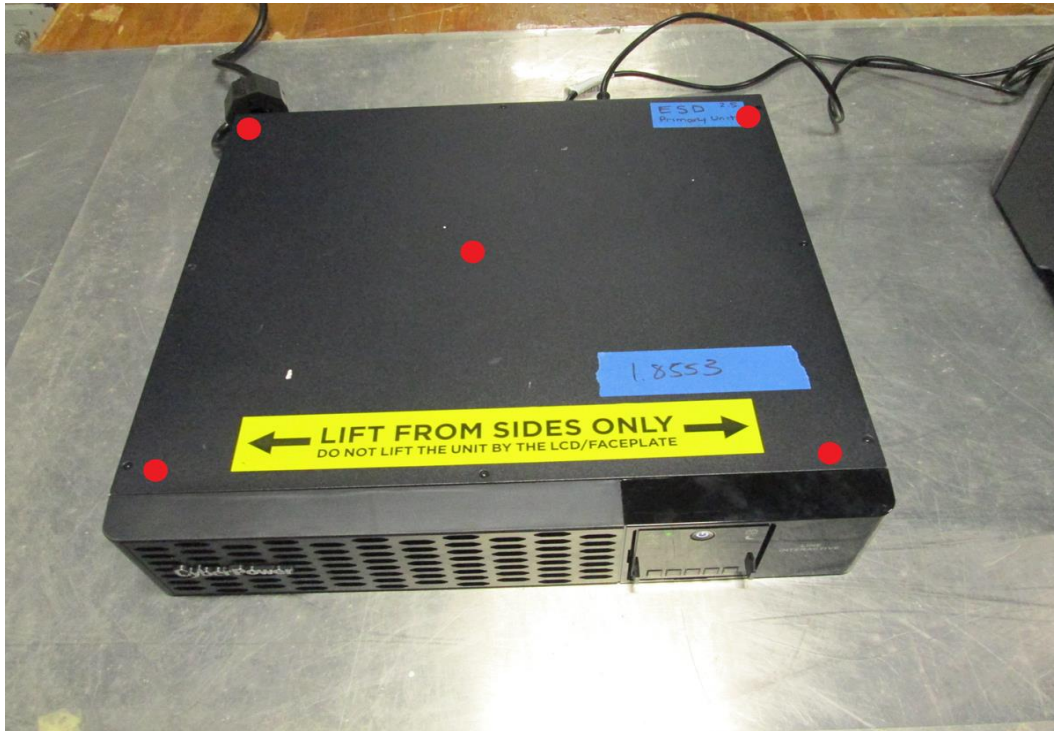
ESD Config 1 View 10

| Test Location | Voltage Level | Polarity | | Number of Pulses | Pulses Per Second | Comments | Criteria Met | Pass/Fail |
|---|---|---|---|---|---|---|---|---|
| ESD Config. 1 10 | 8 | X | X | 10 | 1 | | A | Pass |
| ESD Config. 1 10 | 2, 4, 8, 15 | X | X | 10 | 1 | ND | - | - |
