# Element Materials Technology Denver-Longmont A.K.A. NTS Labs, LLC

## Test Report for Electromagnetic Interference (EMI) Testing of the VxMarkScan

SLI Compliance | 4720 Independence Street | Wheat Ridge, CO 80033

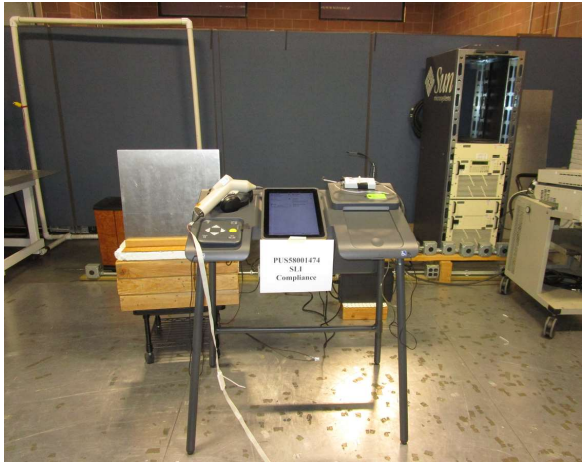
ESD Setup

| Element Materials Technology | | | | | | | | |
|---|---|---|---|---|---|---|---|---|
| ESD Setup | | | | | | | | |

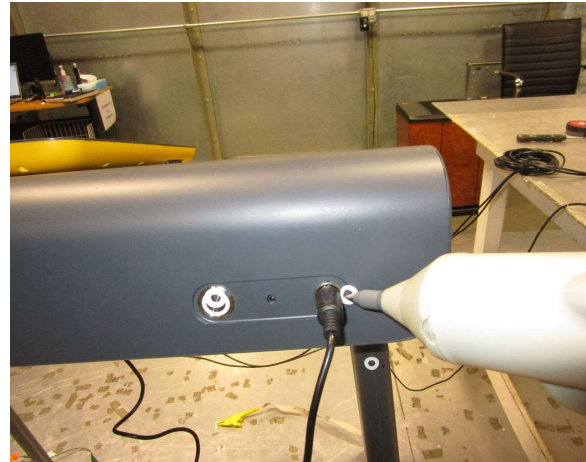
ESD 01 Contact Discharge

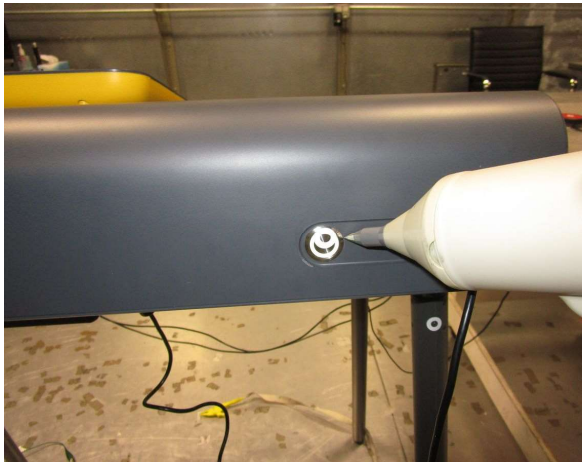
ESD 02 Contact Discharge

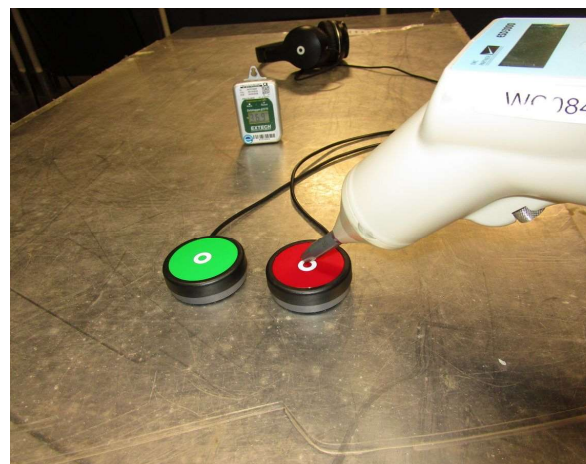
ESD 10 Air Discharge

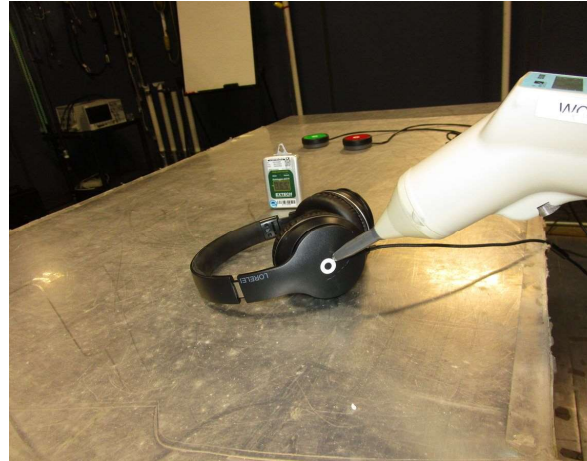
ESD 12 Air Discharge

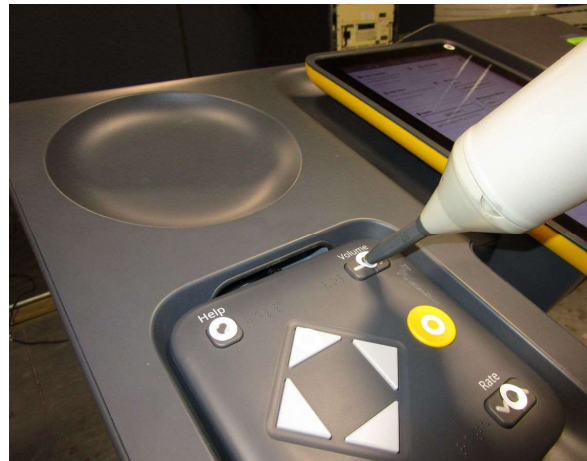
ESD 14 Air Discharge

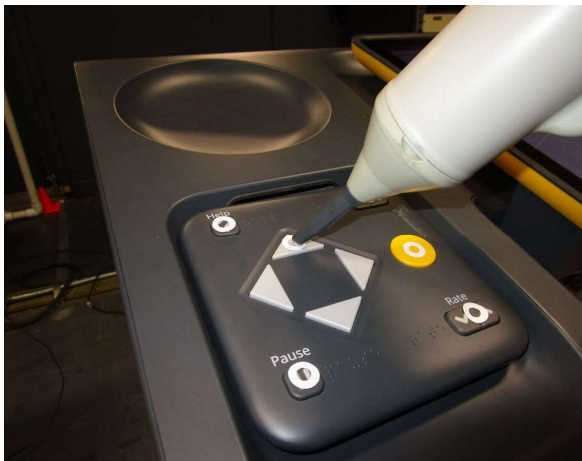
ESD 15 Air Discharge

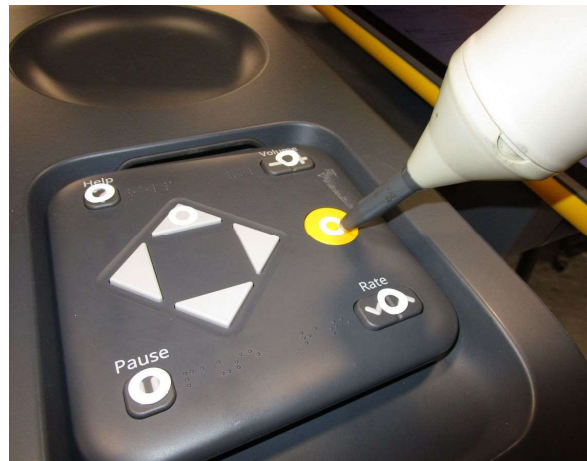
ESD 16 Air Discharge

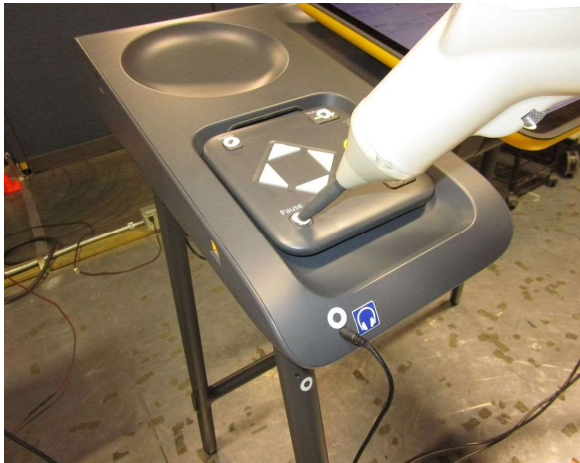
ESD 17 Air Discharge

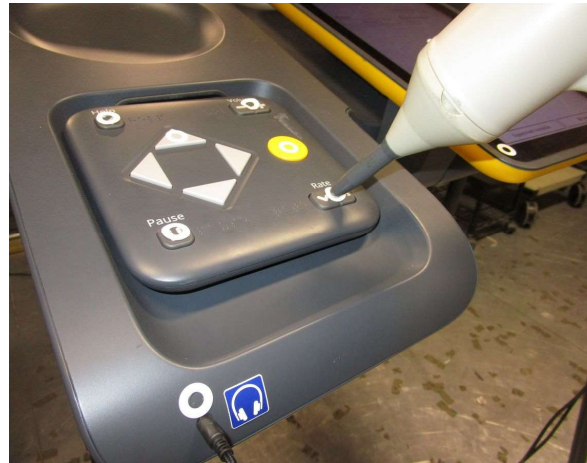
ESD 18 Air Discharge

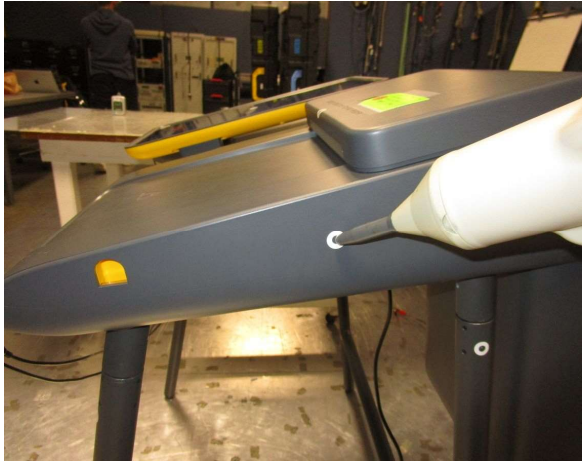
ESD 23 Air Discharge

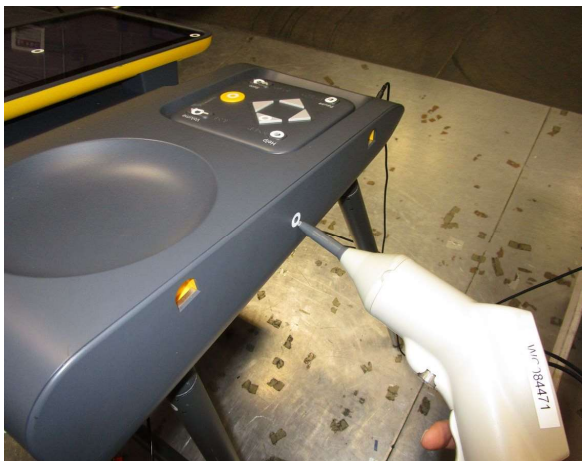
ESD 25 Air Discharge

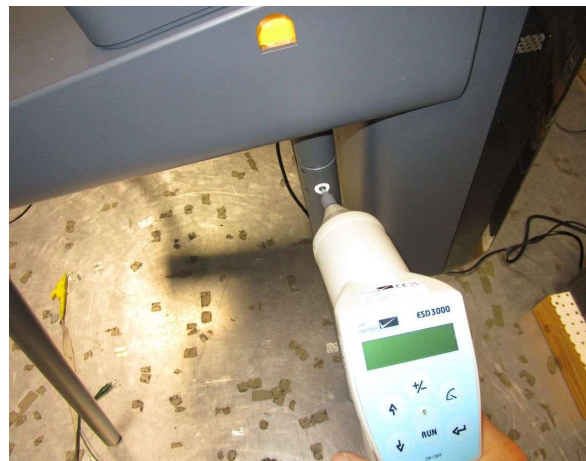
ESD 04 Contact Discharge

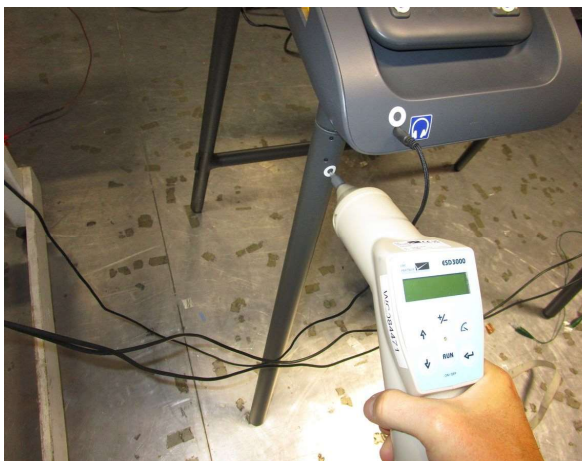
ESD 05 Contact Discharge

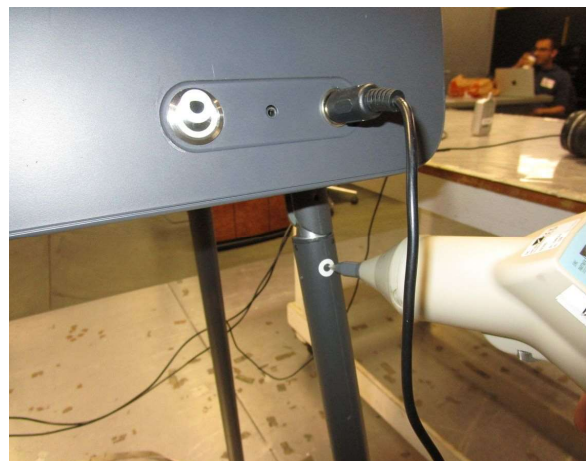
ESD 06 Contact Discharge
