# Element Materials Technology Denver-Longmont A.K.A. NTS Labs, LLC Test Report for Environmental Testing of the VxScan v.4.0.5

This document presents the test procedures used and the results obtained during the performance of an Environmental test program at Element Materials Technology Denver-Longmont (hereafter referred to as “Element”). The test program was conducted to assess the ability of the specified Equipment Under Test (EUT) to successfully satisfy the requirements defined in the test specification.

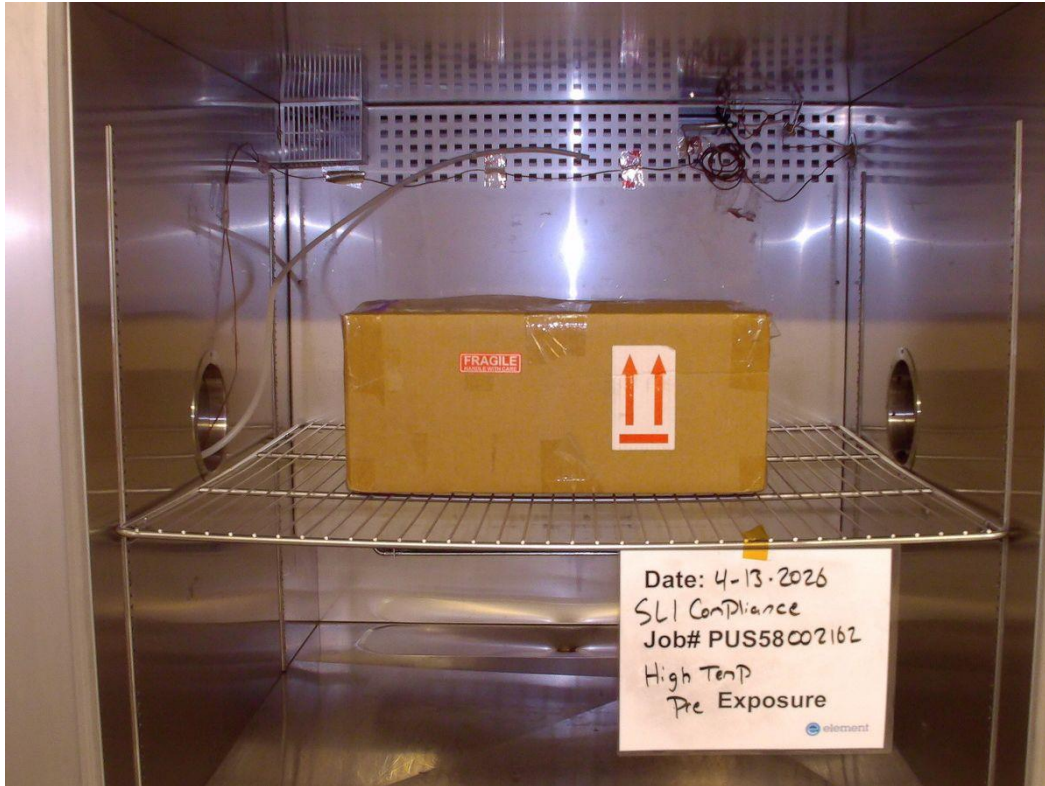
Pre-Exposure

| CLIMATICS TEST LOG | | | | | |
|---|---|---|---|---|---|
| | | Sample will be exposed in accordance to MIL-STD-810H Method 501.7 High Temperature Procedure I-Storage. The sample will be exposed to +60C with a relative humidity of 55%. The rate of temperature change will not exceed 3C/minute. The sample will dwell in those conditions for a duration of 4 hours. After the exposure the chamber will return to ambient conditions | | | CS |
